# Arborist Report

<b>File #:</b>	17-050.2
<b>Date:</b>	03 April 2017
<b>Revision Date:</b>	8 July 2019
<b>Client:</b>	ARC Real Estate Development Group
<b>Telephone:</b>	604-762-8596
<b>Email:</b>	info@arcdevelopmentgroup.com
<b>Site Address:</b>	1758 & 1752 Salisbury Ave, Port Coquitlam

Burley Boys Tree Service Ltd. has been contracted to provide tree inventory and tree removal/tree retention outline for the property at 1752 & 1758 Salisbury Ave, Port Coquitlam, BC. Plans include the development of the properties, including the construction of a new 9 unit townhouse complex.

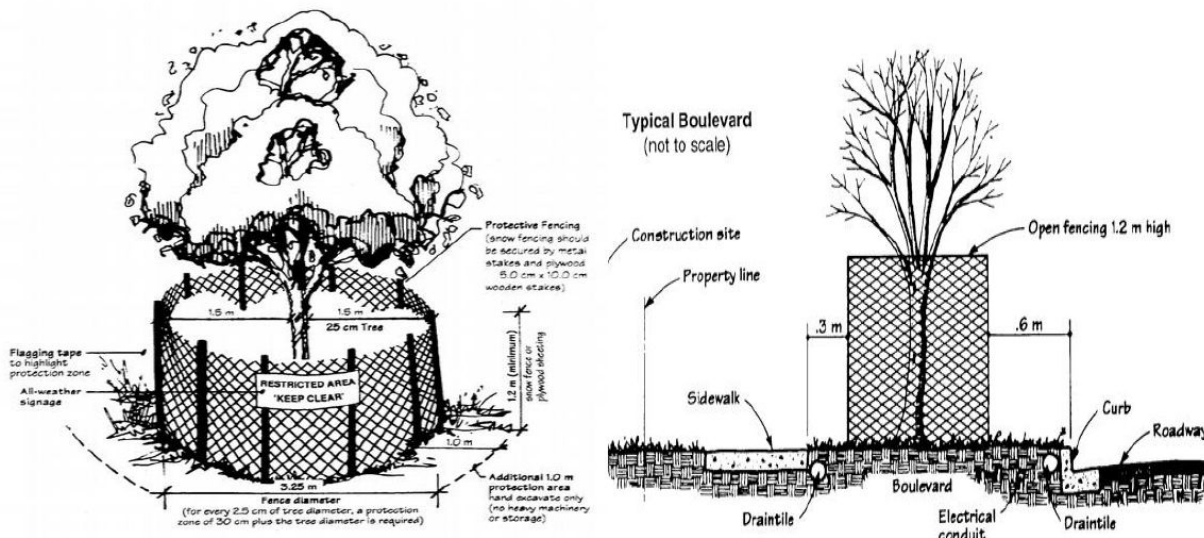
### Standard and Boulevard Tree Protection Barrier (TPB) guide/outline (Fig 3)

TPB is to be erected in accordance with municipal bylaw. Traditionally it is composed of wooden 2x4 construction and orange snow fencing material. It is to be erected in a suitable geometrical form or shape to encompass the outlined areas in the above mentioned report, or as described by development services. It is to be a permanent structure that can be maintained for the entire development process. It is to be adhered to and the inside area is not to be used for storage of supplies or rubbish. Any reduction in TPB should be supervised and Arborist consultation is mandatory.

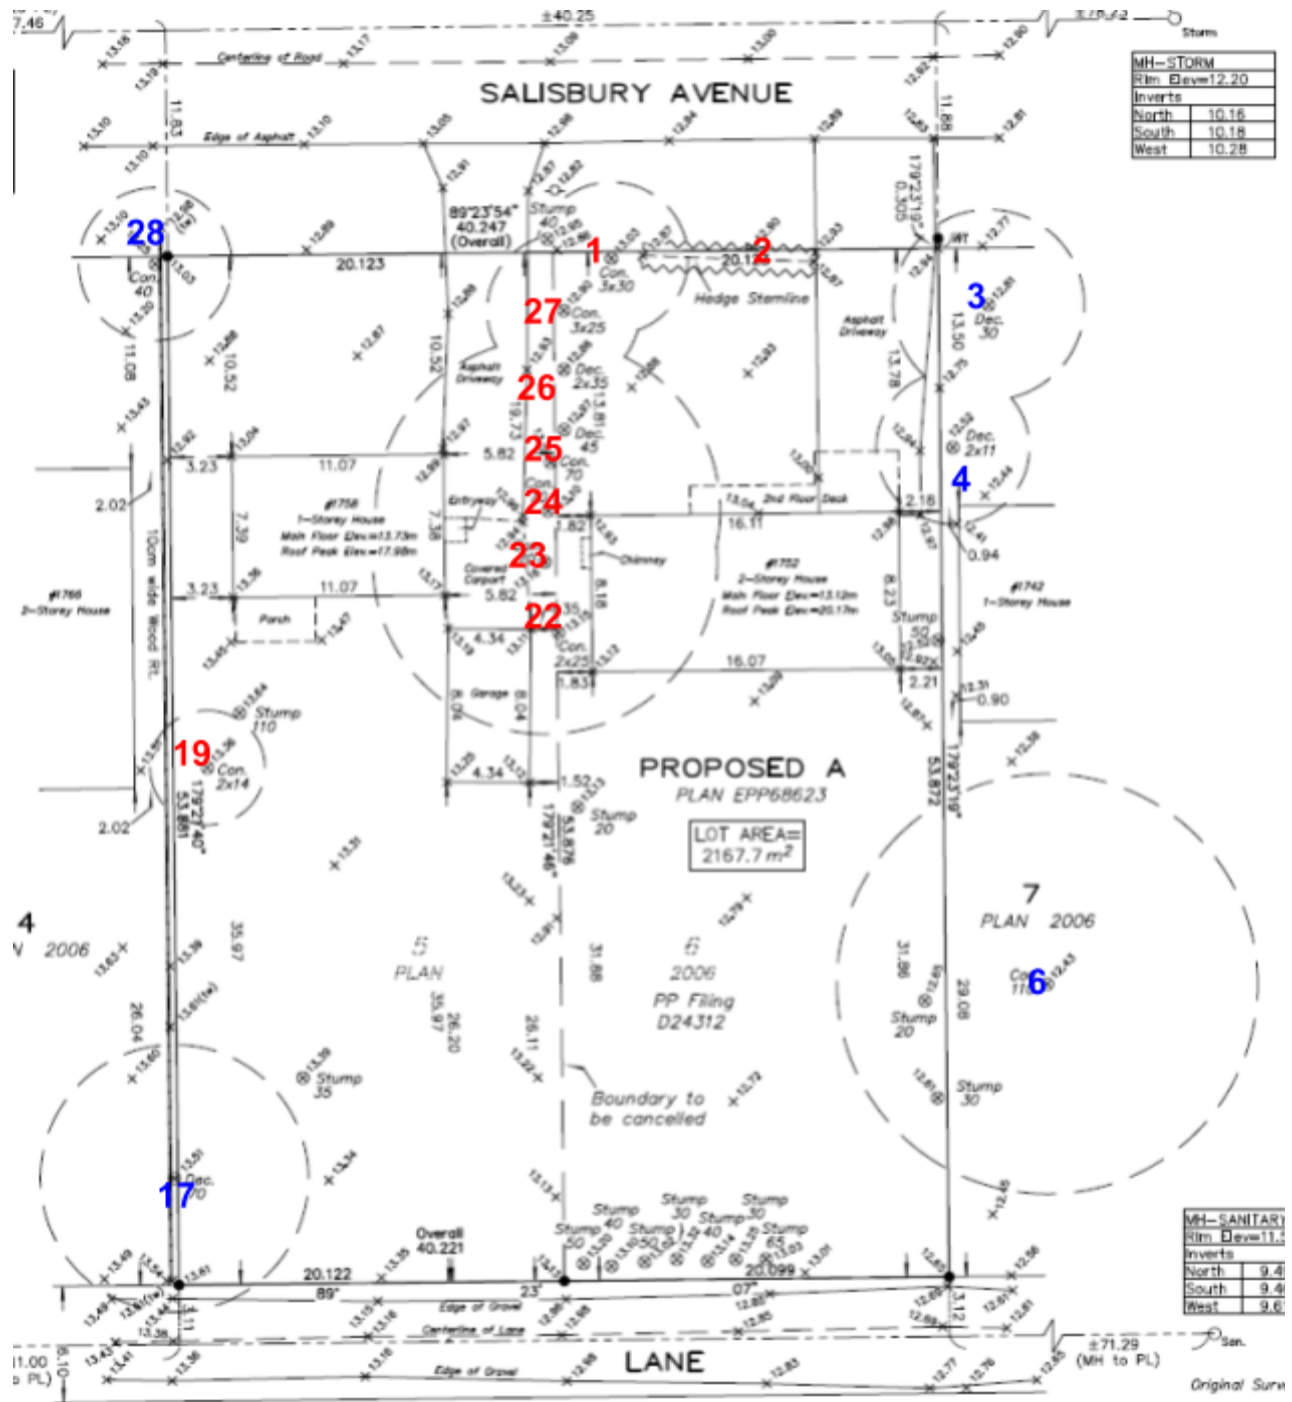
## Updated Site Survey:

Updated site survey showing all previously existing trees and outlines removal / retention recommendations (*Retain*, *Remove*, *Developer's Discretion*).

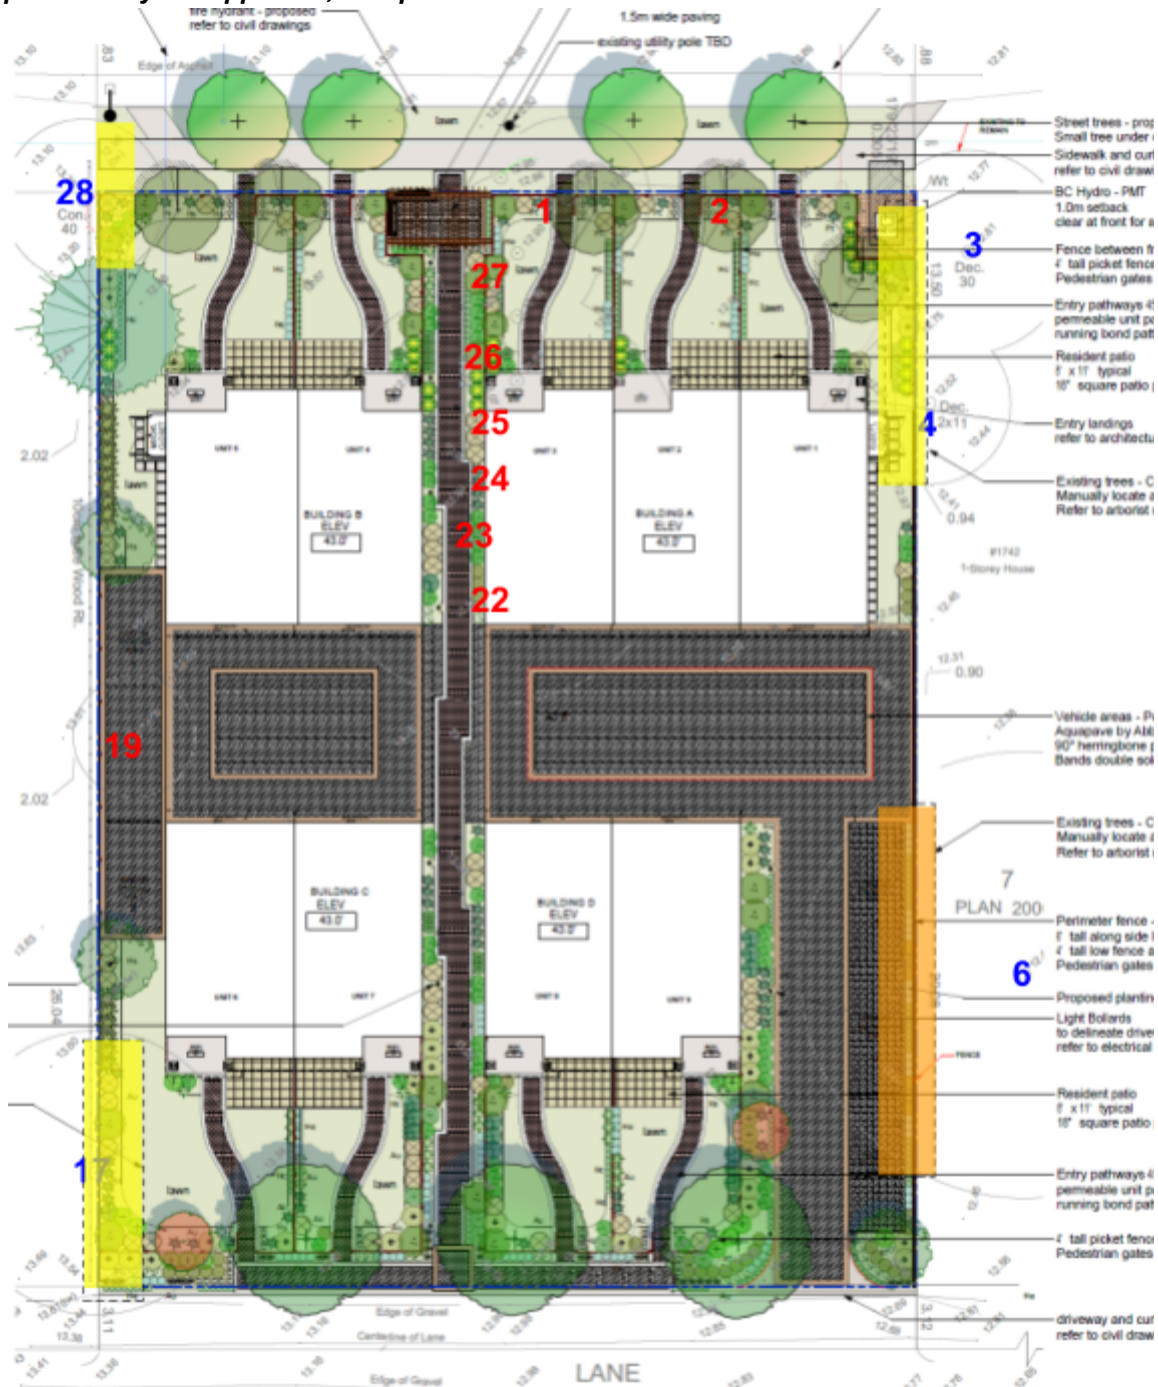
**Site Plans:** The below site plan plots tree locations and outlines removal / retention recommendations (*Retain*, *Remove*, *Developer's Discretion*). Location of tree protection barriers are shown in **Yellow**. Retained Trees requiring Arborist Supervision are outlined in **Orange**. **An original large, scaled copy of the site plan indicating trees marked for removal, and the locations of Tree Protection Zone fencing & Areas requiring Arborist Supervision has not been included with this report; this is to be provided by the applicant, if required.**
