# **PORT COQUITLAM COMMUNITY CENTRE**

## **Owner's Representative Progress Report #30**

**September 2019**

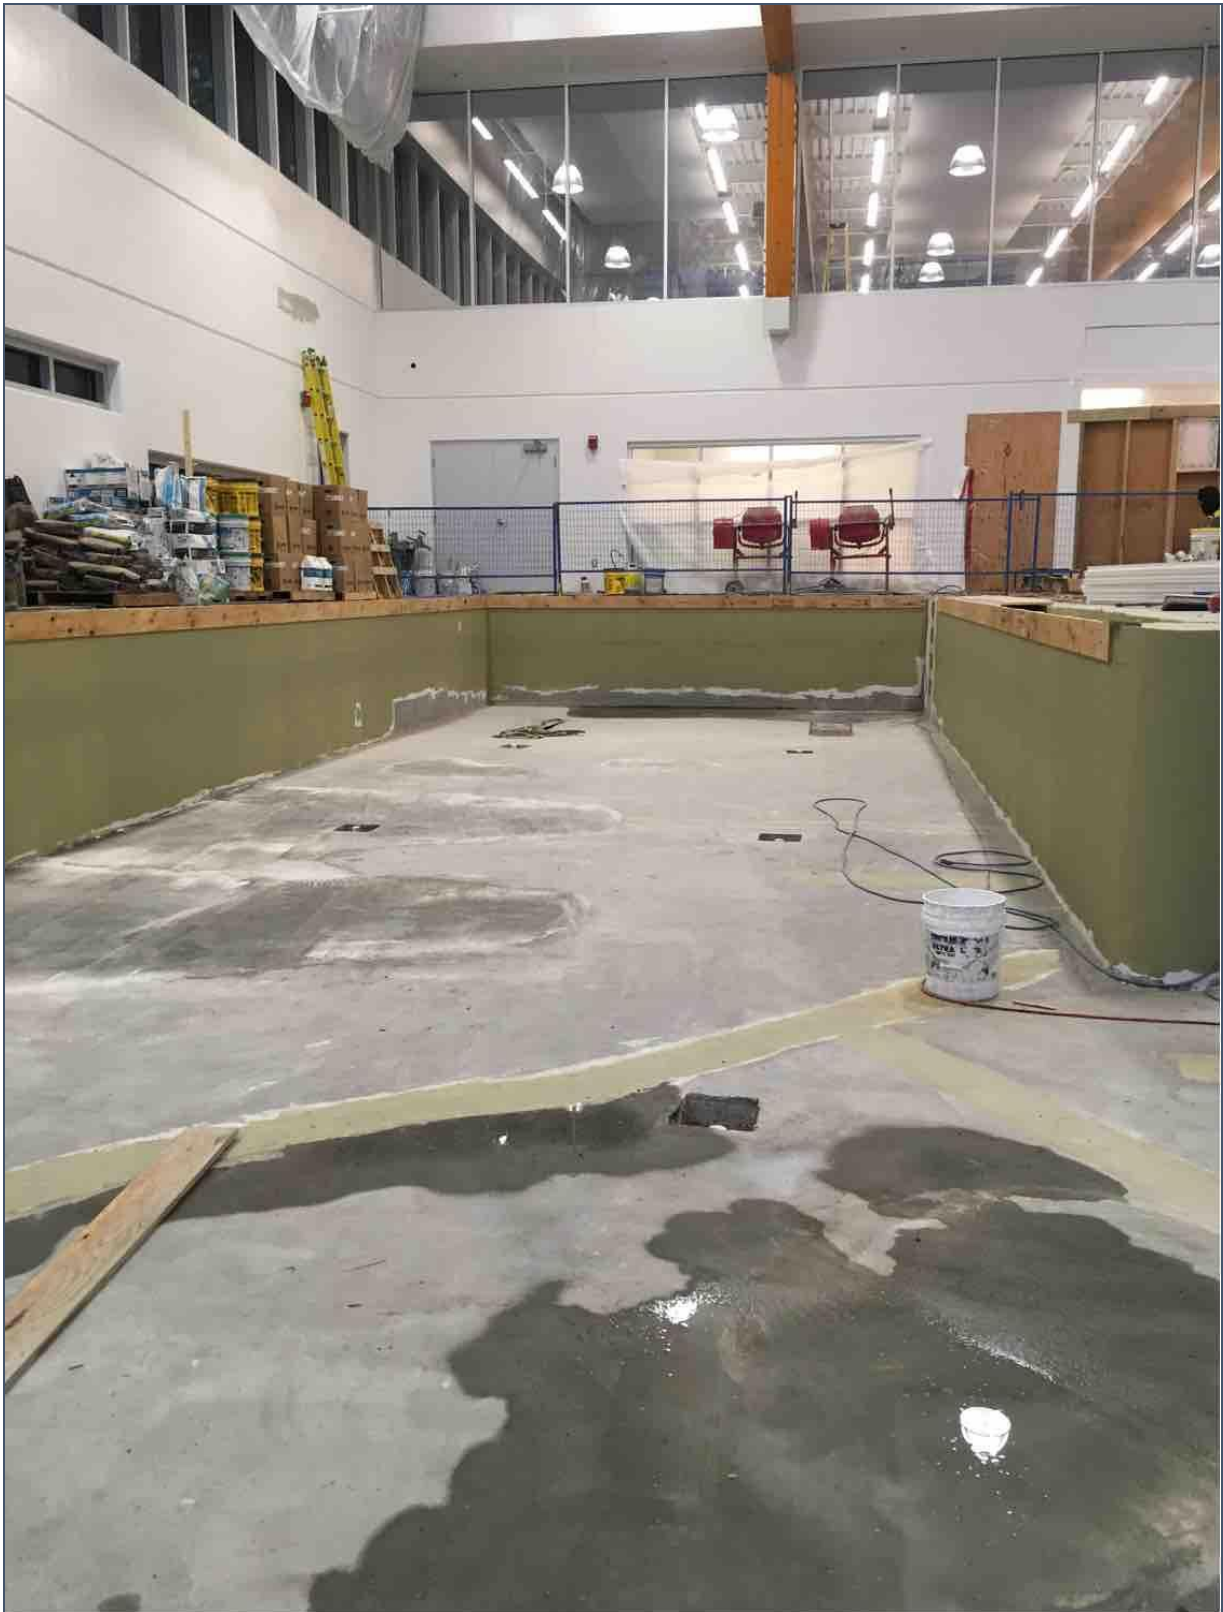
Phase 1C – Pool tank walls waterproofing progress

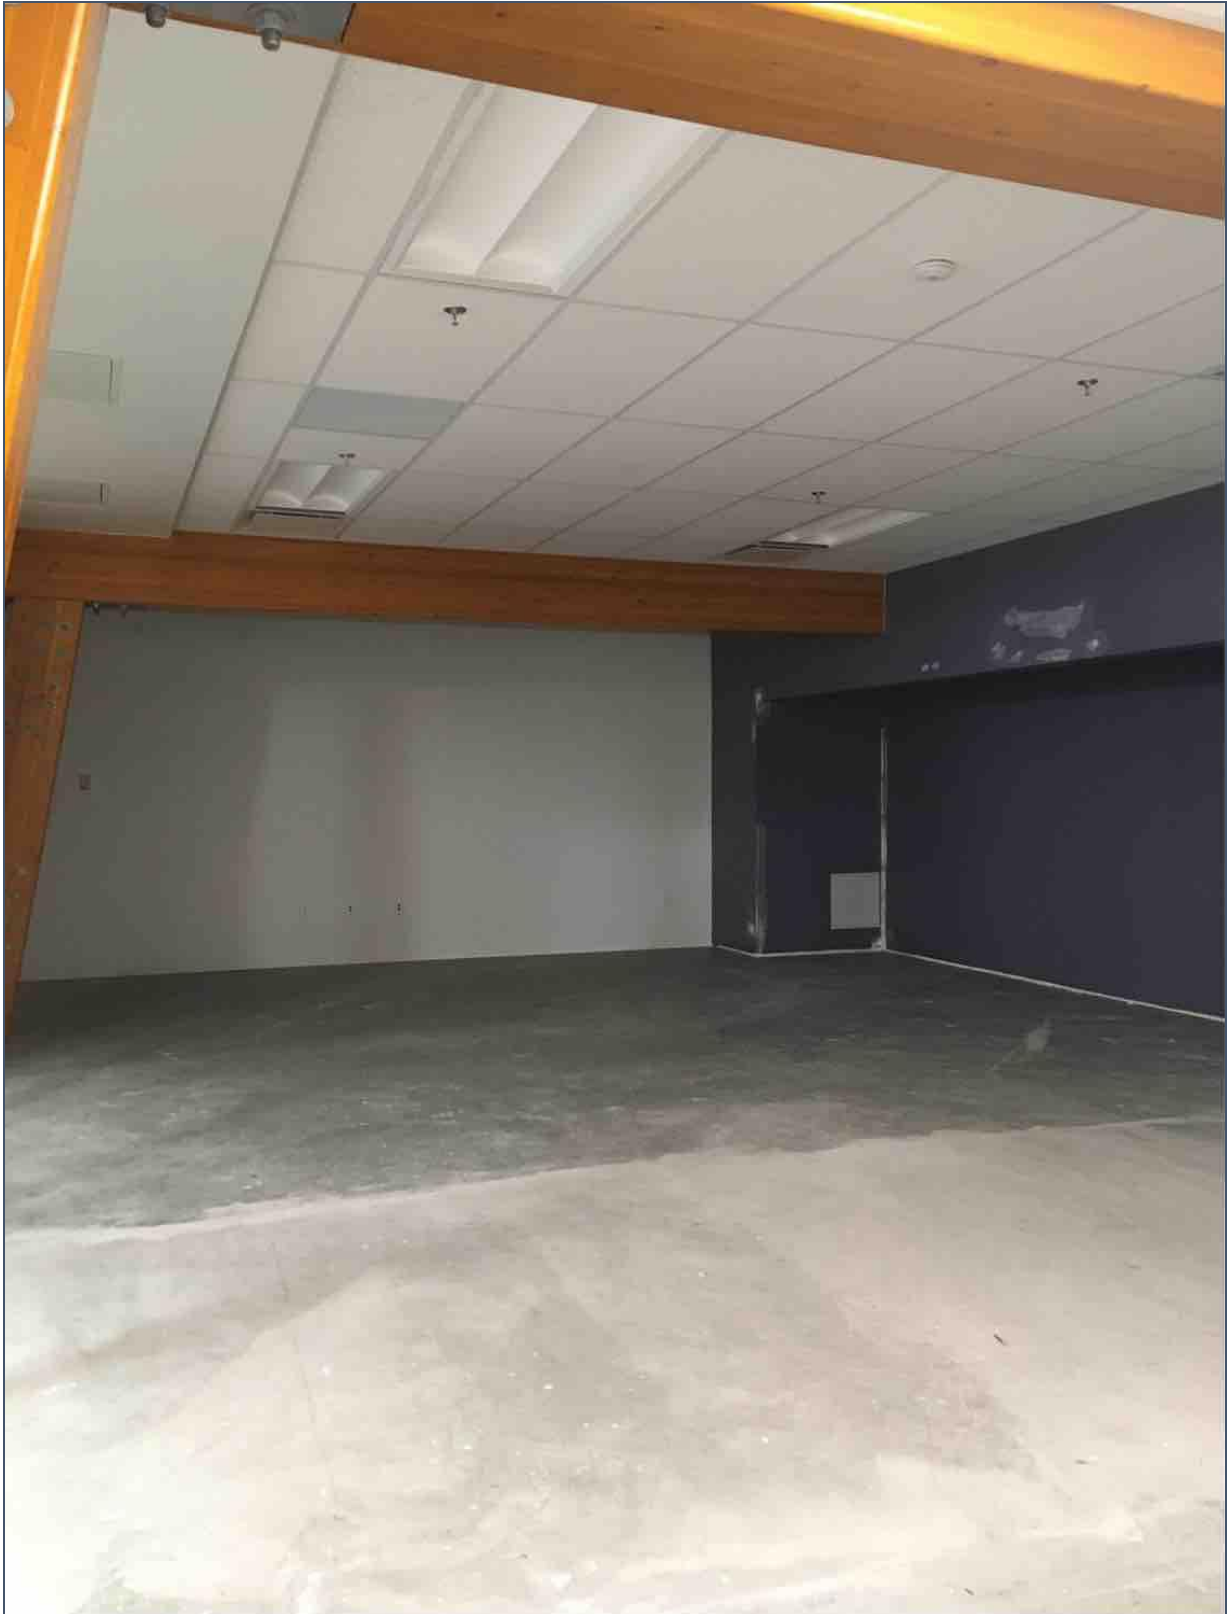
Phase 1C – Small MP room ready for floor finish

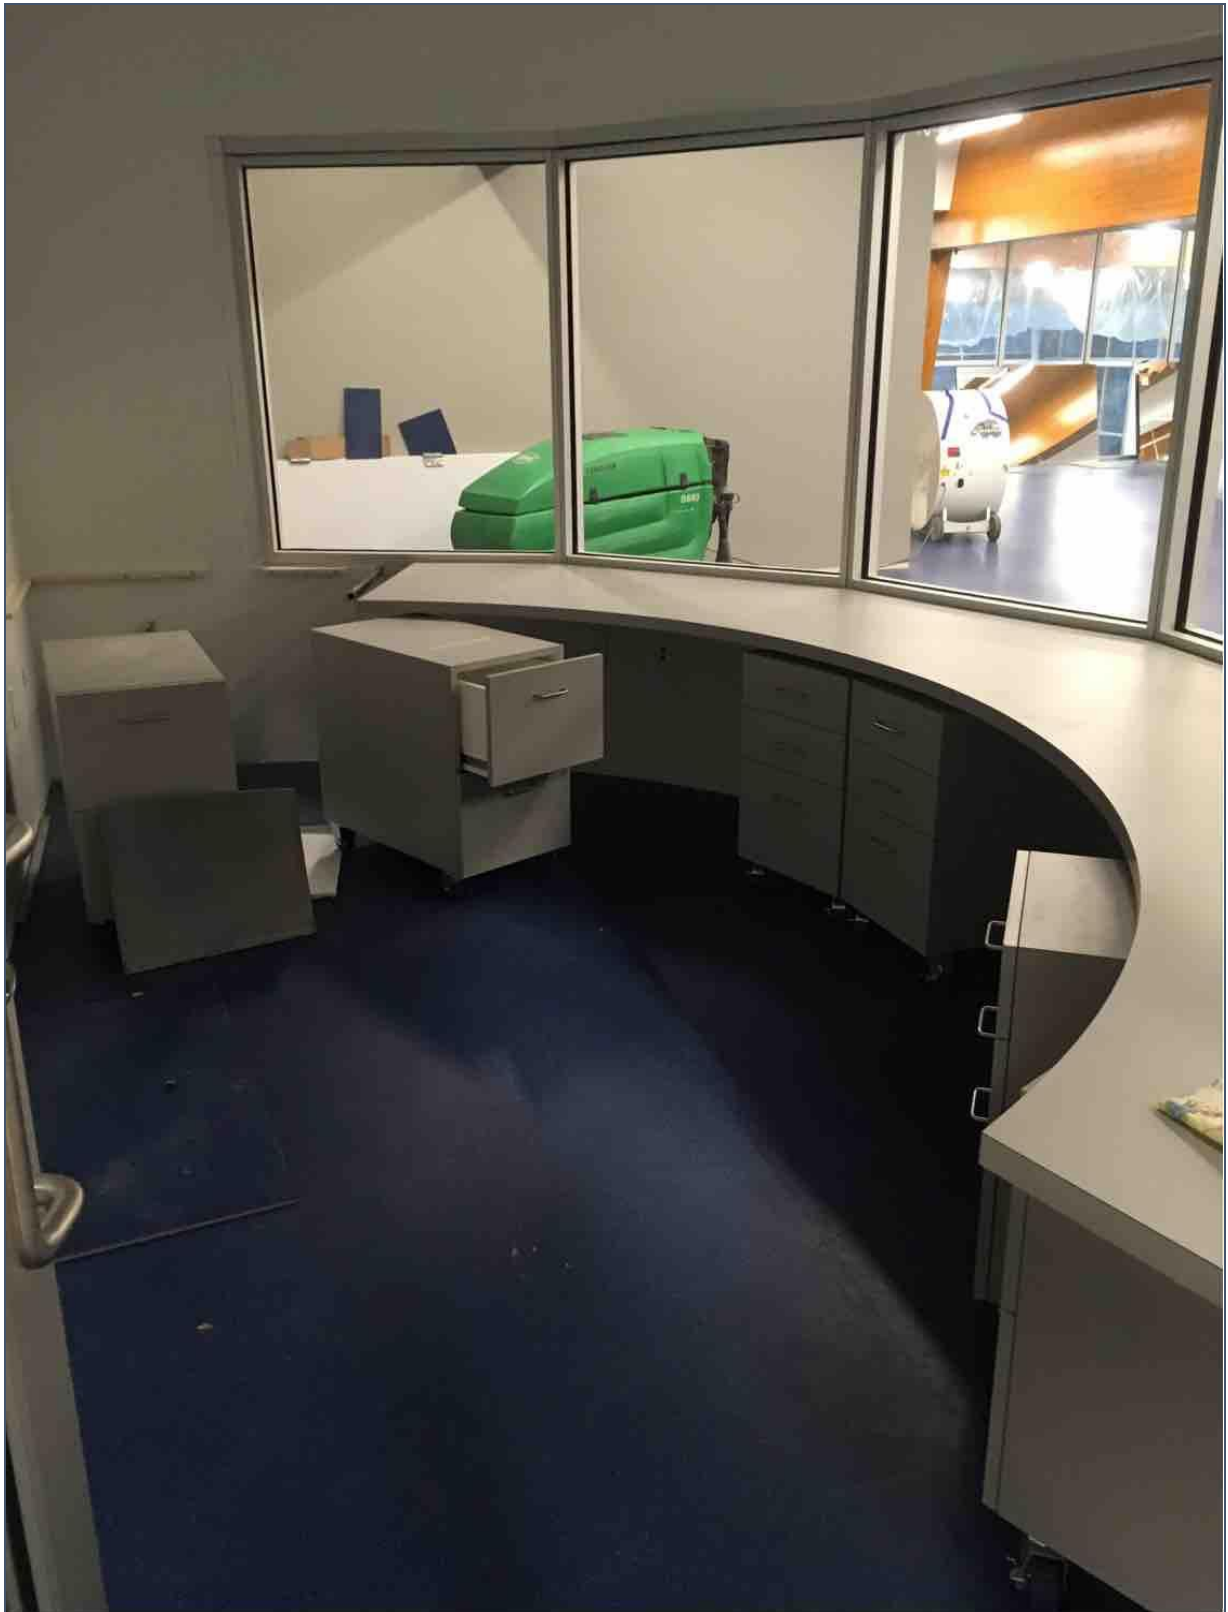
Phase 1C – Fitness 2<sup>nd</sup> floor coordinators office

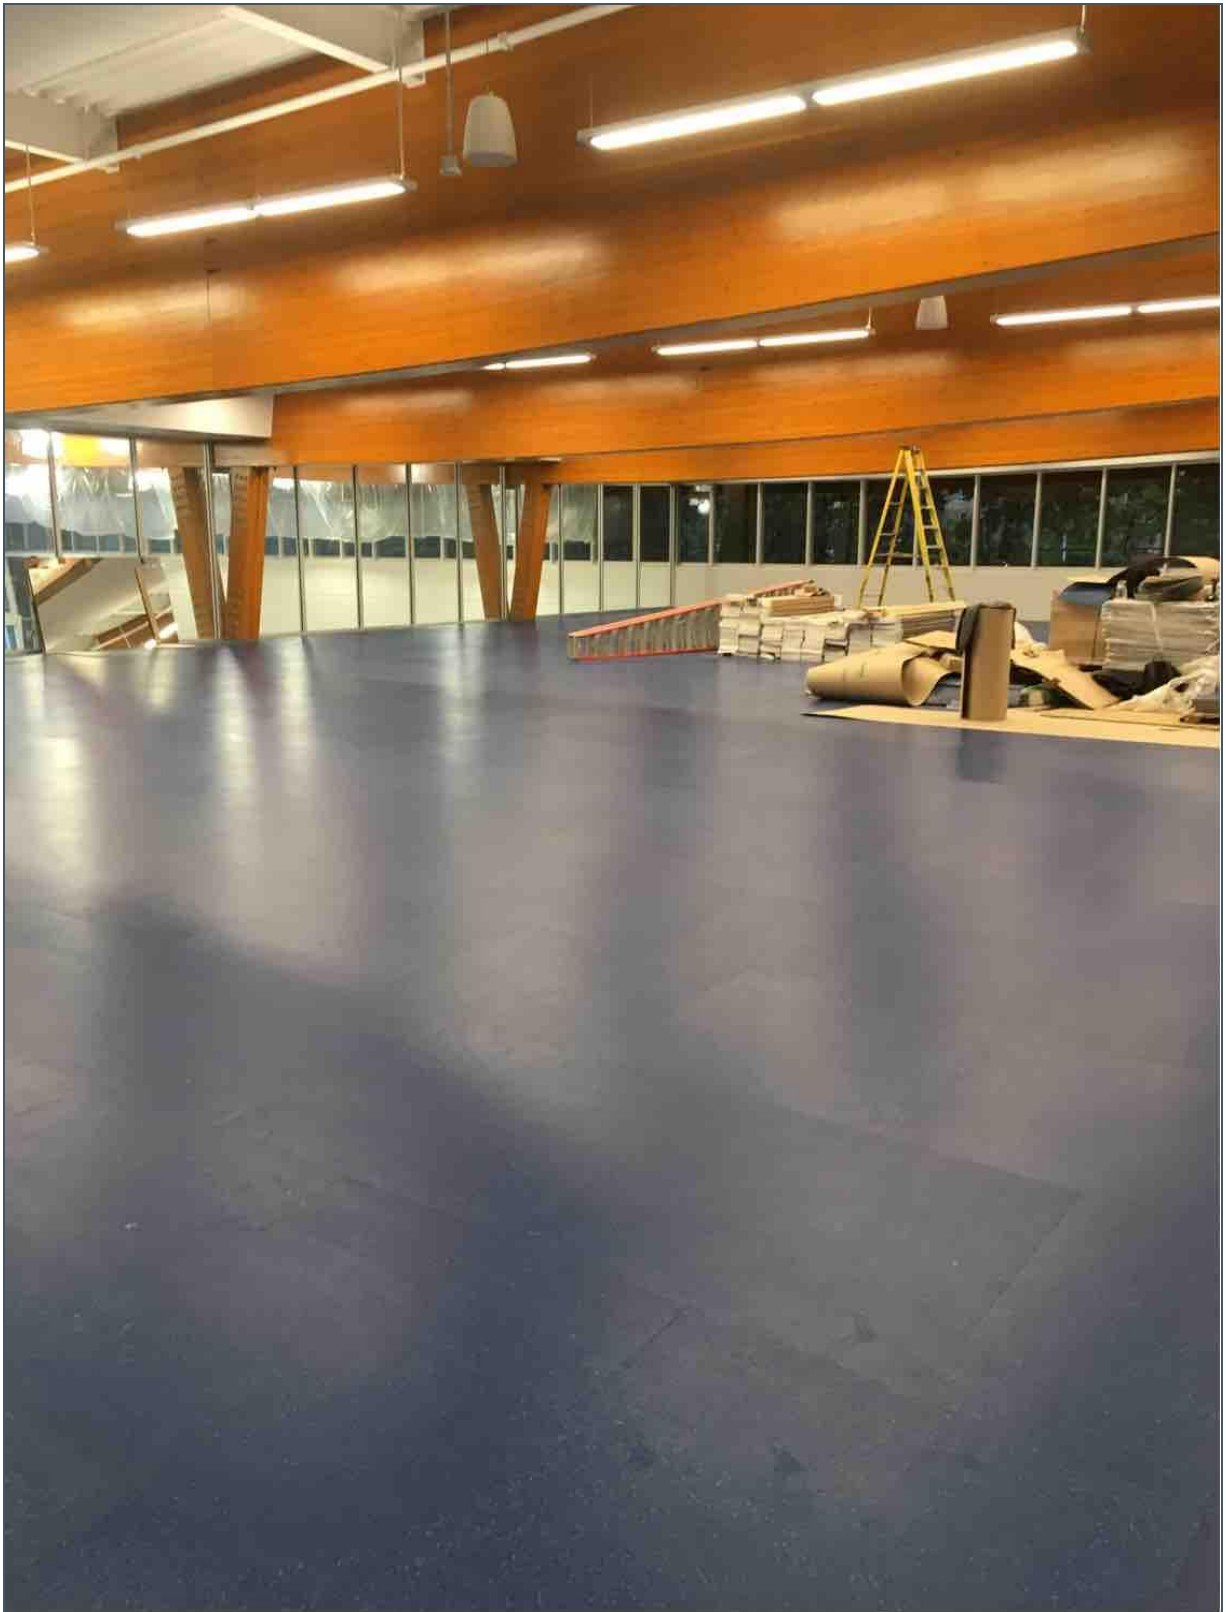
Phase 1C – 2<sup>nd</sup> weight room rubber flooring

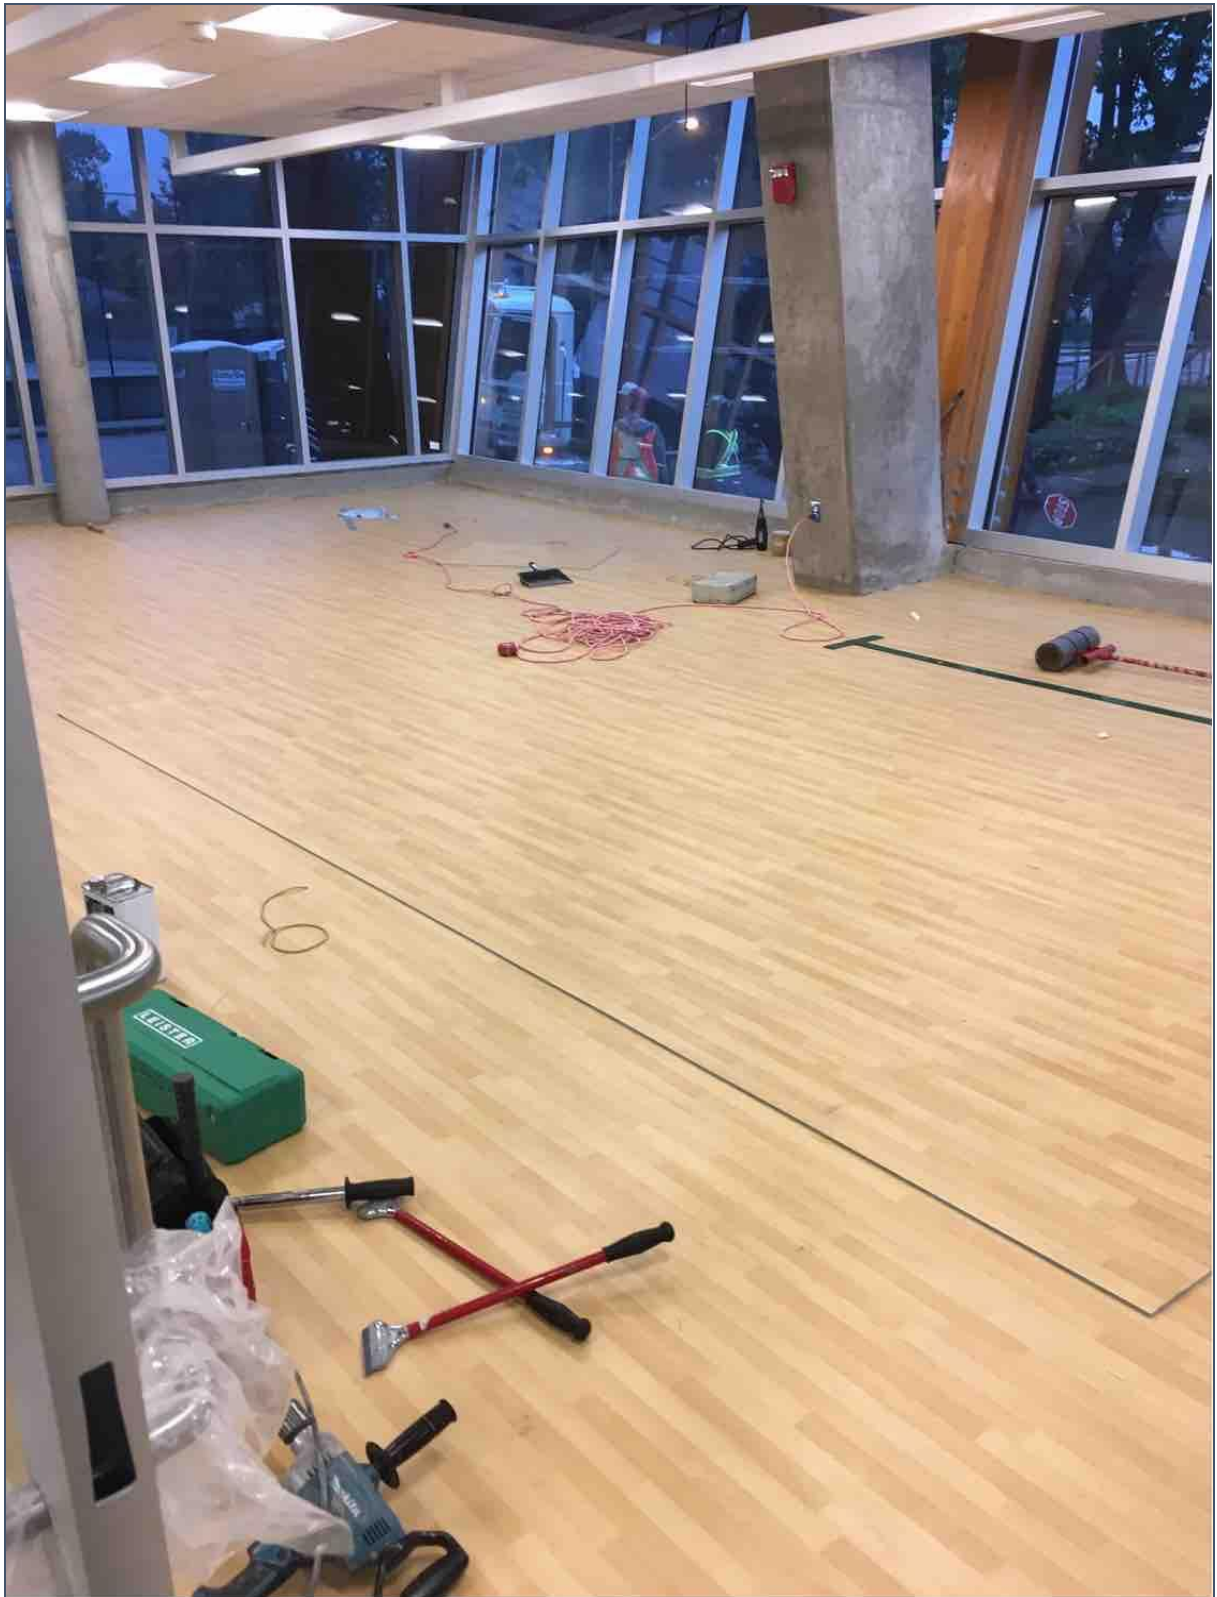
Phase 1C – Wood floor in main floor fitness area

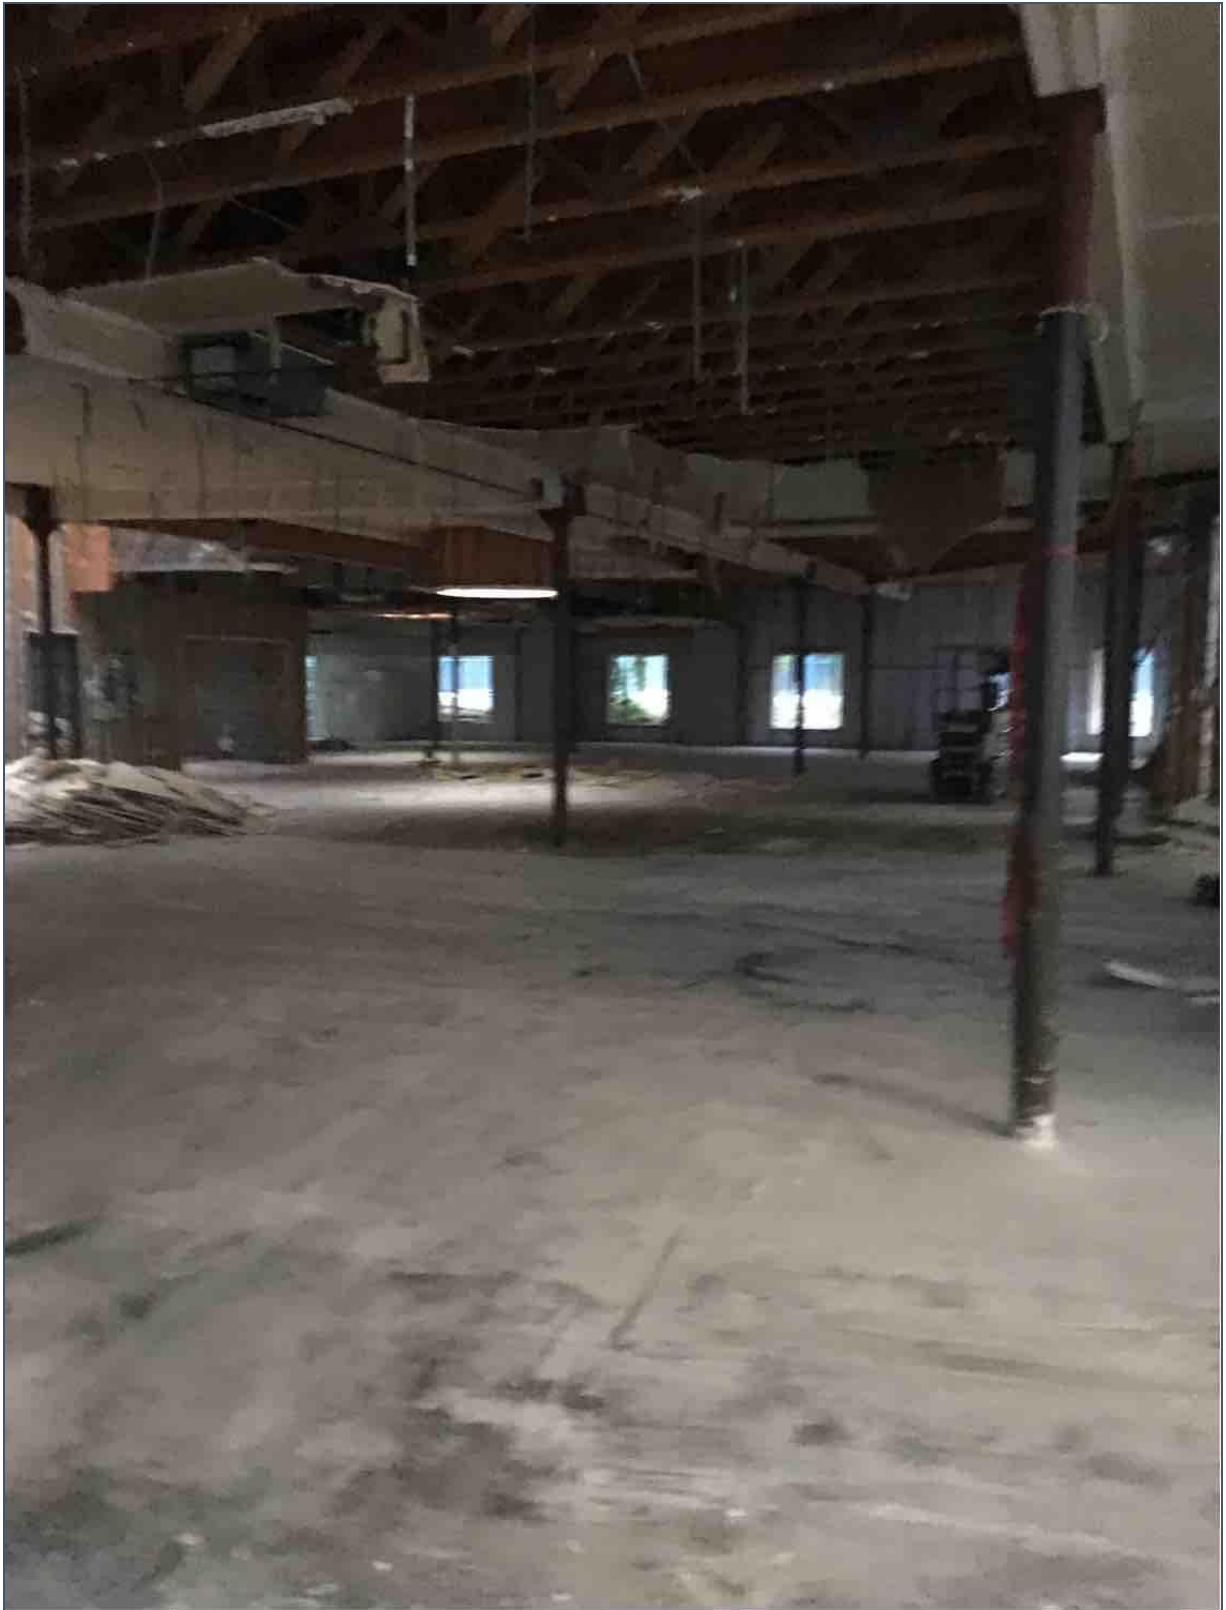
Phase 2 – Terry Fox Library demolition

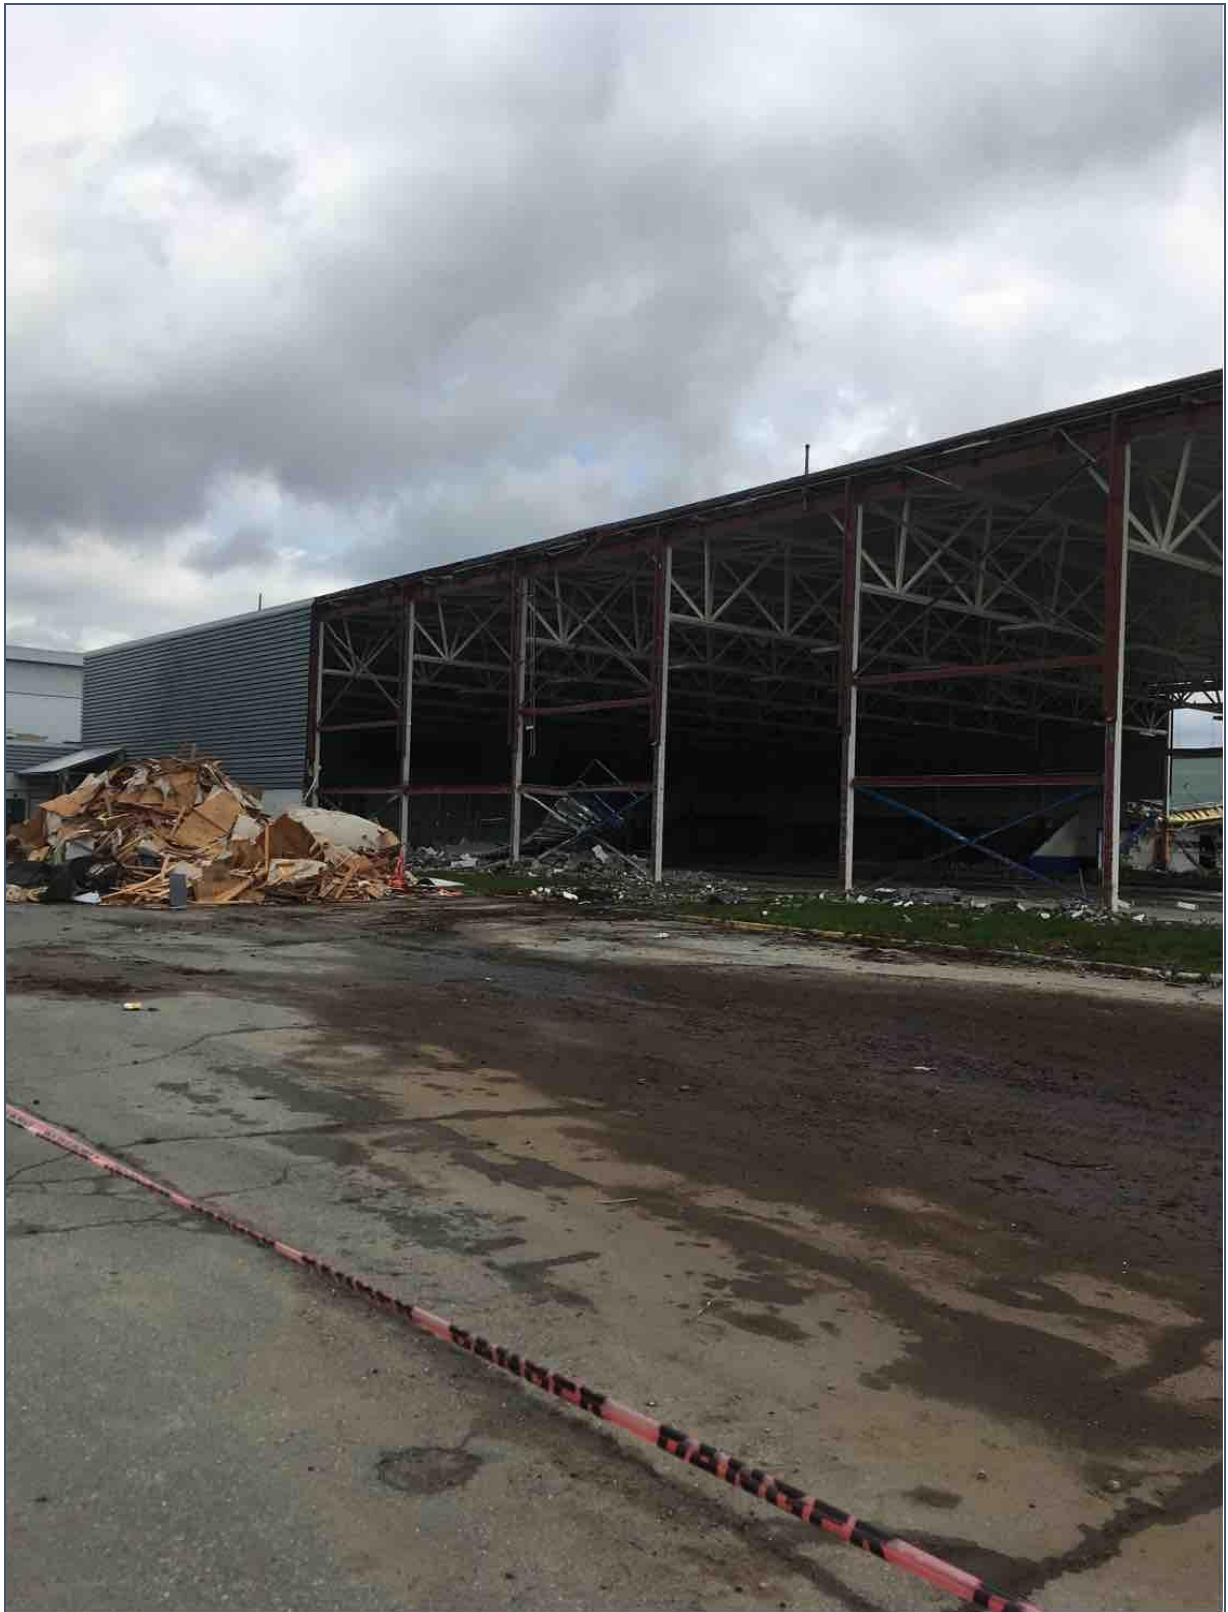
Phase 2 – Blue Arena demolition

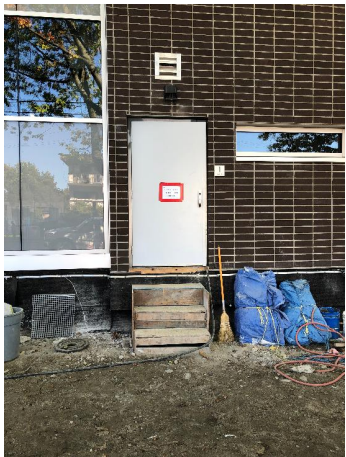
IMG\_0188.JPG - Oct 02, 2019 - Adam Chambers

Type / Subtype	Action Required / Action Required
Location	P1C > Exterior > Wall > Pool/Fitness West (Door S1C3A to sidewalk)
Root Cause	
Checklist Source	
Reference Drawing	
Creator	Adam Chambers Architecture49
Issue Owner	Adam Chambers Architecture49
Assignee	
Description	Path to be completed from exit door to sidewalk.

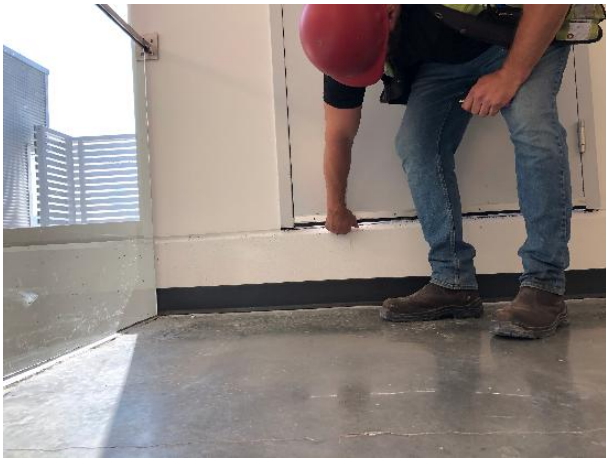
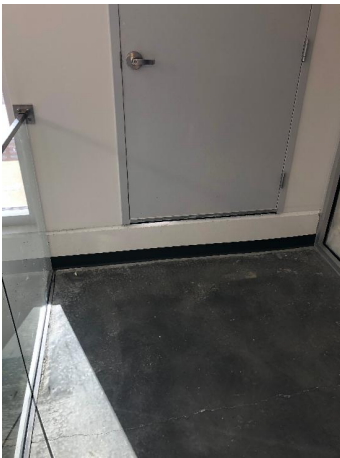
#365 56.1.02 - Ext - Door 1C200 sill to be Sealed and Waterproofed

Door 1C200 sill to be sealed and waterproofed. Daylight was visible from the interior of building.

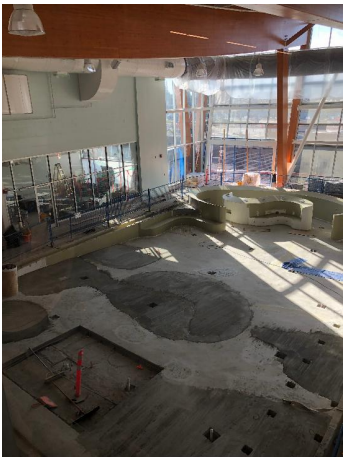
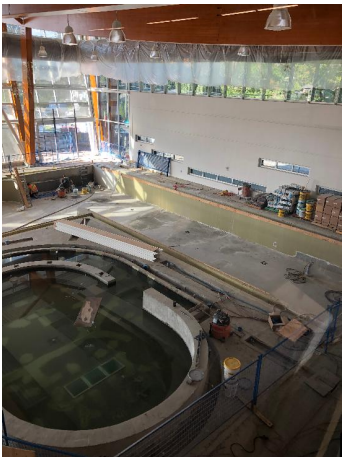
#345 56.2.01 - Int - Pool Progress

Description Progress of the pool construction and fill tests.

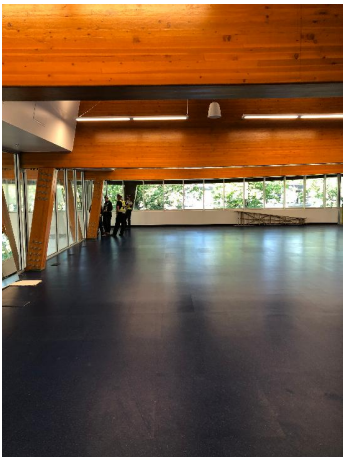
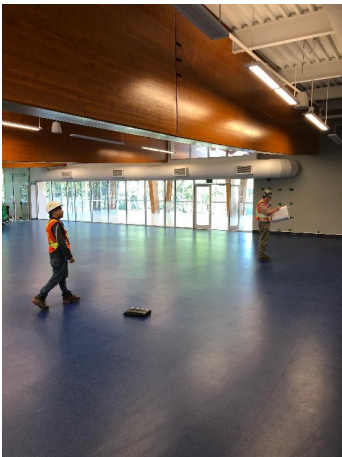
#346 56.2.02 - Int - Level 2 Weight Room Progress

Description Progress of the Level 2 Weight Room

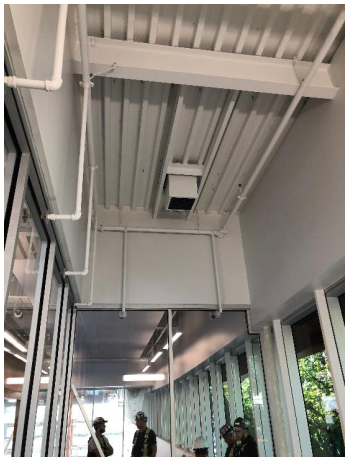
#348 56.2.04 - Int - Alternate Solution Sprinklers in Stair 3

Alternate Solution Sprinklers have been installed at interior glazing in Stair 3.

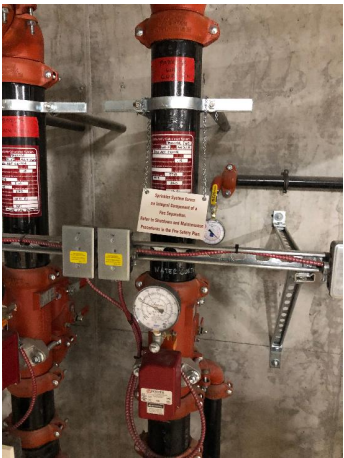
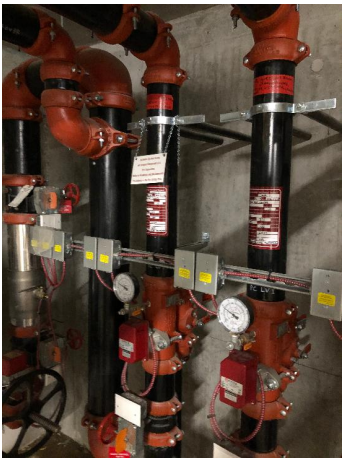
#349 56.2.05 - Int - Alternate Solution Signage at Sprinkler Control Valves

Type / Subtype	Observation / Observation
Location	P1C > Parking > 1C001 - BOILER ROOM (Sprinkler Valve Bank in North-East Corner of room.)
Root Cause	
Checklist Source	
Reference Drawing	
Creator	Adam Chambers Architecture49
Issue Owner	Adam Chambers Architecture49
Assignee	
Description	Required signage as part of the alternate solution for glazing in fire separations is visible and placed on correct sprinkler zones.

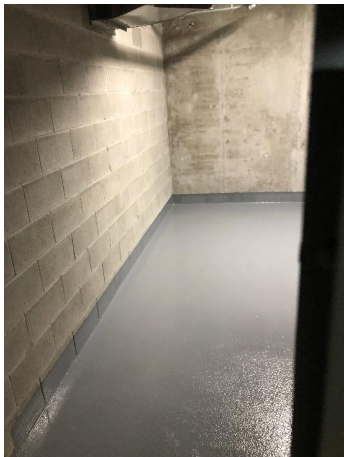
#351 56.2.07 - Int - Floor Sealant Progress

Progress of the chemical resistant sealant.

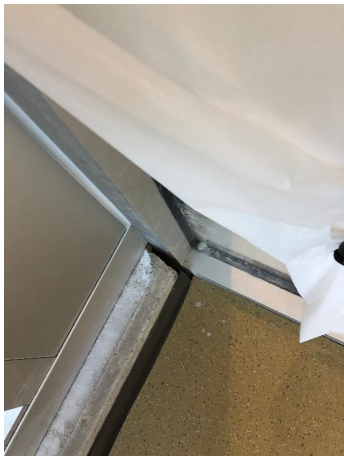
#355 56.2.11 - Int - Sealant required at Glazing/Curb Interface

Type / Subtype	Action Required / Action Required
Location	P1C > Level 1 > 1C121 - WEIGHT ROOM LEVEL 1 (Intersection of Exterior and Interior Glazing near Entrance to Weight Room)
Root Cause	
Checklist Source	
Reference Drawing	
Creator	Adam Chambers Architecture49
Issue Owner	Adam Chambers Architecture49
Assignee	
Description	Gap between mullion and concrete curb to be sealed.

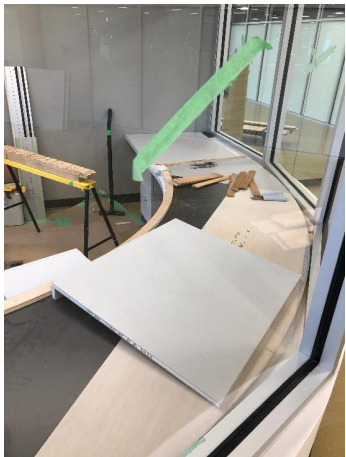
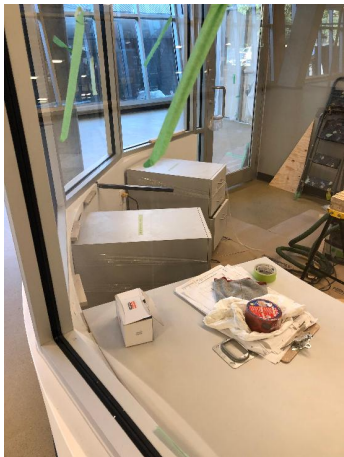
#356 56.2.12 - Int - Millwork installation progress in Fitness Office

Progress of the millwork installation in Fitness Office 1C122.

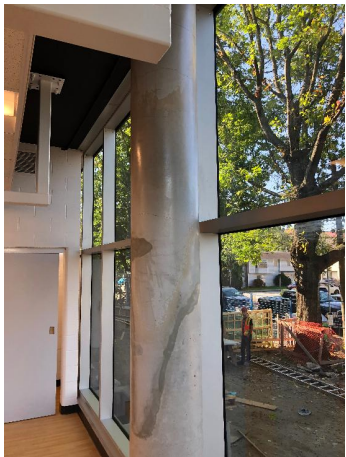
#359 56.2.13 - Int - Column Finish to be Repaired

Concrete repair to column is cracking. Repair and make good.

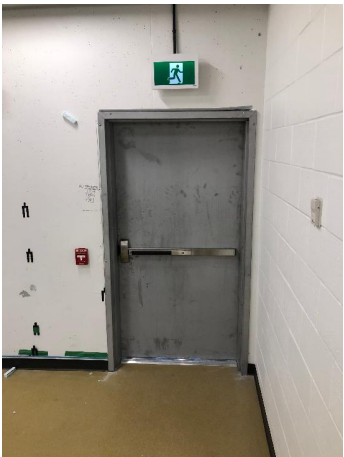
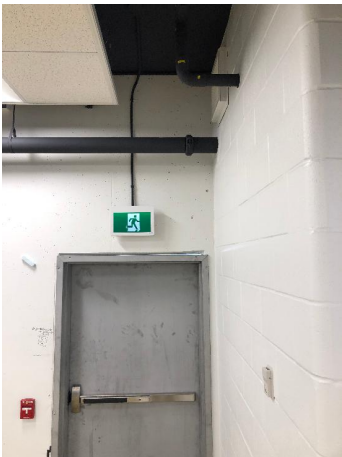
#361 56.2.15 - Int - Repair or Replace Door S1C3

Description Repair or replace door S1C3 as gaps visible around door.

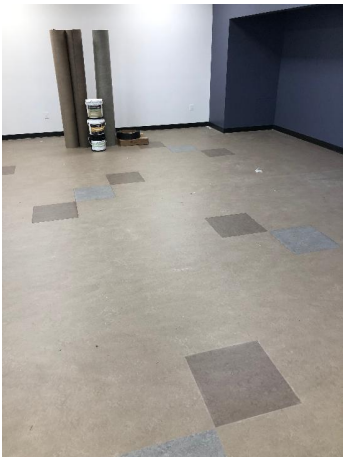
#363 56.2.17 - Int - Flooring Installation Progress in the Small Multipurpose Room

Description Progress of the patterned flooring installation.

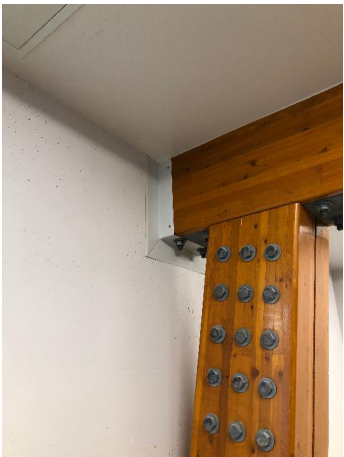
#364 56.2.18 - Int - Flashing around Glulam

Description Metal flashing installation around Glulam penetration of concrete shear wall.

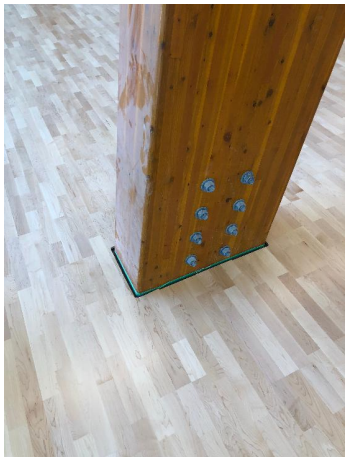
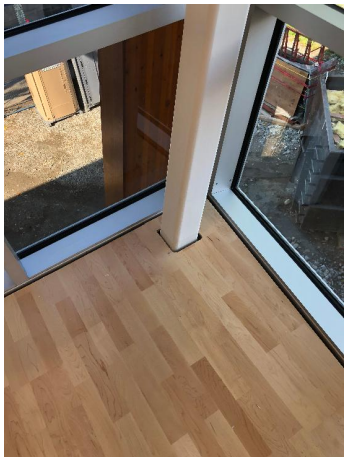
#366 56.2.19 - Int - Flooring Base to be installed.

Type / Subtype	Action Required / Action Required
Location	P1C > Level 2 > 1C230 - FITNESS STUDIO
Root Cause	
Checklist Source	
Reference Drawing	
Creator	Adam Chambers Architecture49
Issue Owner	Adam Chambers Architecture49
Assignee	
Description	Flooring base around room and columns was discussed with VCC as traditional rubber base may not be wide enough to cover expansion gap. A49 would prefer a product similar to Johnsonite Vented Cove Base.

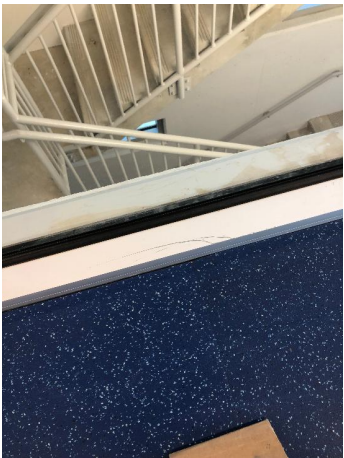
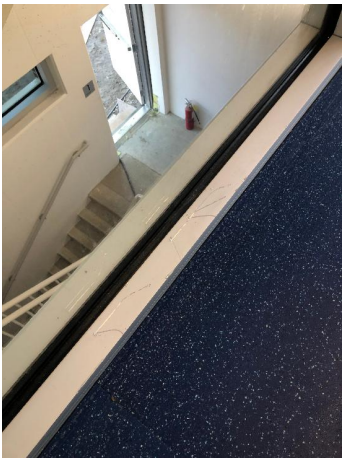
#367 56.2.20 - Int - Scratches on Glazing Mullion to be Repaired

Description Scratches on glazing mullions to be repaired. Glazing installer noted that the glazing caps can be replaced to eliminate the scratches.

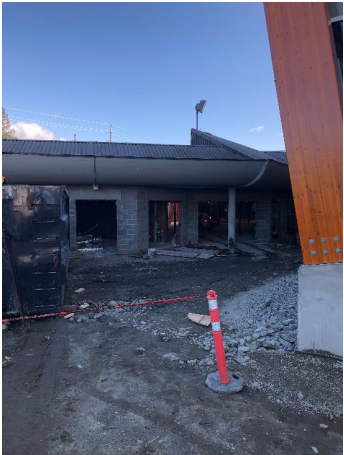
#358 56.4.01 - Mis - Existing Library Demolition Progress

Description Demolition work on the existing library has begun.
