PORT COQUITLAM COMMUNITY CENTRE

Owner's Representative Progress Report #32

November 2019

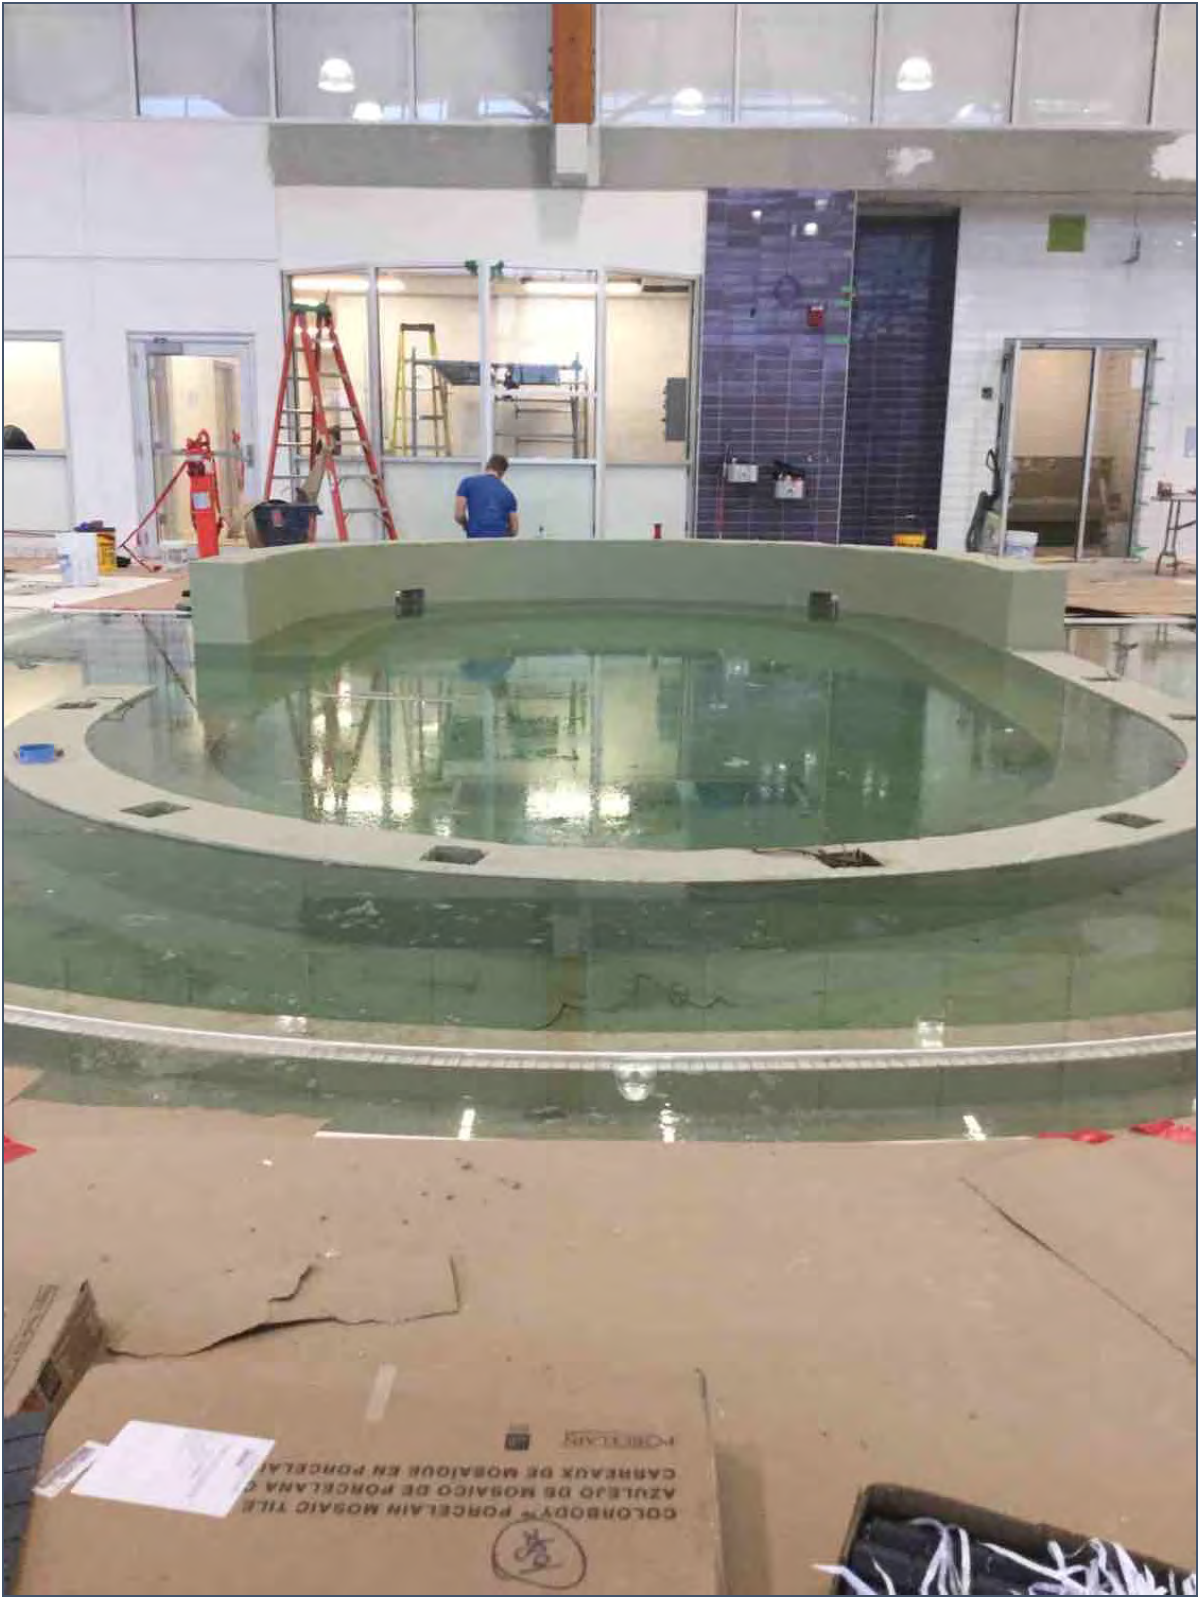
Phase 1C – Hot tub water testing

As previously noted and discussed with Ventana
 Problem with hot tub water test, after hydra-ban. Test held for 36 hours, then dropped 18mm, then held again for 12 hours. Reviewed the area with Matt (VCC) & Jakub (tile setter) and the possible issue may be along the N side of the hot tub. The higher curb was placed later (no water stop or key way was used here) and there are two holes through the wall, to allow water to get to the gutter. The bottom of these holds is the level the water finally stayed at, after dropping. It appears only the primer has been applied to the wall and not the hydra-ban at the gutter frame. As the wall is radiused, the gutter frame is faceted, there are some gaps behind the frame. Possible the water held for 36 hours and something dissolved / moved from the weight of the water and a hairline crack has appeared in the cold joint of the curb, where the hydra-ban has not been applied. Discussed filling hot tub to first bench and leaving for 24 hours, then upto the underside of the holes through the N curb wall and leaving for 24 hours. If no water loss, then tile setter is going to obtain a caulking that can be used underwater and caulk the rear of the gutter frame. Once complete and dry, the hot tub to be filled to final level and left for 48 hours.

As previously noted and discussed with Ventana
 VCC believe issue with hot tub was a hand rail pocket. Pocket has more hydra-ban installed and hot tub will be tested again this week

As previously noted and discussed with Ventana
 VCC stated hot tub is no longer losing water. Survey team are scheduled for this evening to carry out final survey
 Occupancy sensor in H/C changerroom in universal changerooms, is palced behind the H/C lift / bench. Need to relocate
 Thought needs to be provided into the location of the H/C lift / bench controller, due to issues in other 1C H/C washroom already handed over
 Geotech on site during over excavation works
 Rope holders (6 locations) have been missed while forming and will be cut into the walls and placed by the tiling contractor

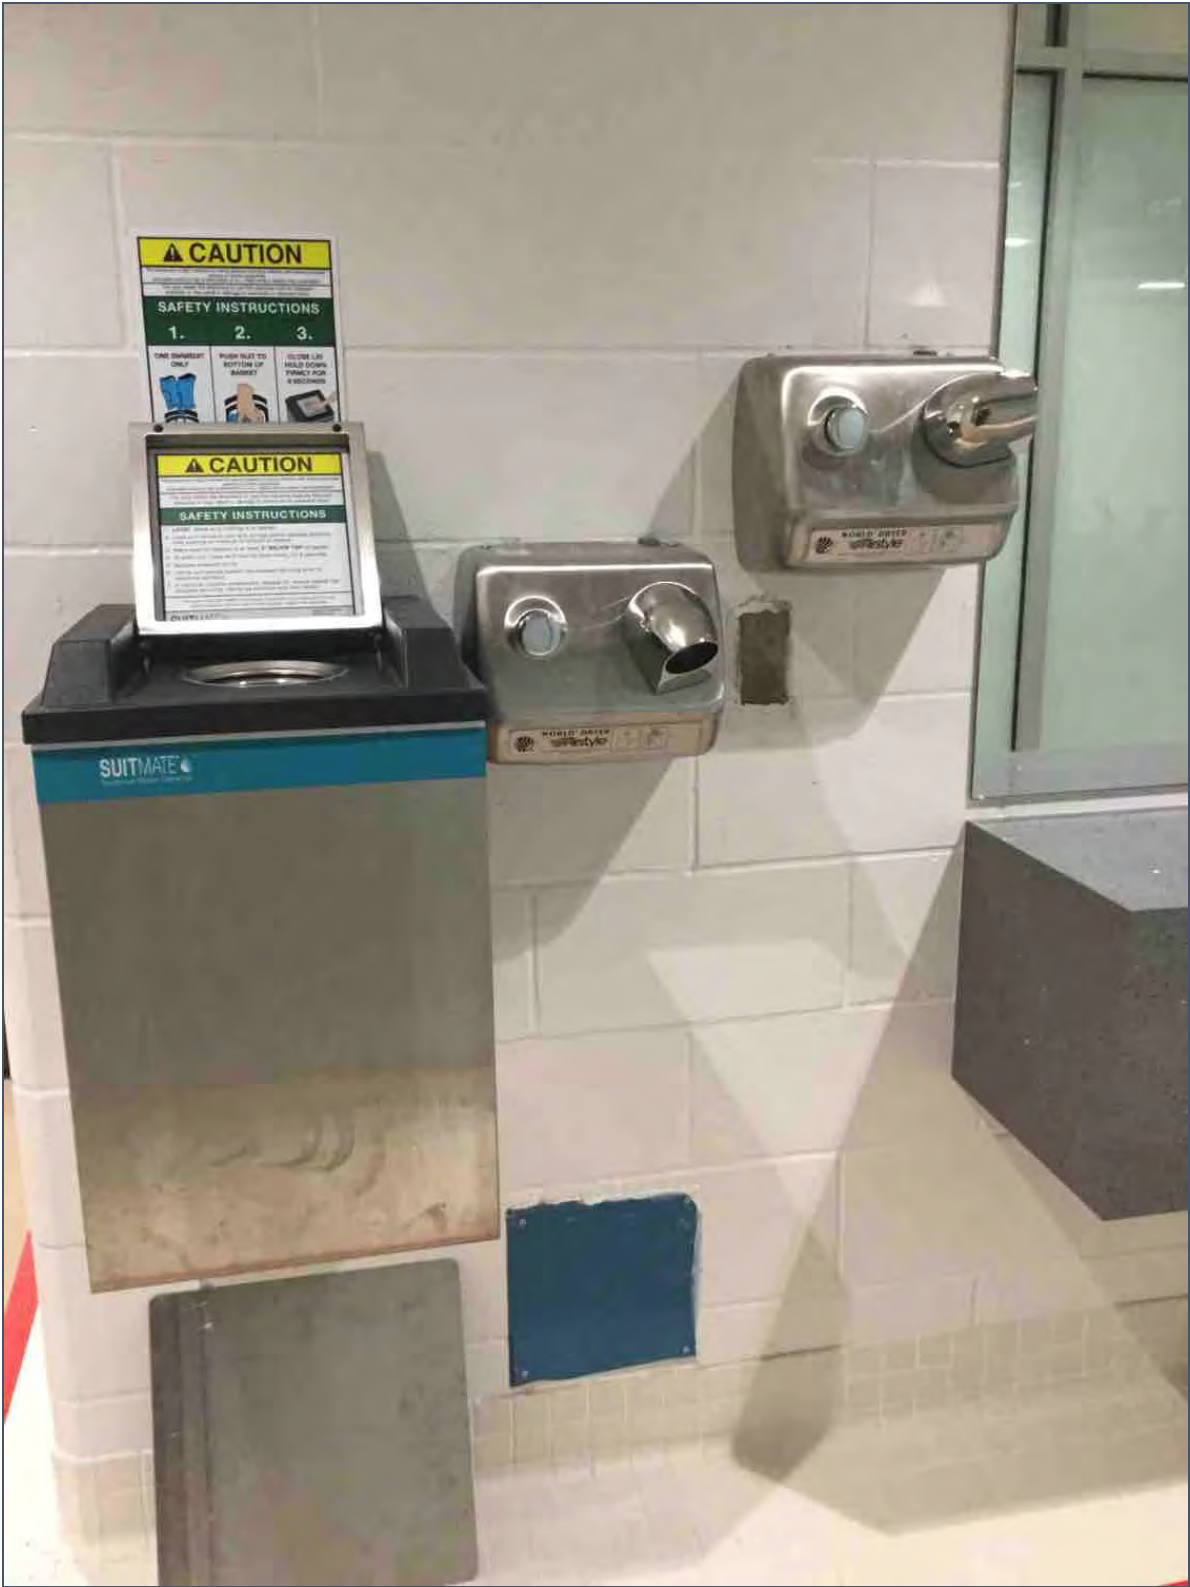
Phase 1C – Dryer install in universal changerroom

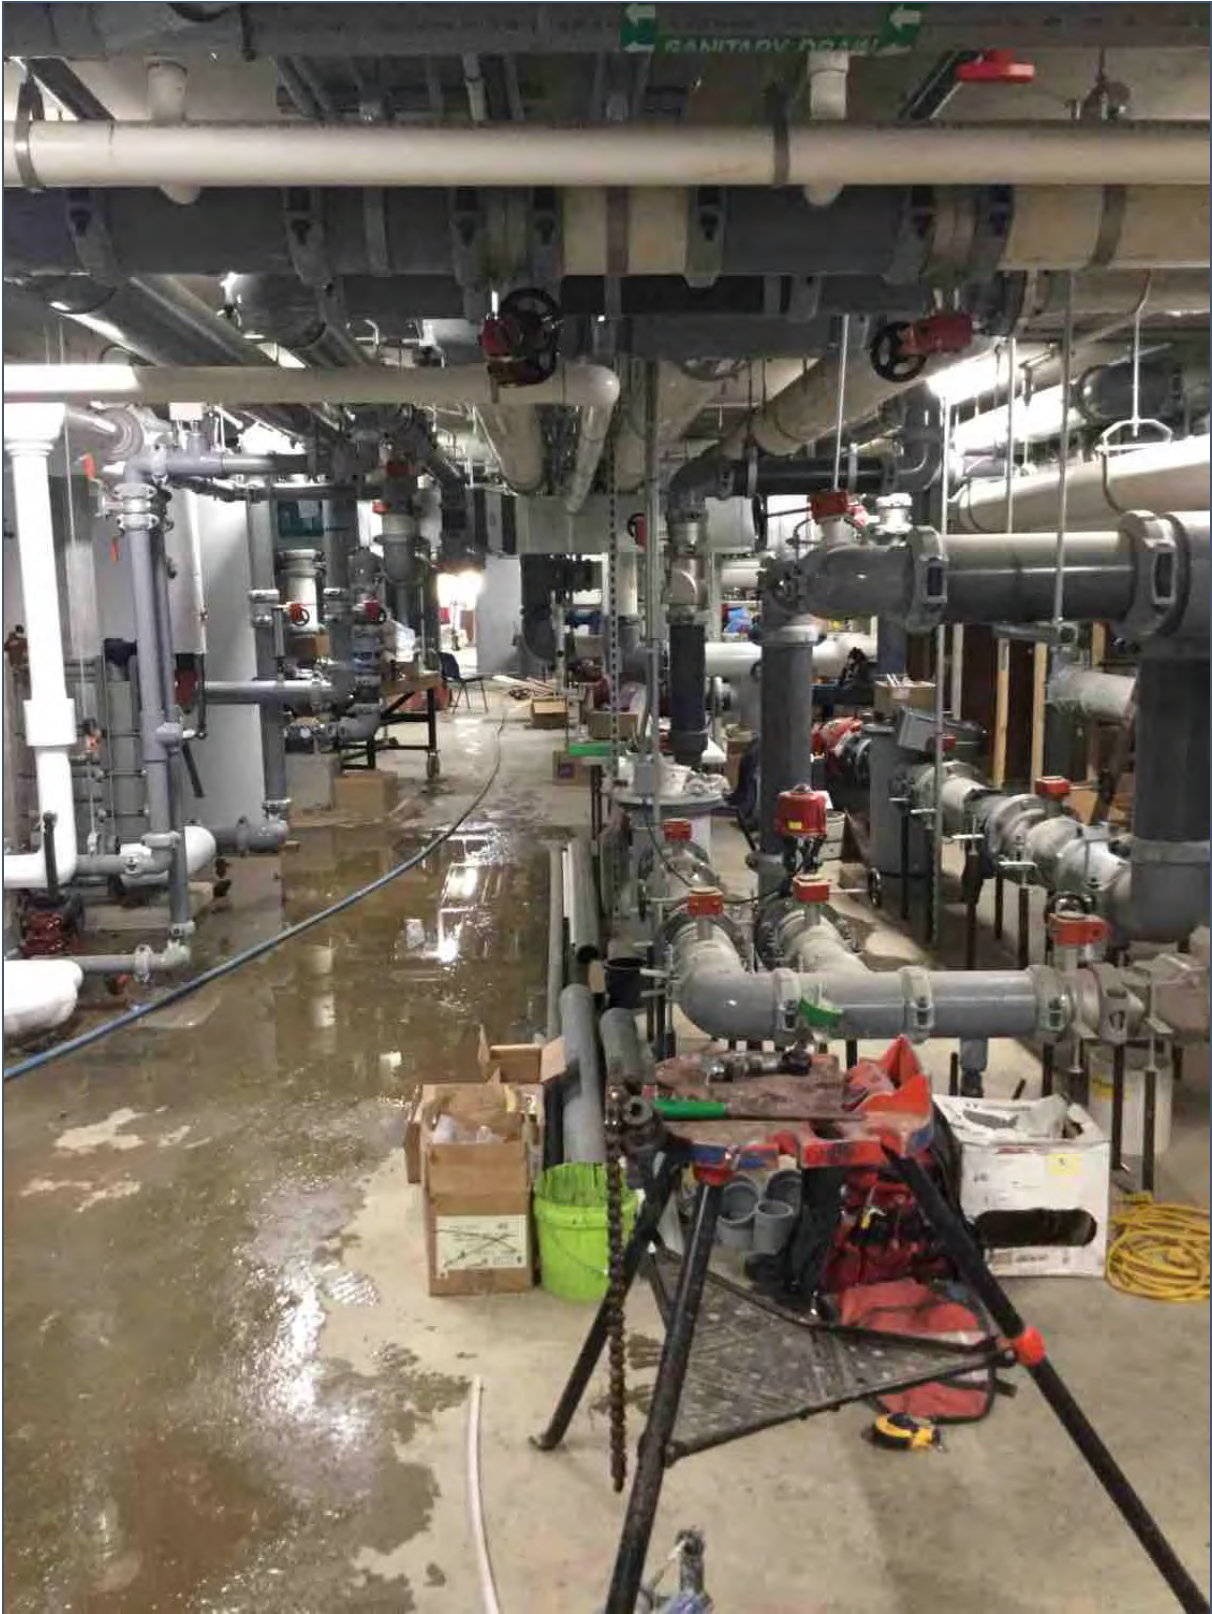
Phase 1C – Pool equipment room

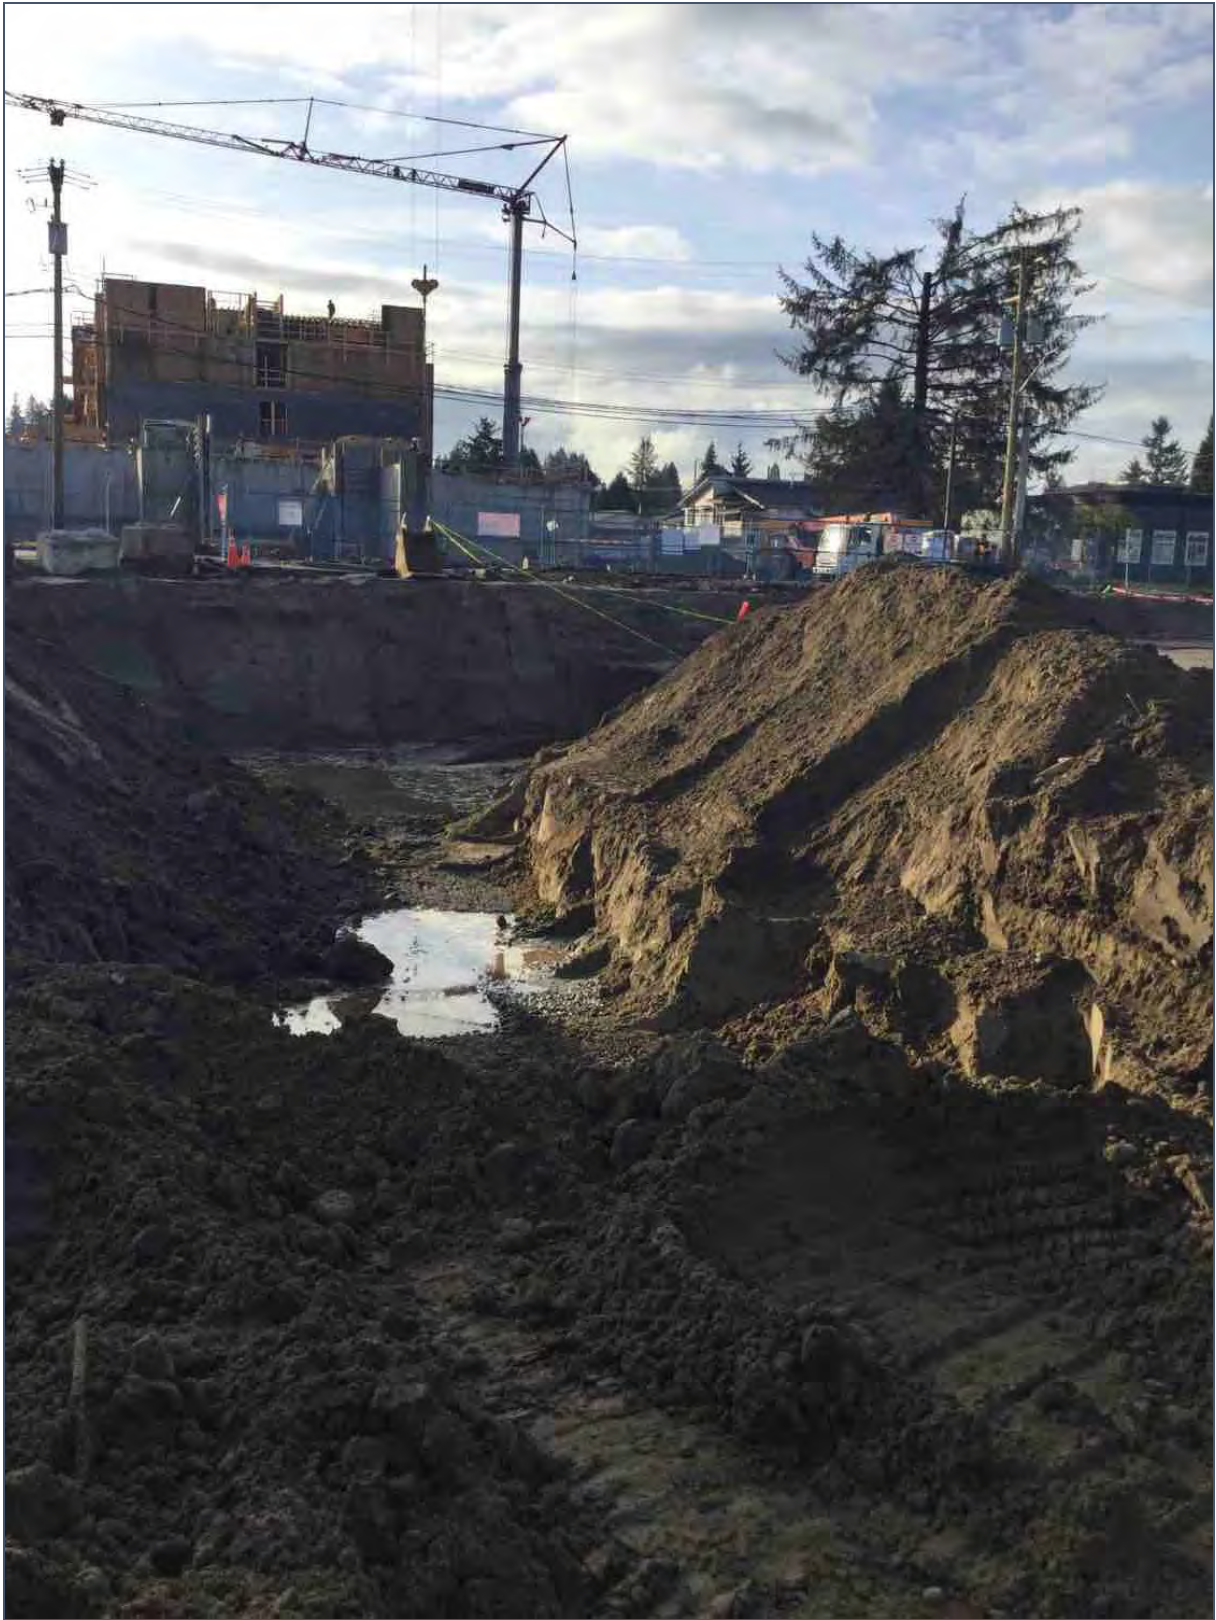
Phase 2 – Bulk Excavation

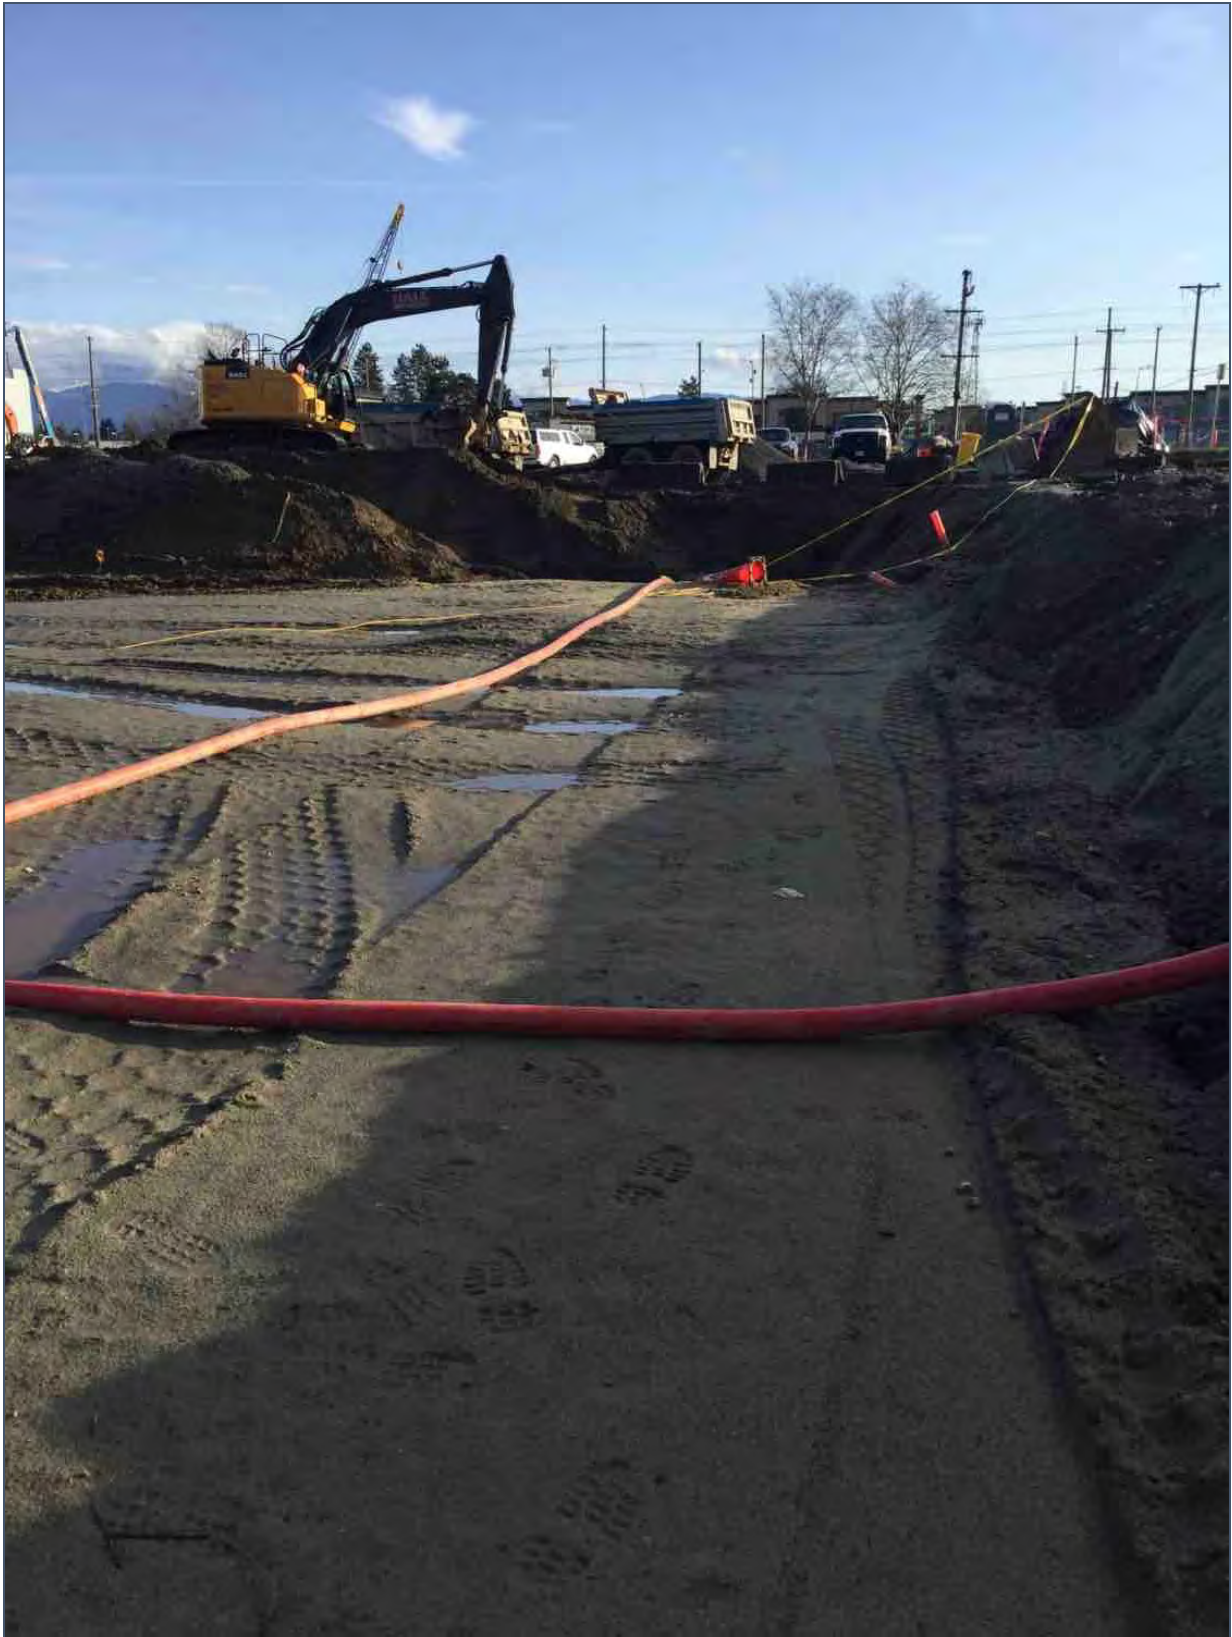
Phase 2 – Bulk excavation

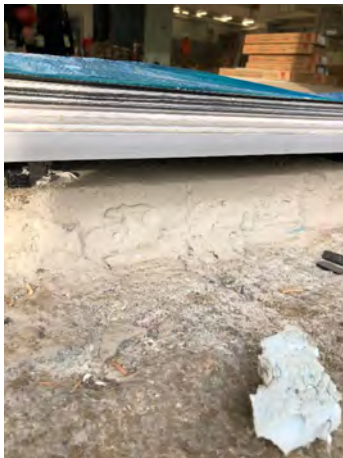
<i>Type / Subtype</i>	Observation / Observation
<i>Location</i>	P1C > Exterior > Wall > Pool South
<i>Root Cause</i>	
<i>Checklist Source</i>	
<i>Reference Drawing</i>	
<i>Creator</i>	Adam Chambers Architecture49
<i>Issue Owner</i>	Adam Chambers Architecture49
<i>Assignee</i>	
<i>Description</i>	VCC to provide A49 with photo of Alsan application before door sill install.

#440 59.1.02 - Pool Slider Door Installation

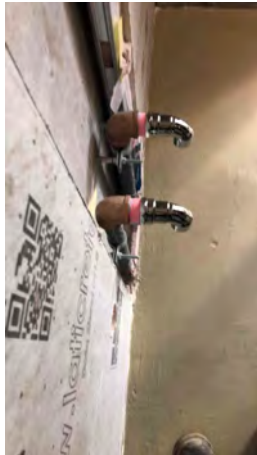
#434 59.2.02 - Steam Pipe Penetrations

Type / Subtype	Observation / Observation
Location	P1C > Level 1 > 1C140 - STEAM ROOM
Root Cause	
Checklist Source	
Reference Drawing	
Creator	Adam Chambers Architecture49
Issue Owner	Adam Chambers Architecture49
Assignee	
Description	Pipe are 6" out from wall

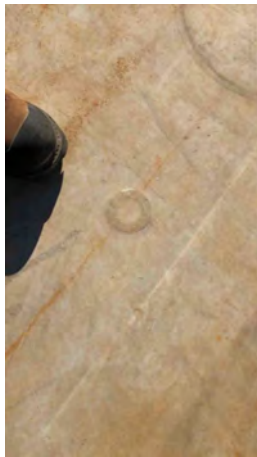
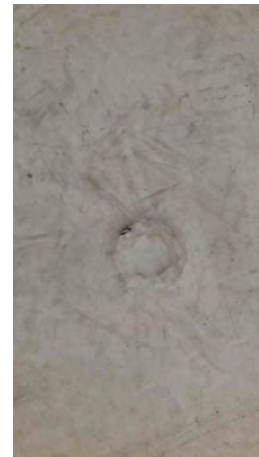
#428 58.3.02 - Roof Fastener Abrasions

<i>Type / Subtype</i>	Action Required / Action Required
<i>Location</i>	P1C > Exterior > Roof
<i>Root Cause</i>	
<i>Checklist Source</i>	
<i>Reference Drawing</i>	
<i>Creator</i>	Adam Chambers Architecture49
<i>Issue Owner</i>	Adam Chambers Architecture49
<i>Assignee</i>	
<i>Description</i>	Advised by vcc that roofer has reviewed and no issue

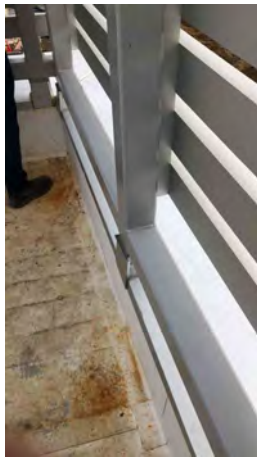
#427 58.3.01 - Clean Rust and Debris

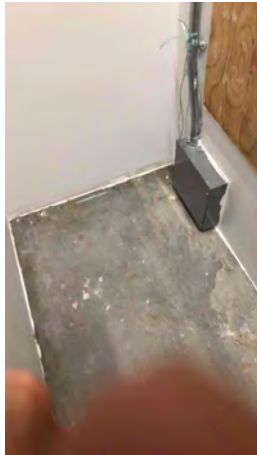
#421 57.2.39 - Fire Stopping Missing at Base of Wall around Electrical Closet

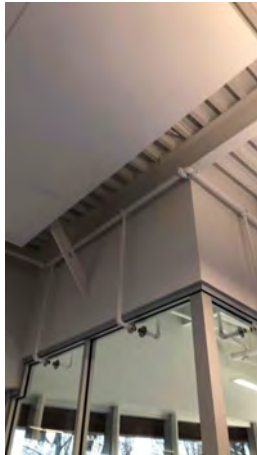
#419 57.2.37 - Fire Stopping Missing at Exterior of Bulkhead at Stair 3

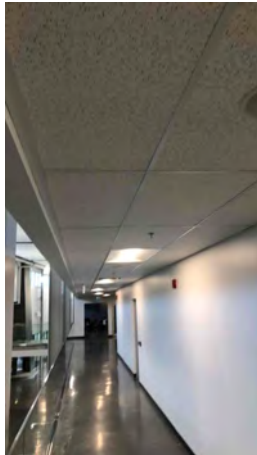
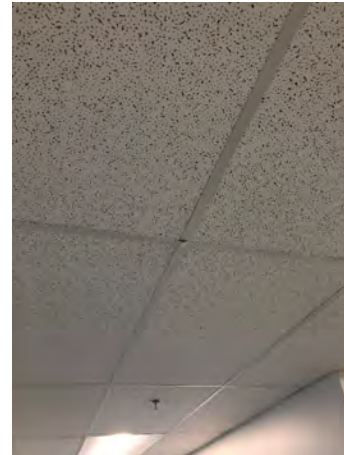
#409 57.2.30 - Bent Ceiling Grid

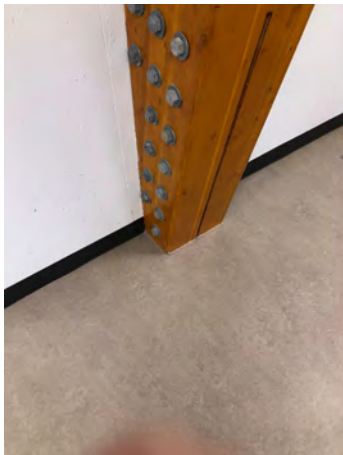
#402 57.2.23 - Cracked Glulam Column

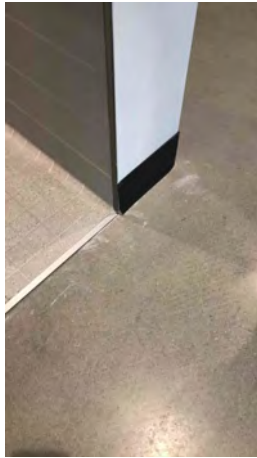
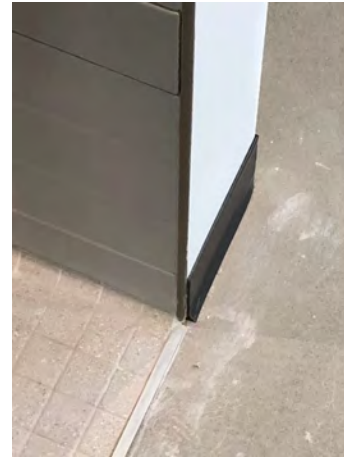
#399 57.2.20 - Rubber Base Exposed End

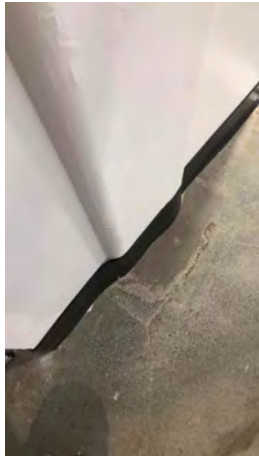
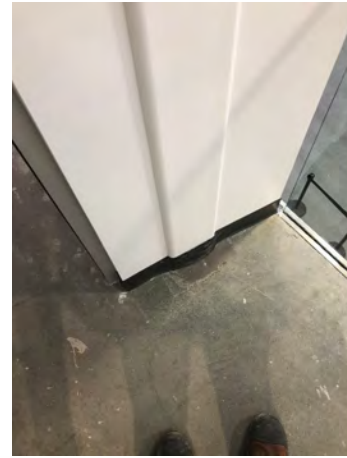
#398 57.2.19 - Repair or Make Good Rubber Base

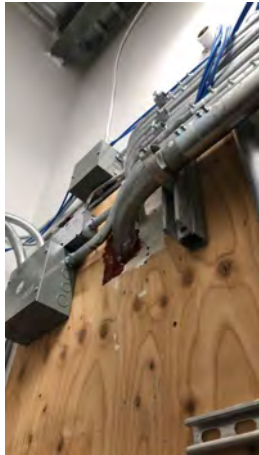
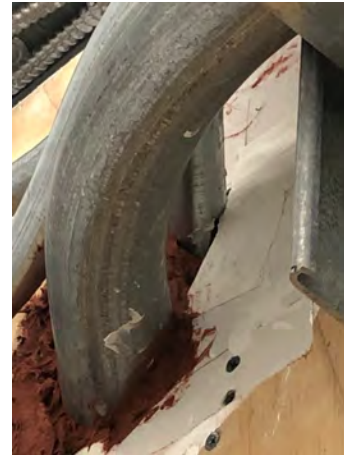
#397 57.2.18 - Review and touch up Fire Stopping

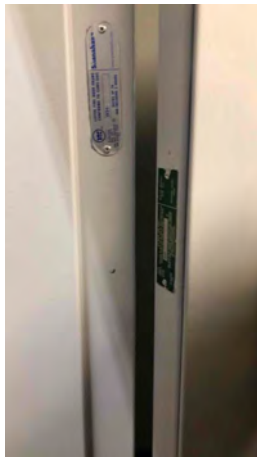
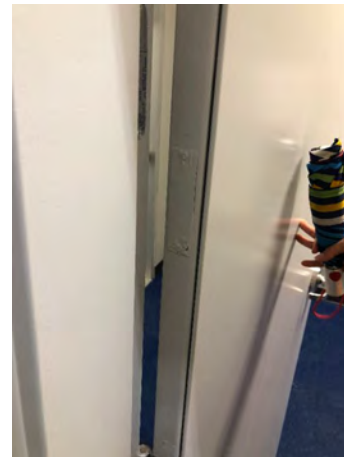
#396 57.2.17 - Remove Tape from Fire Rating Label

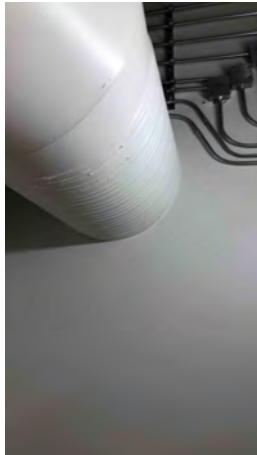
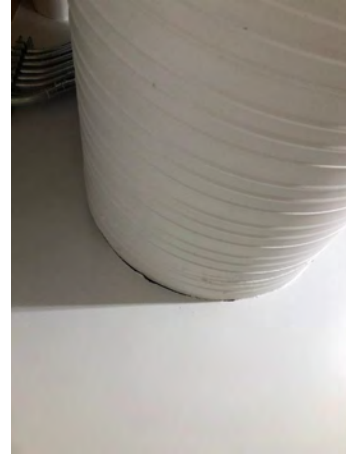
#394 57.2.15 - Seal around Ductwork

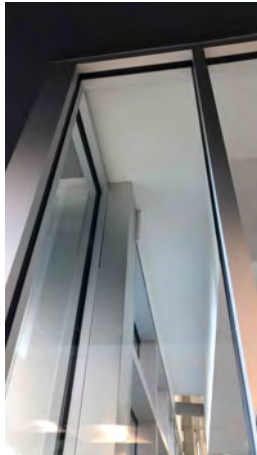
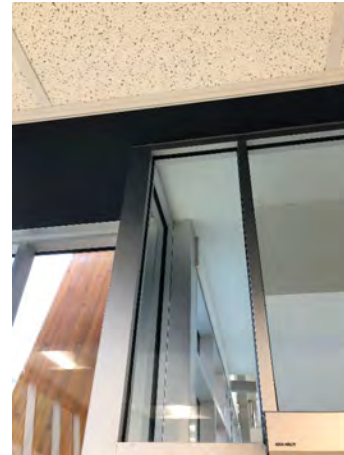
#380 57.2.02 - Gypsum Board End to be Finished.

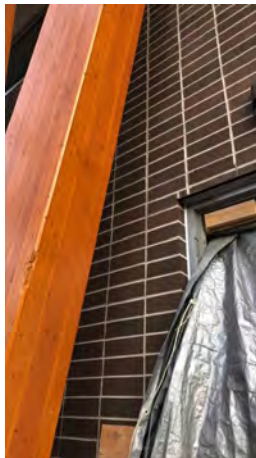
#388 57.1.03 - Cracked Masonry Mortar

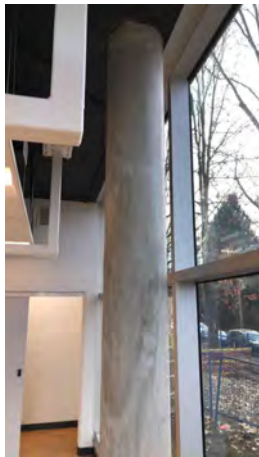
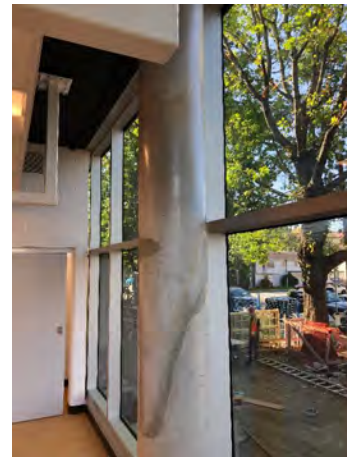
#359 56.2.13 - Int - Column Finish to be Repaired

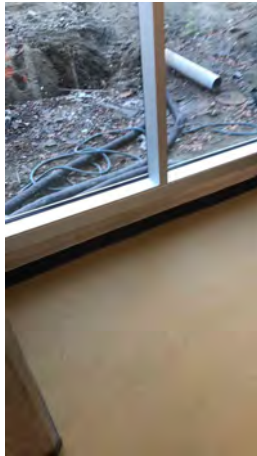
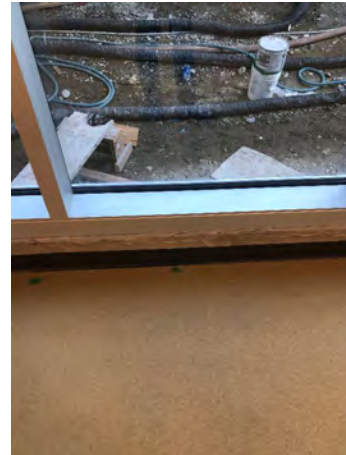
#354 56.2.10 - Int - Grout Underneath Mullion to be Repaired and Made Good

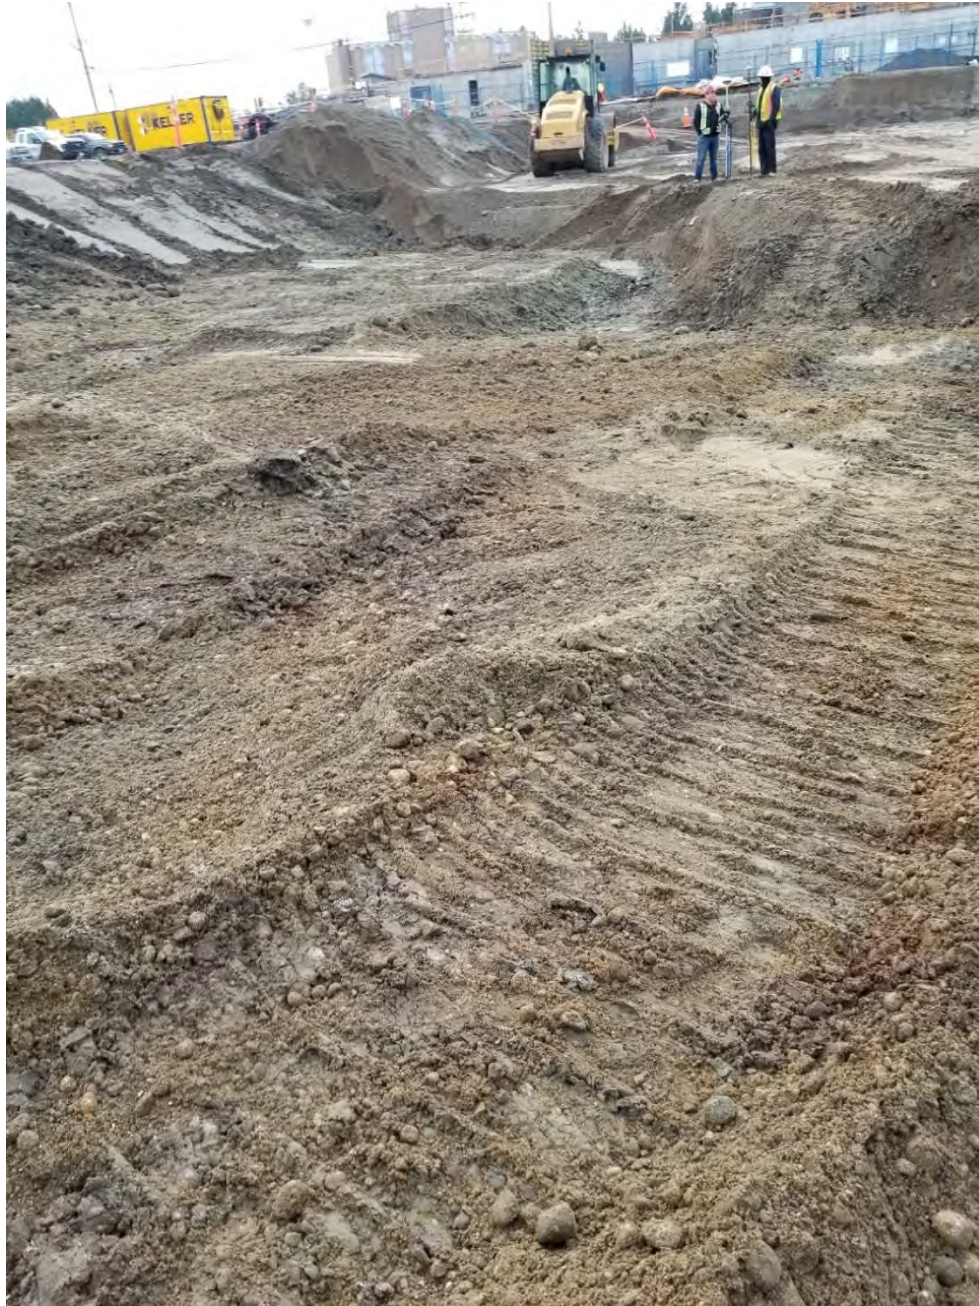
Photo 1 – Looking south. Approved subgrade area (Item 3).
[photo taken by JAL and dated 20191114]

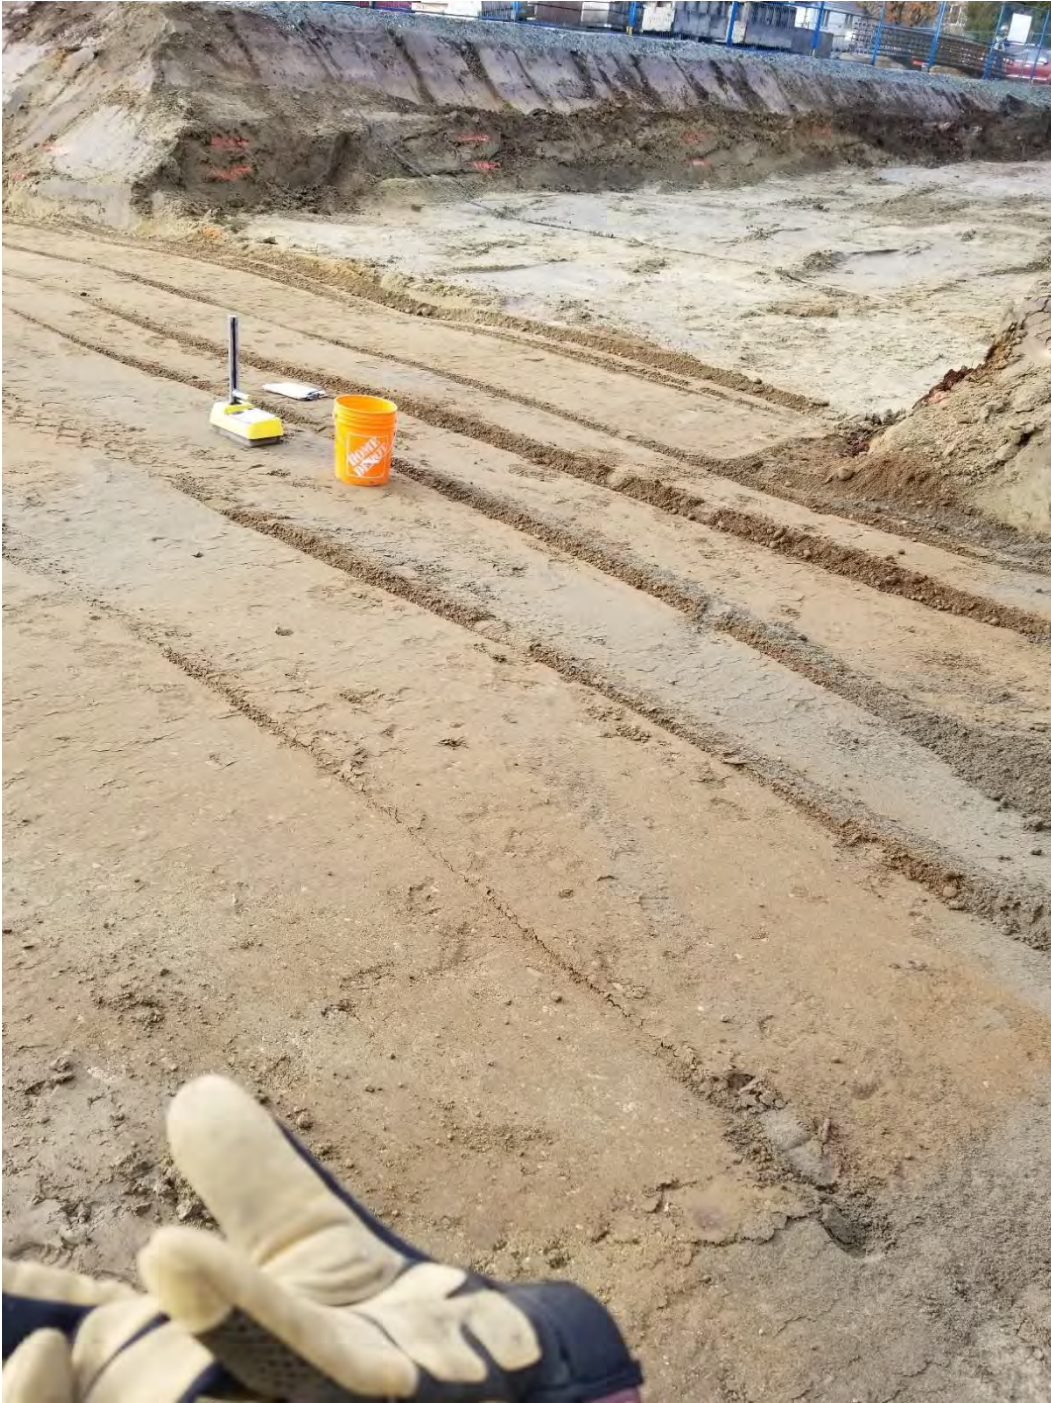
Photo 2 – A lift of Sand and Gravel placed over the west portion of the approved subgrade area. The lift varied in thickness to level out the sloping subgrade (Item 5).
[photo taken by JAL and dated 20191114]

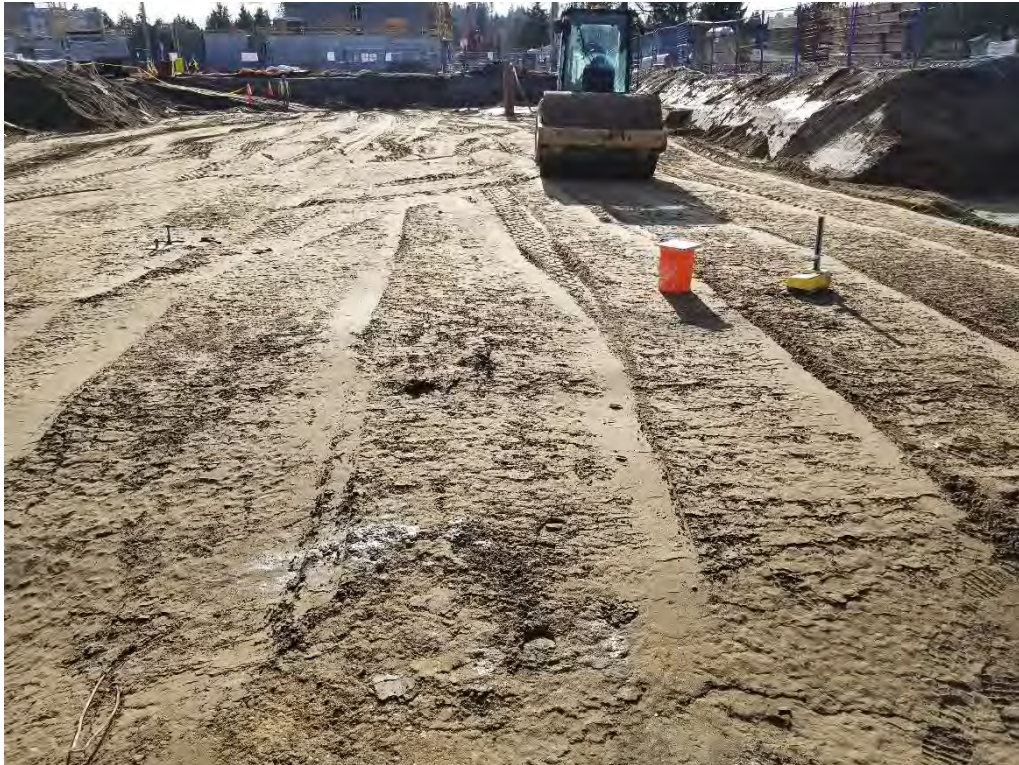
Photo 3 – Second lift placed across the approved subgrade area (Item 6). The base of the entire is now flat (Item 7).
[photo taken by JAL and dated 20191114]

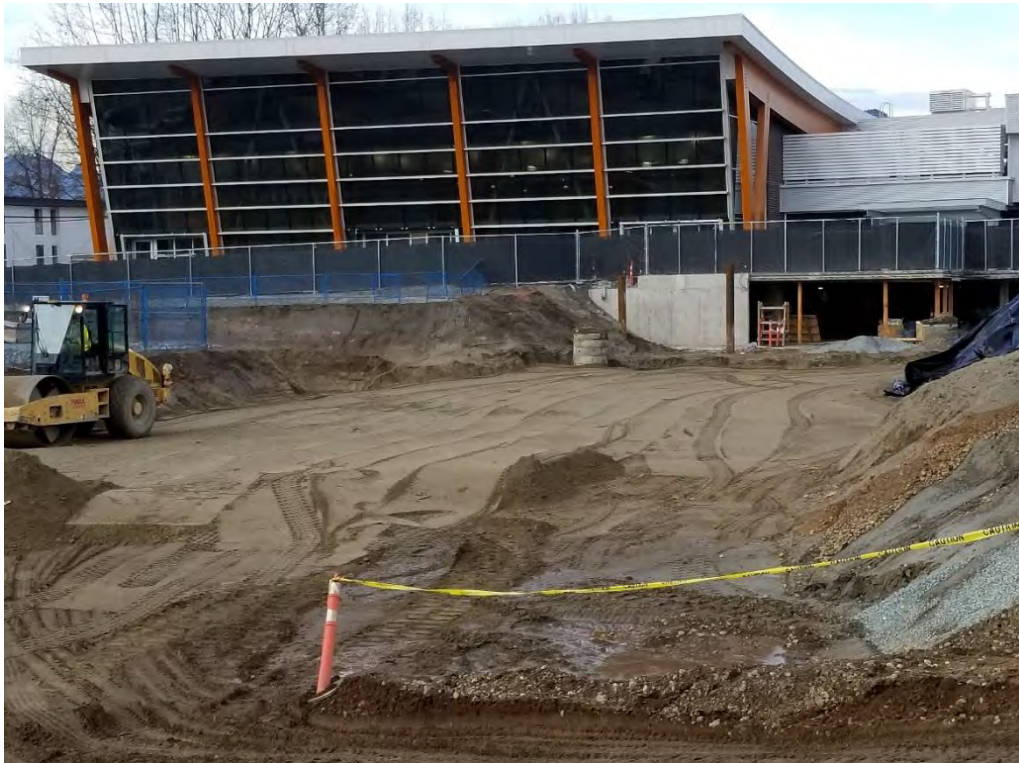
Photo 4 – During compaction of the last lift of fill (Item 9). The lift extended from the north of the excavation up to the well point near the southwest edge of the of the excavation.
[photo taken by JAL and dated 20191114]

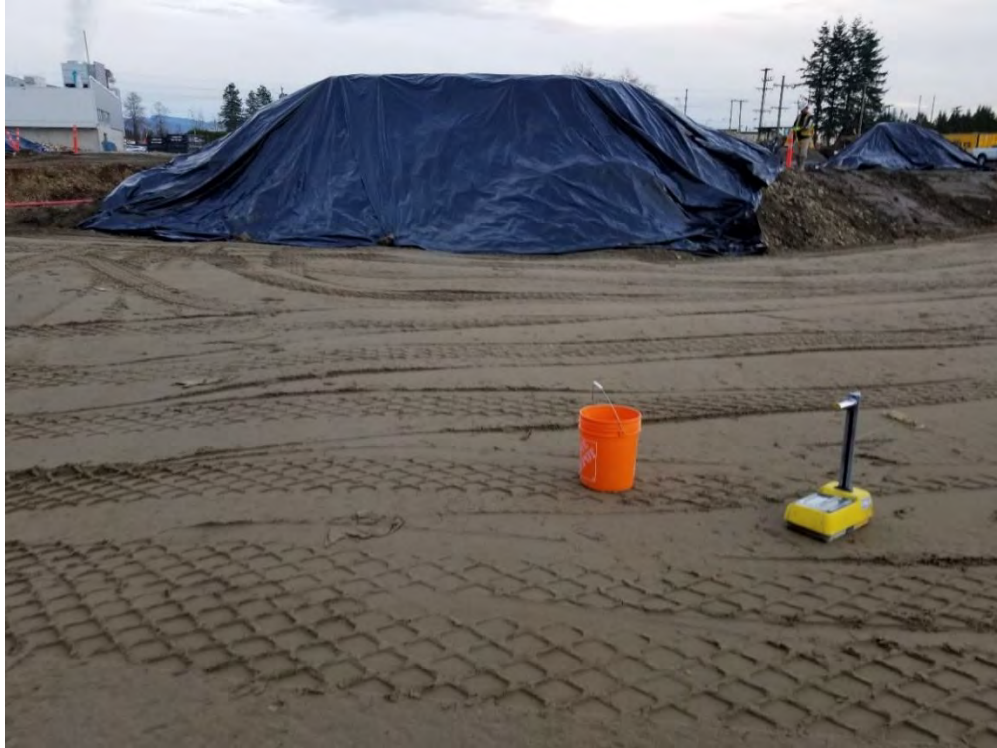
Photo 5 – Testing of third lift.
[photo taken by JAL and dated 20191114]

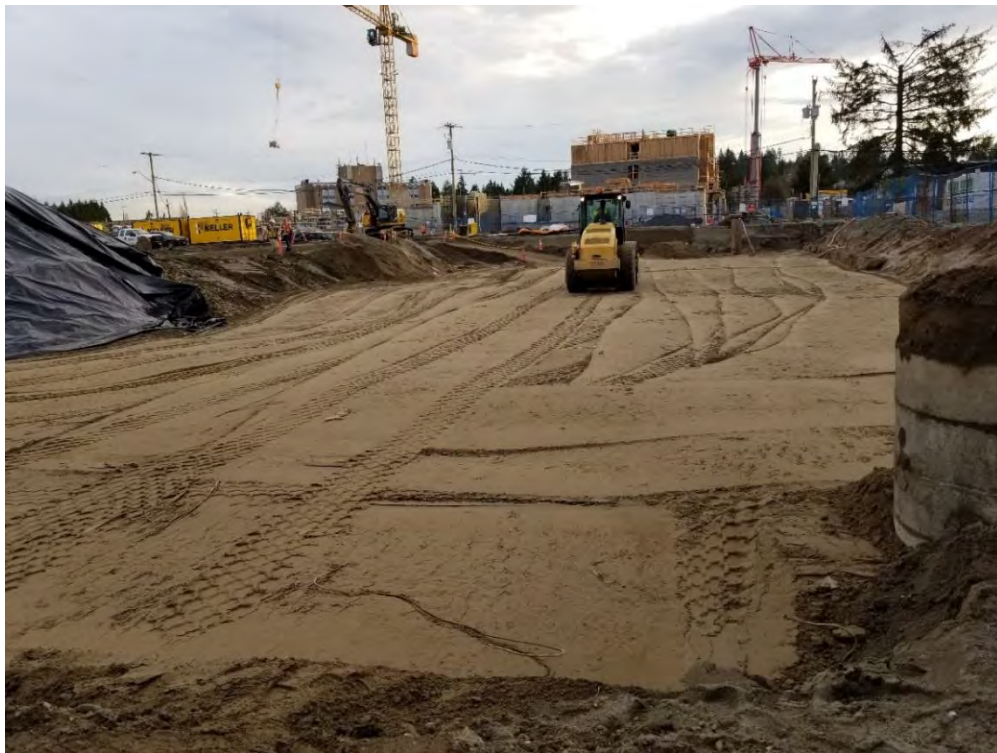
Photo 6 – Recompacting of third lift for the second time.
[photo taken by JAL and dated 20191114]

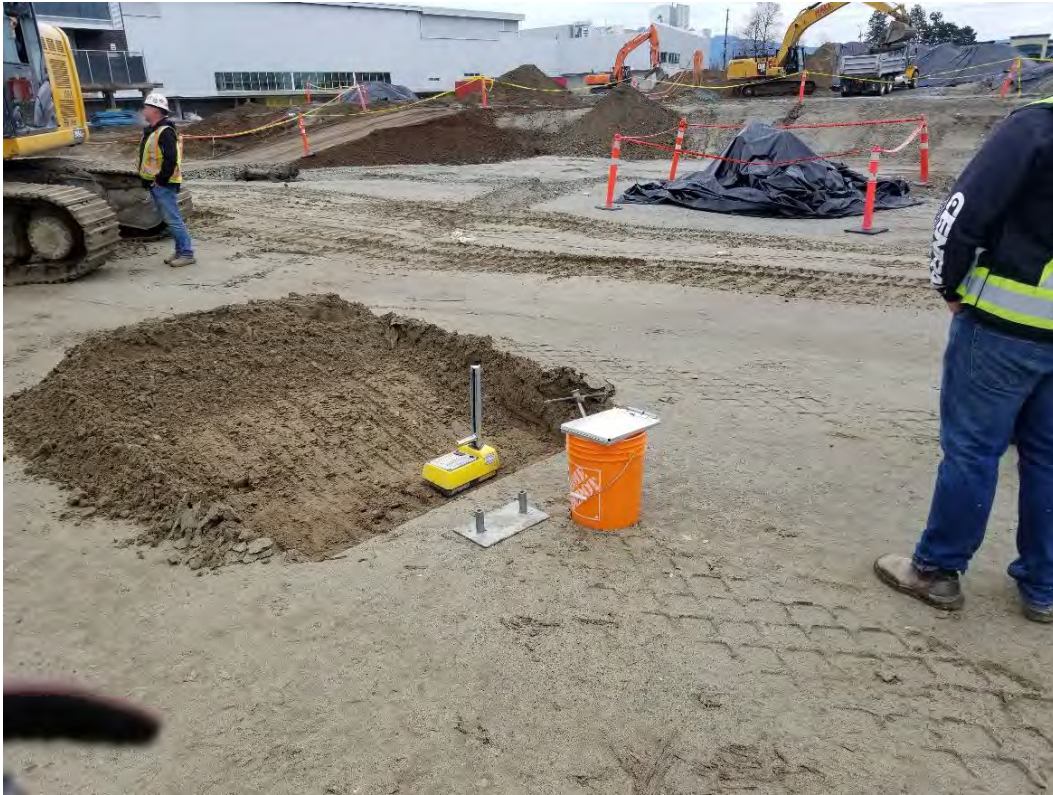
Photo 1 – Compaction testing of fill placed on November 14, 2019 (Item 3).
[photo taken by JAL and dated 20191118]

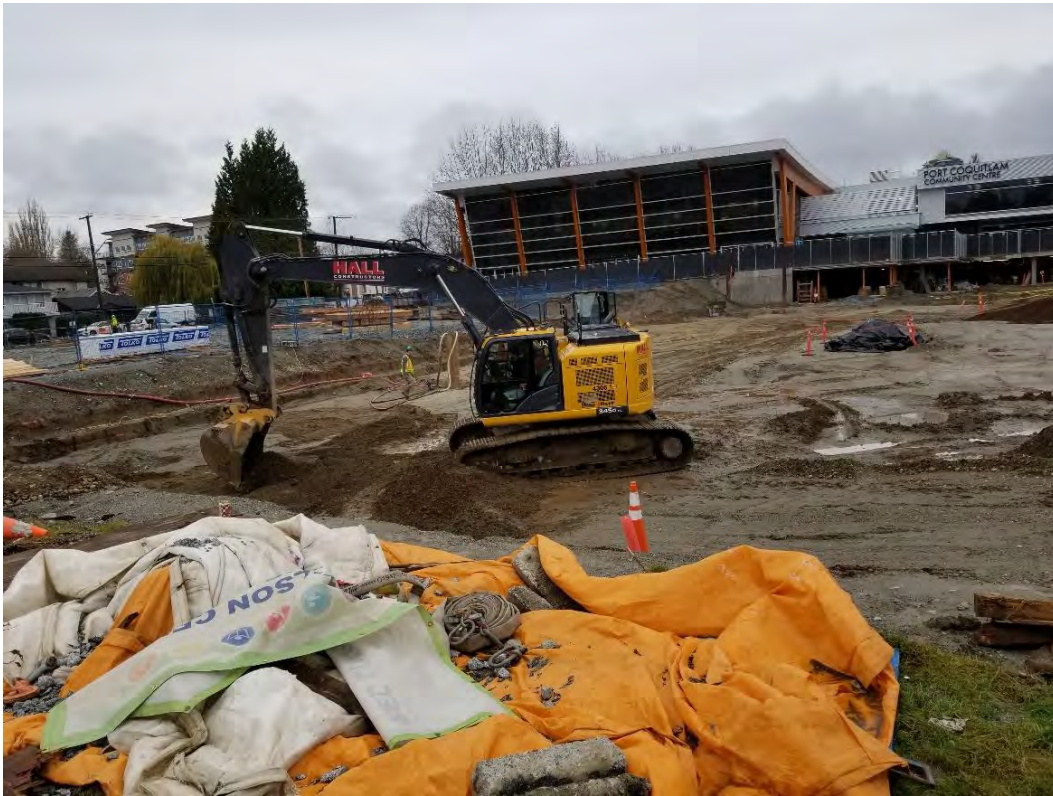
Photo 2 – Removal of standing water and saturated material along south end of excavation (Item 4).
[photo taken by JAL and dated 20191118]

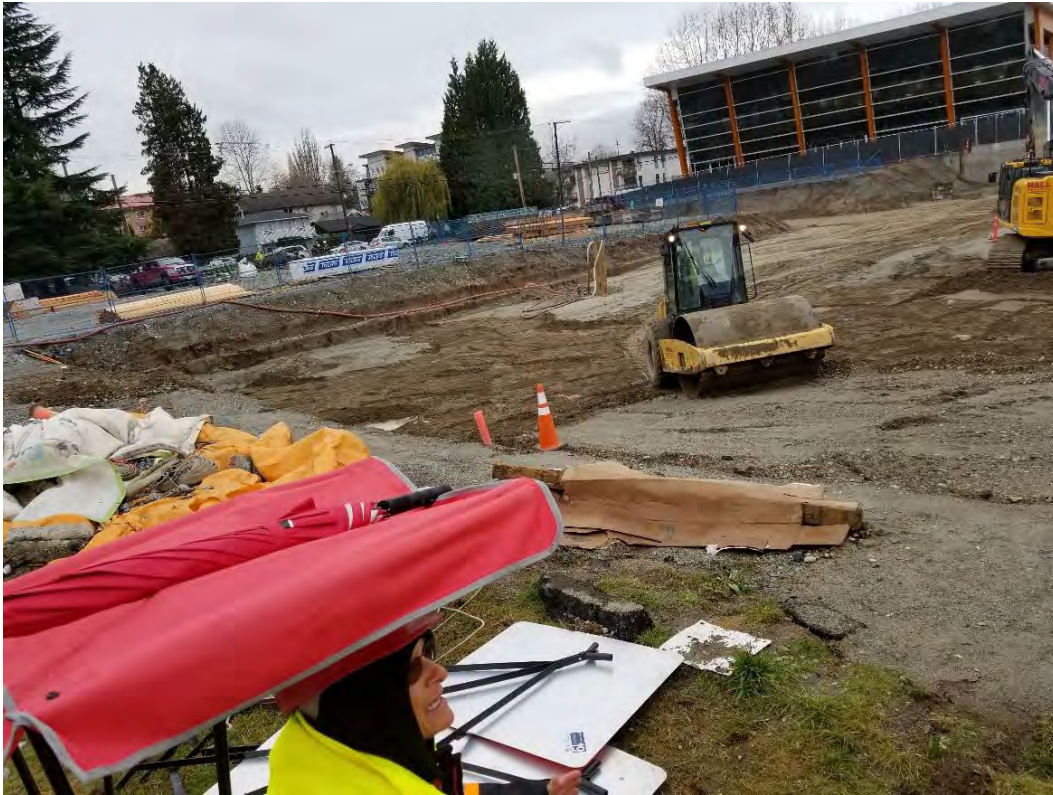
Photo 3 – Compaction of the disturbed surface prior to fill placement (Item 4).
[photo taken by JAL and dated 20191118]
