PORT COQUITLAM COMMUNITY CENTRE

Owner's Representative Progress Report #32

November 2019

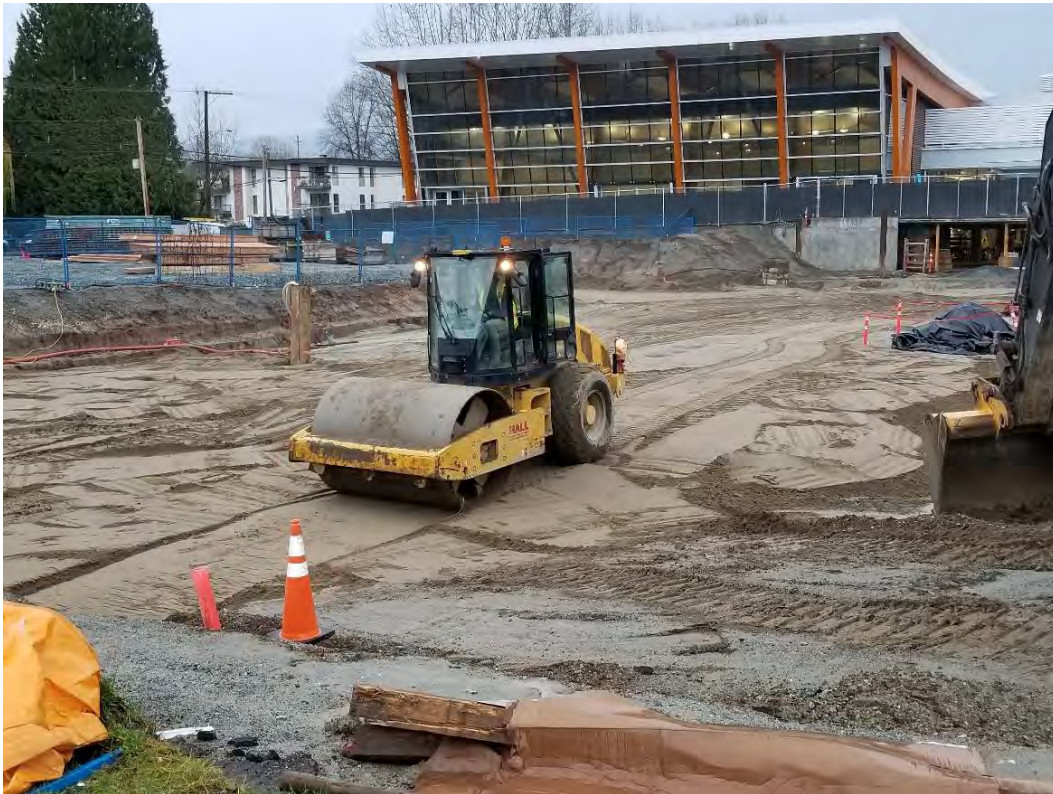
Photo 4 – Compaction of river sand fill at south end of excavation (Item 4).
[photo taken by JAL and dated 20191118]

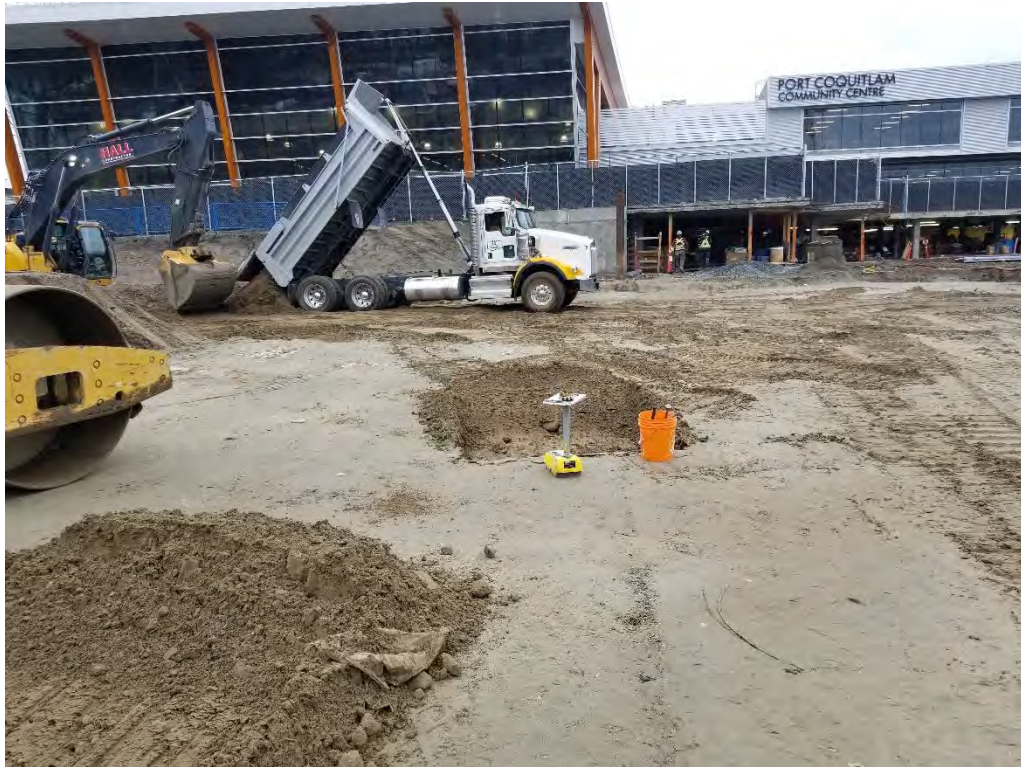
Photo 5 – Fill placement for the access ramp (Item 5).
[photo taken by JAL and dated 20191118]
