## **PORT COQUITLAM COMMUNITY CENTRE**

### **Owner's Representative Progress Report #33**

**December 2019**

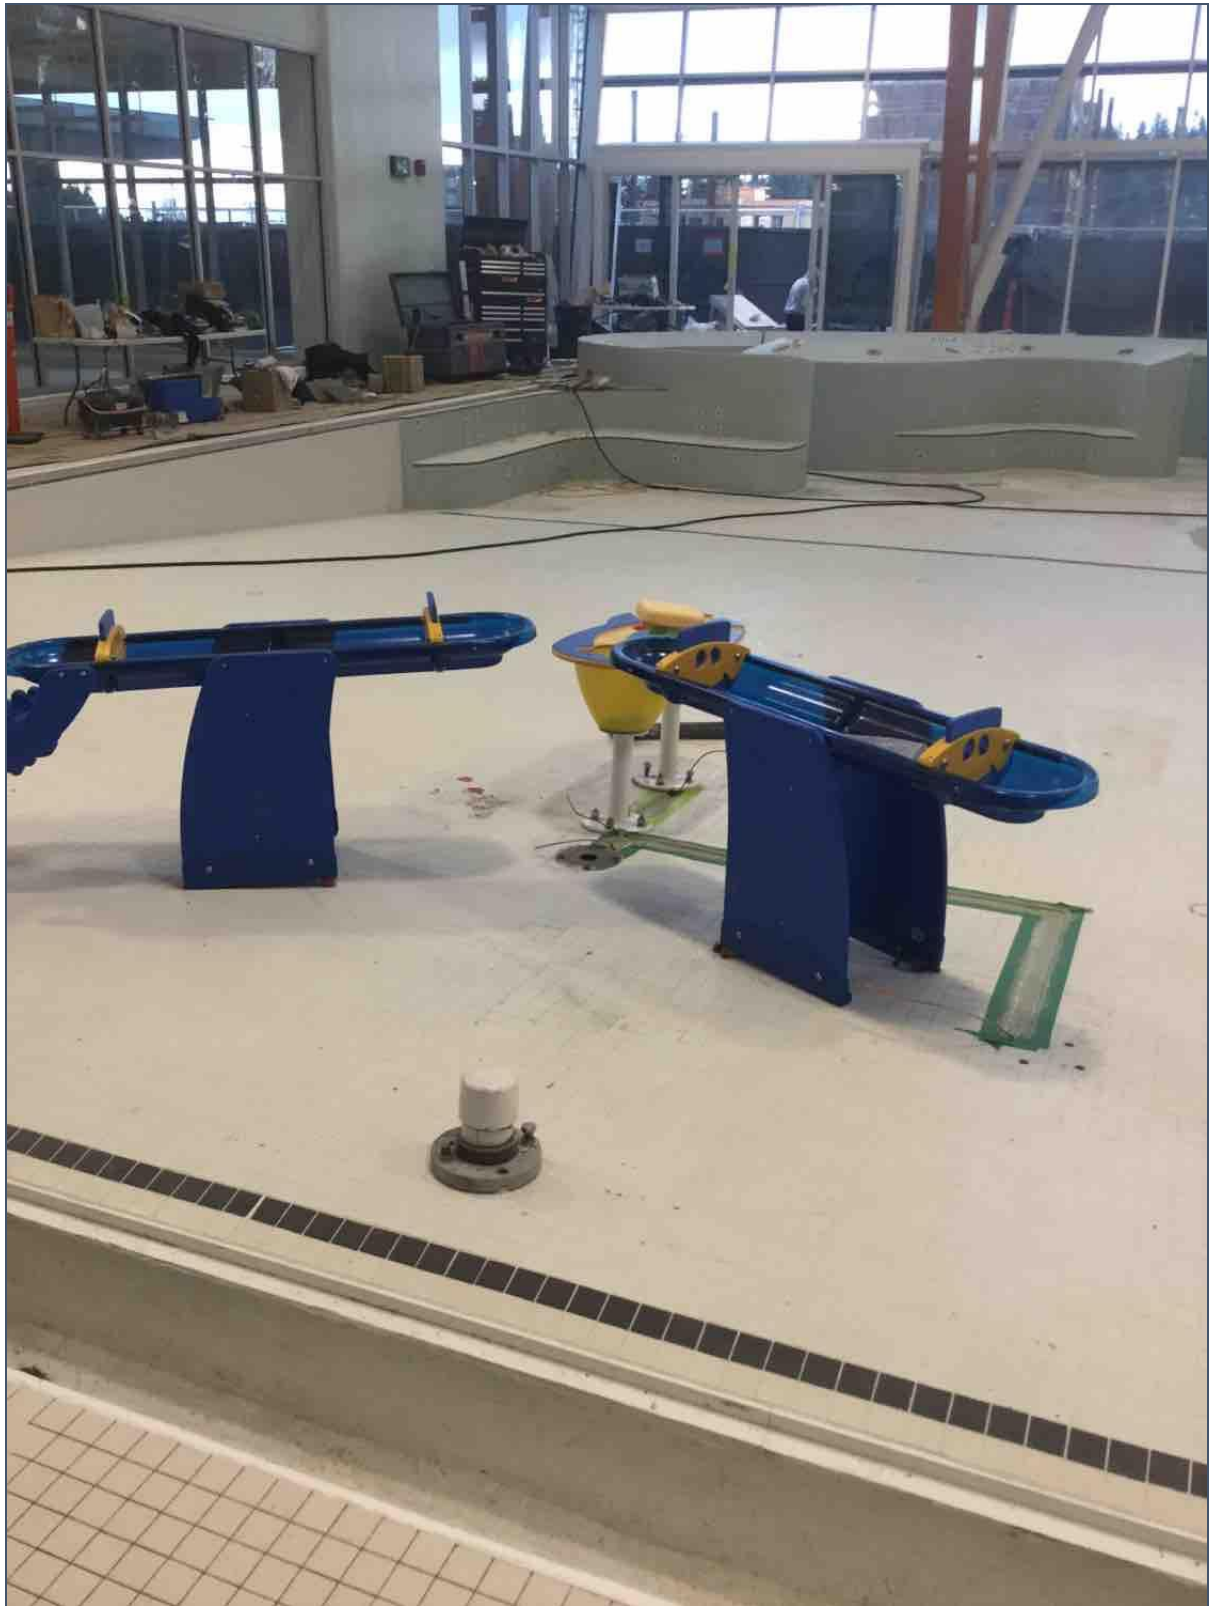
Phase 1C – Pool toys installed

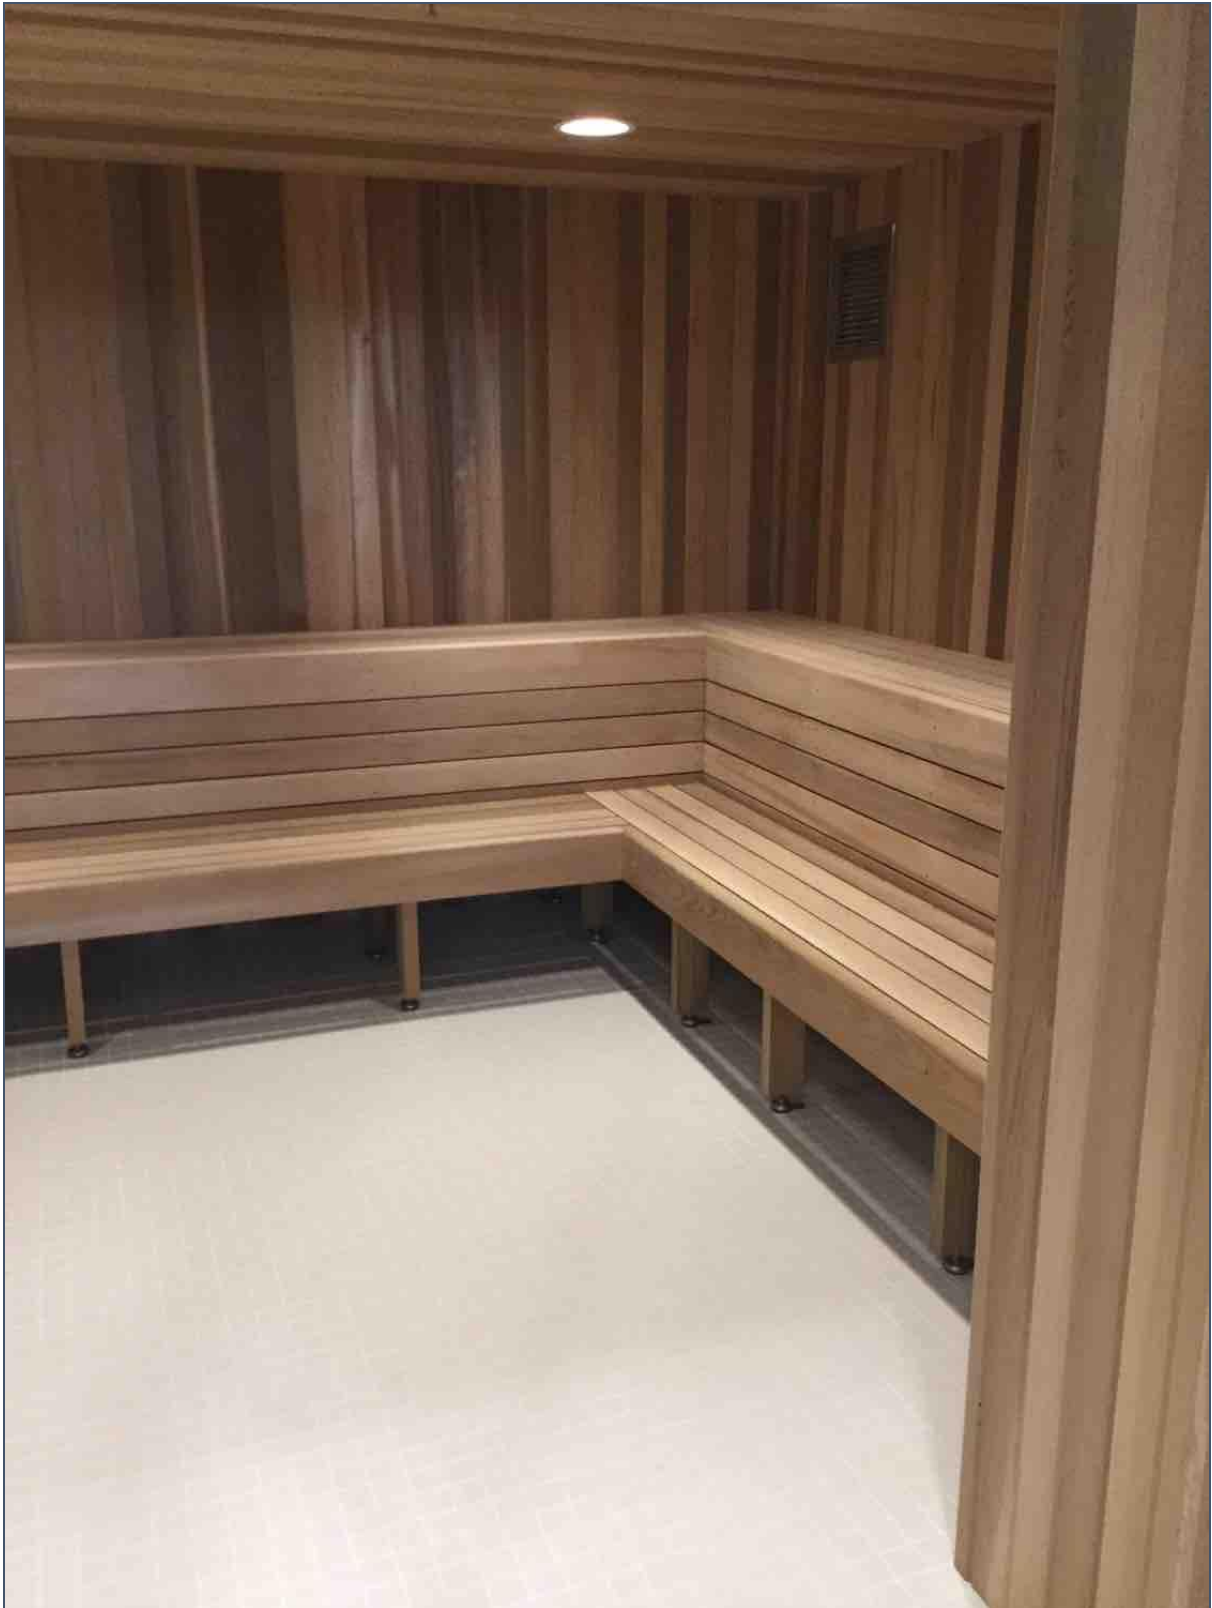
Phase 1C – Sauna walls and benches completed

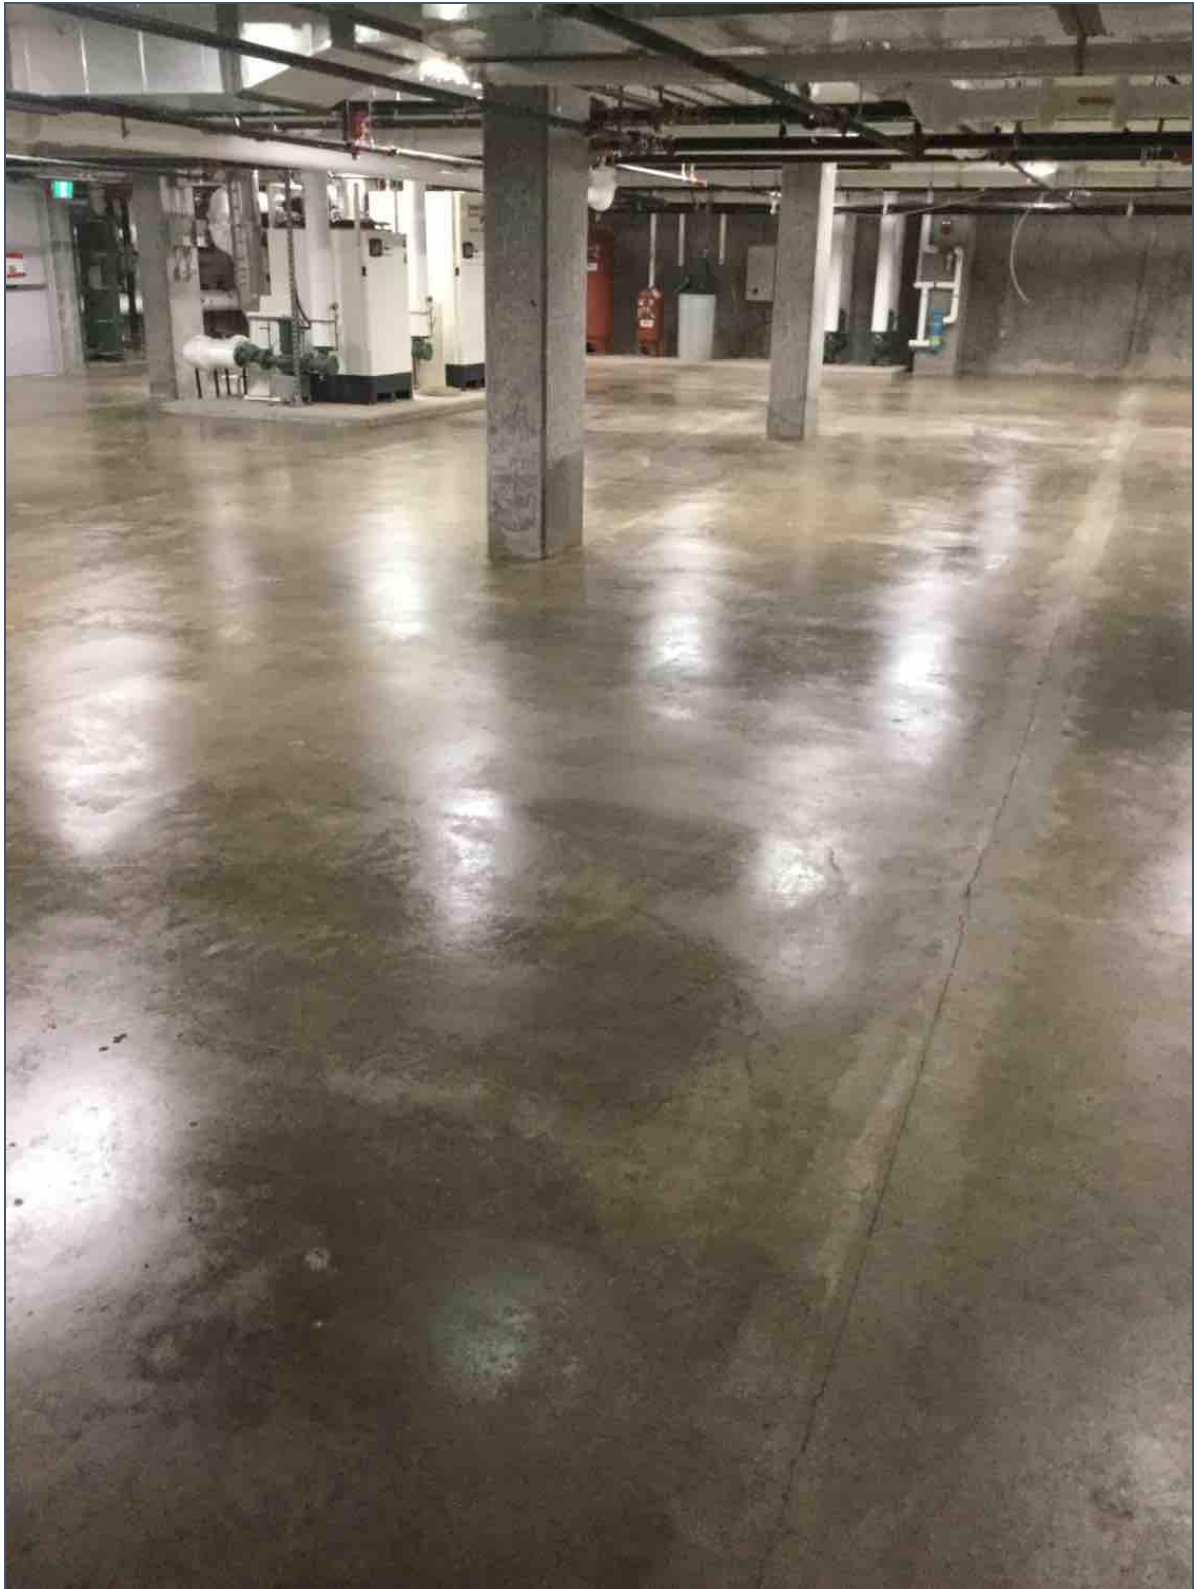
Phase 1C – Boiler room floor sealed

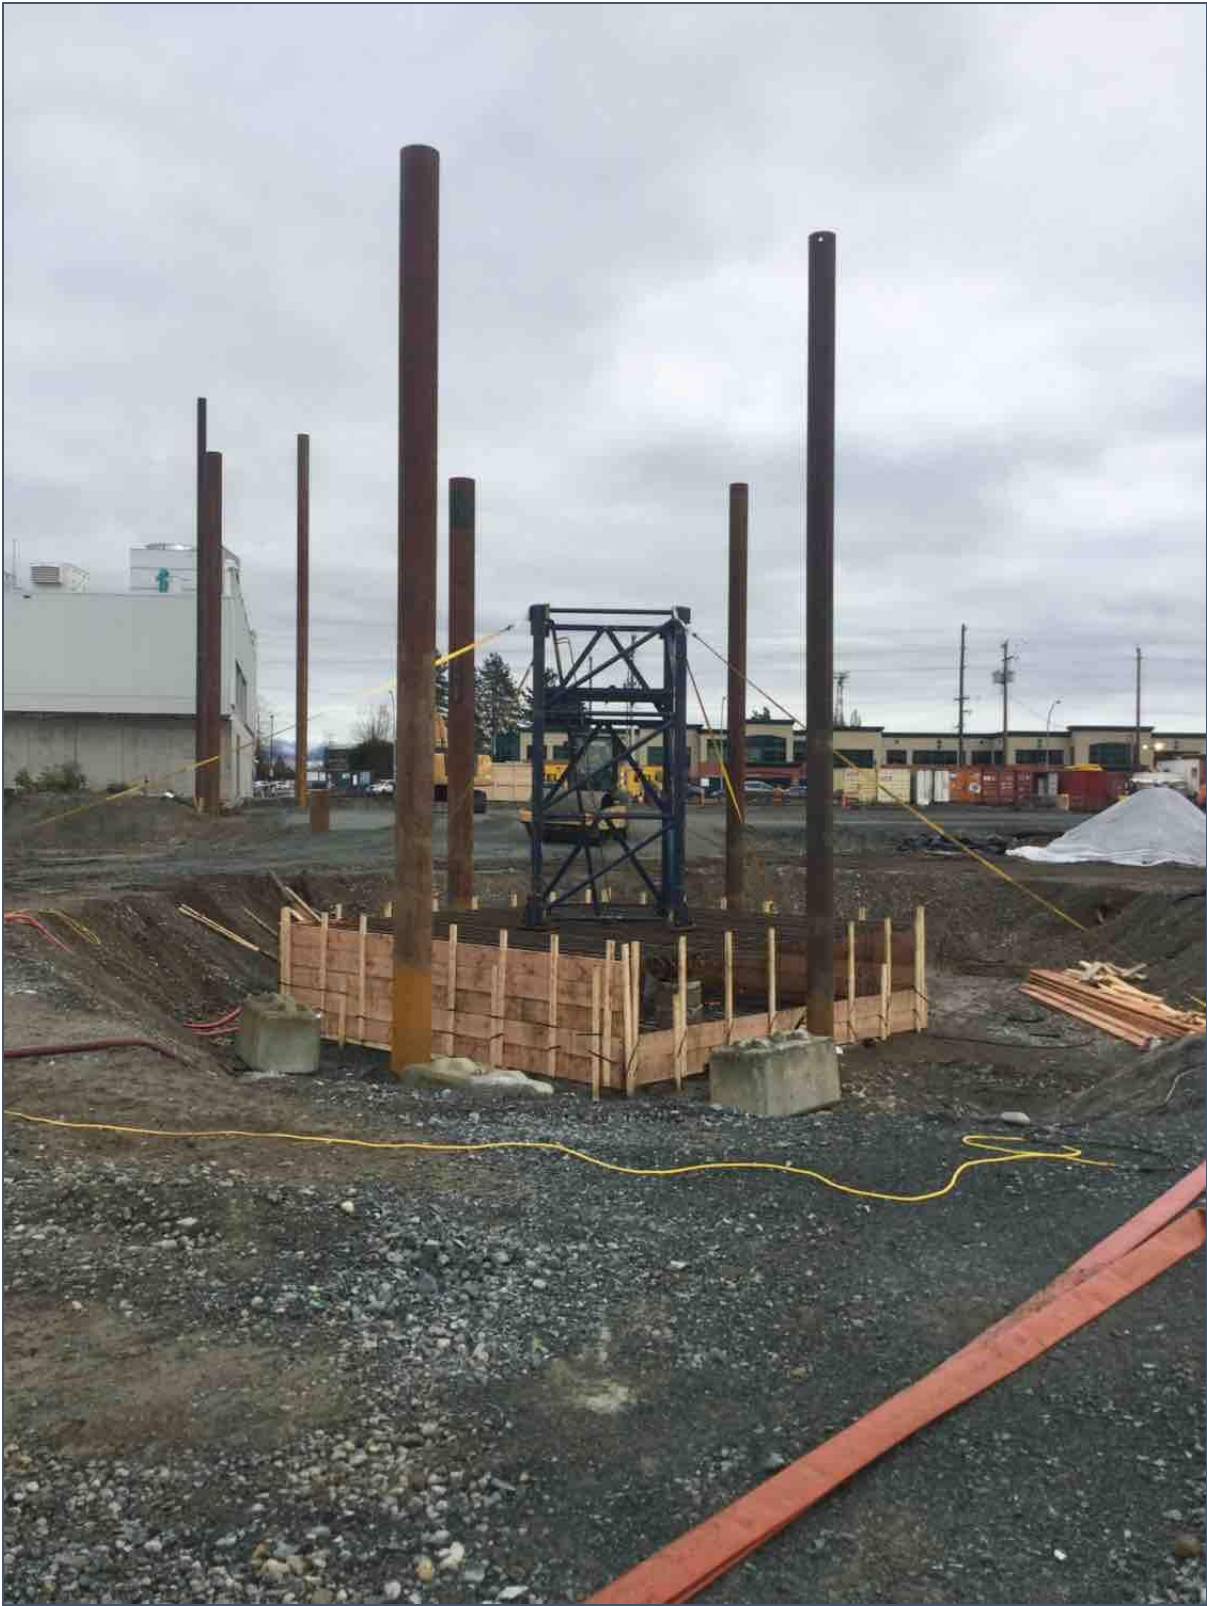
Phase 2 – Crane base

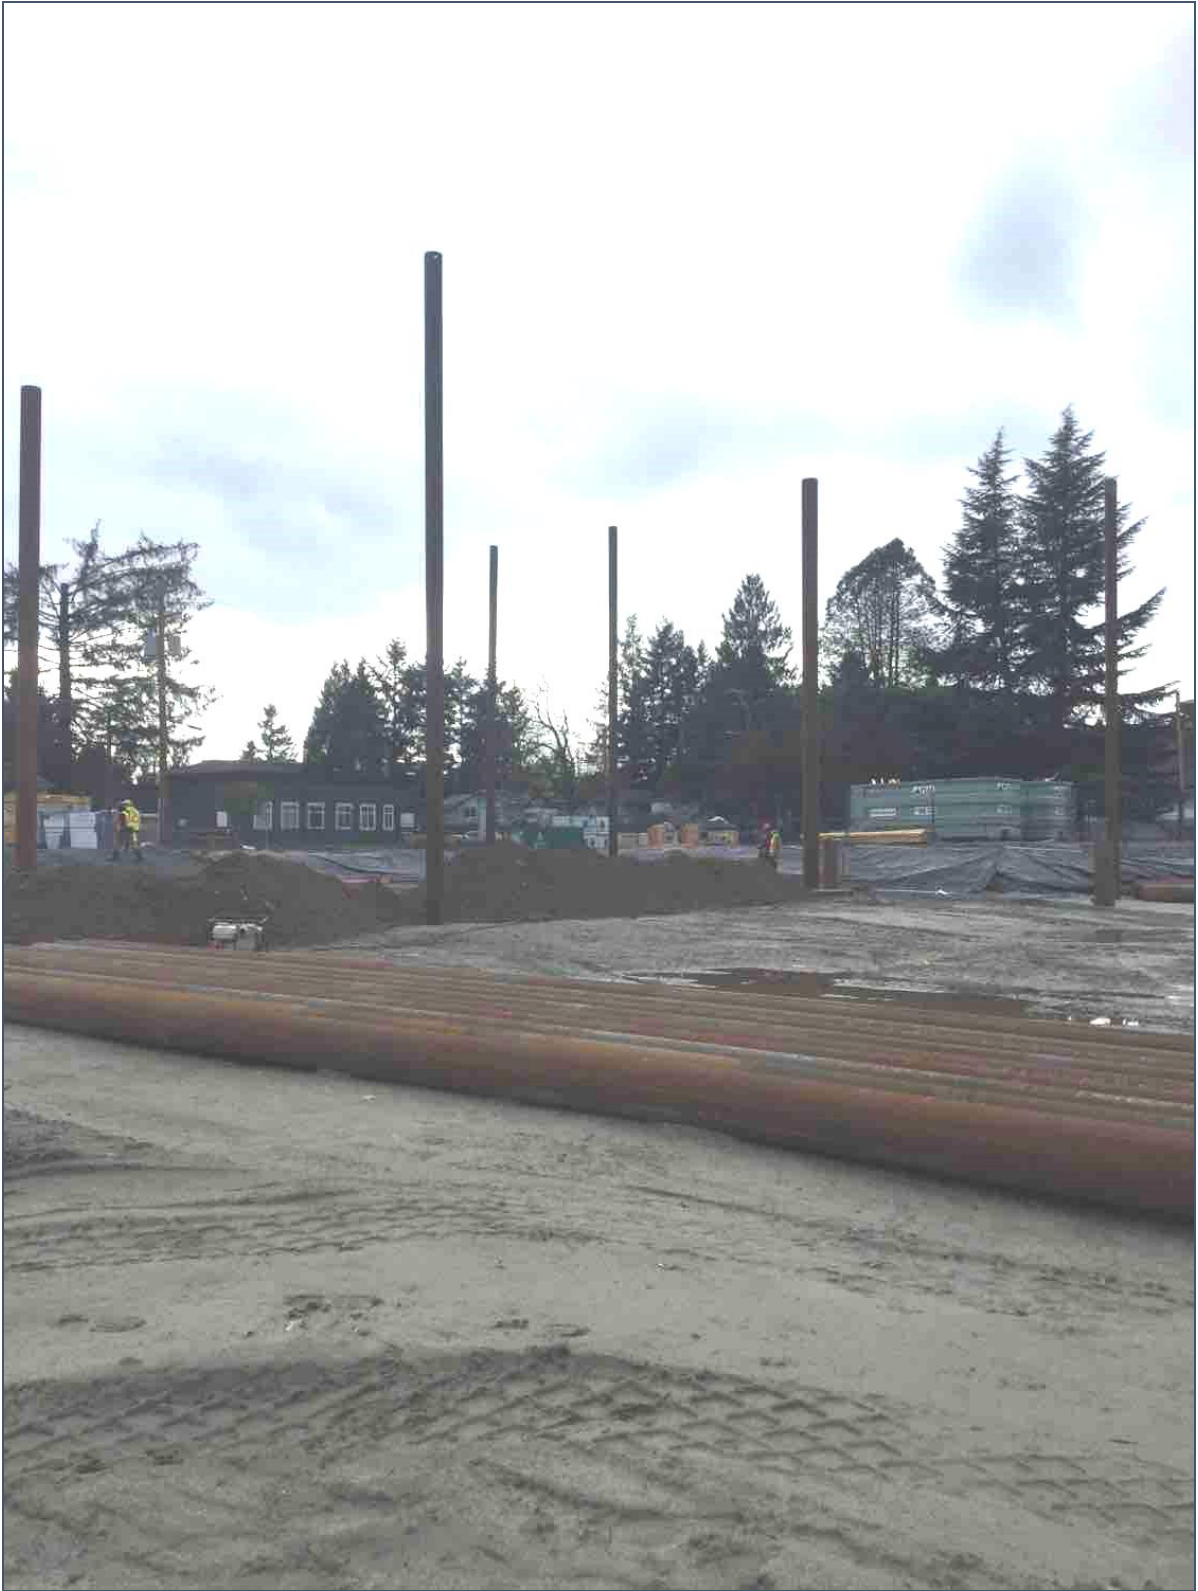
Phase 2 – Piling to SW corner

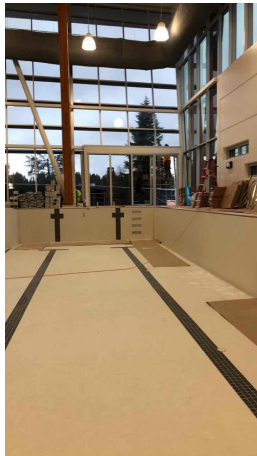
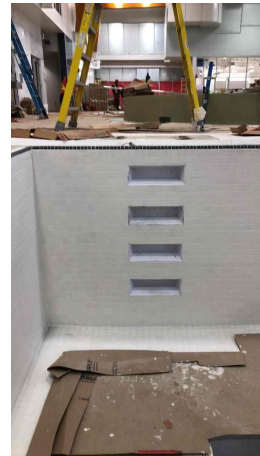
| Description | Pool ladder steps are in place. Ladder rails to be installed at north-east and south-west of the lap area of the pool. |

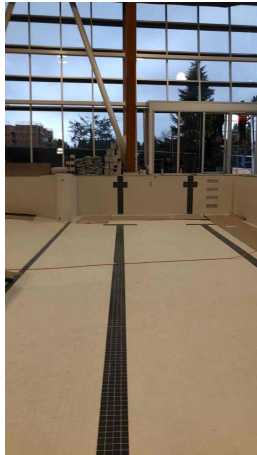
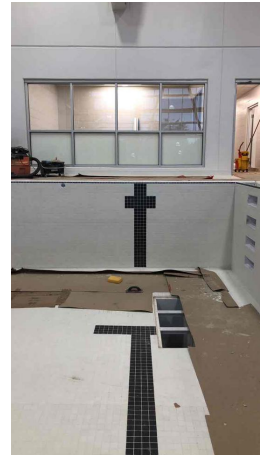
### #445 60.2.02 - Int - Pool Lane Markers

| <i>Description</i> | Pool lane markers are in place, along with cup anchors for lane divider. |

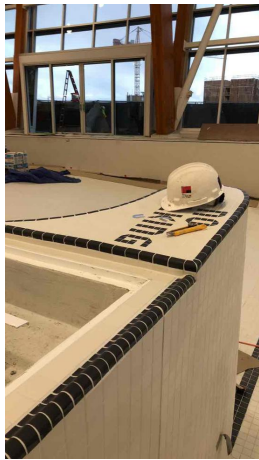
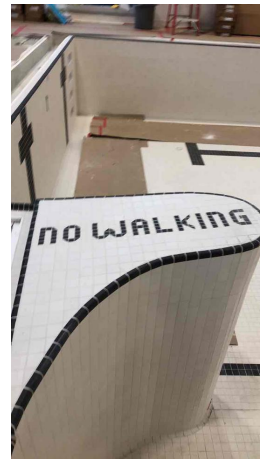
### #446 60.2.03 - Int - Lap Pool Divider Walls

| Description | Divider walls are tiled with signage inset complete. Corners and edges to be reviewed for grout missing, refer to item 60.2.06. |

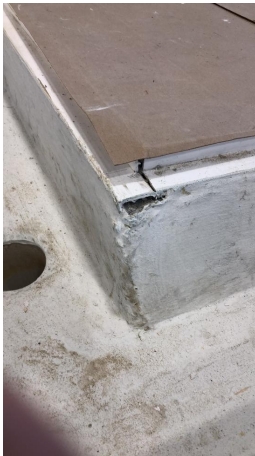
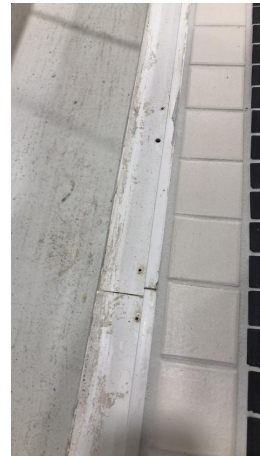
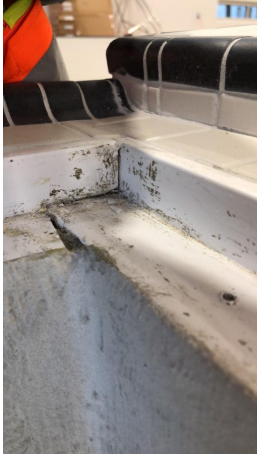
### #464 60.2.04 - Int - Seal Holes in Grating Edge

| Description | Seal holes in pool grating edge, typ. Review corners and along pool edges for screwholes, gaps and cracking/open joints and repair and make good. To be reviewed at ext site visit. |

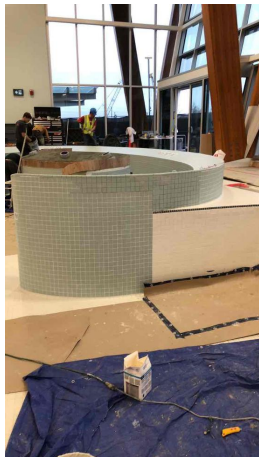
### #448 60.2.05 - Int - Pool Tile Transition

| <i>Description</i> | Transition from white tile to accent colour. |

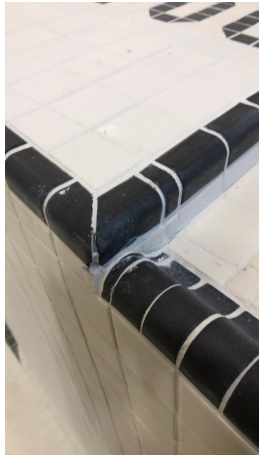
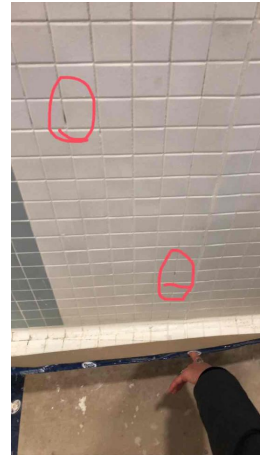
### #449 60.2.06 - Int - Grout to be Checked

| Description | Grout missing in areas, review, repair, and make good. |

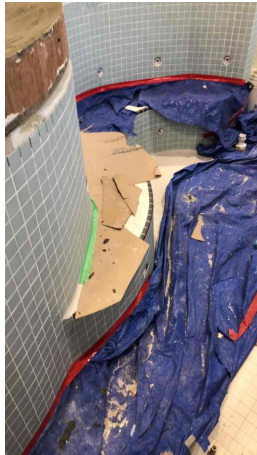
## #450 60.2.07 - Int - Lazy River Bench In Progress

| <i>Description</i> | Progress of the lazy river bench to date. |

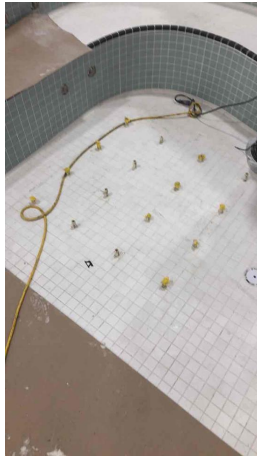
## #451 60.2.08 - Int - Floor Bubbler In Progress

| <i>Description</i> | Progress of the floor bubbler to date. |

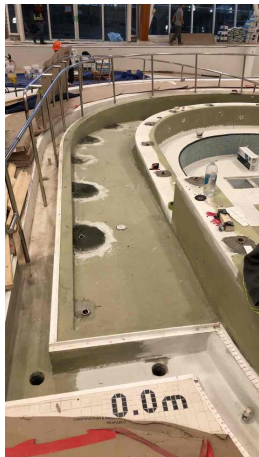
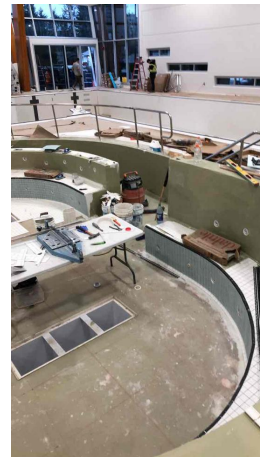
### #452 60.2.09 - Int - Hot Tub Progress

| Description | Grouting and setting of hand rail anchors in progress. Tiling of hot tub in progress. |

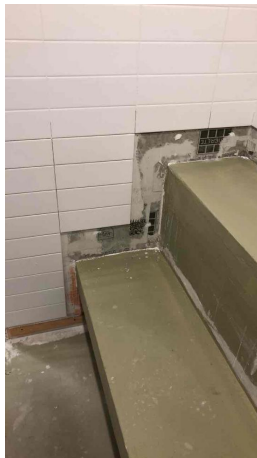
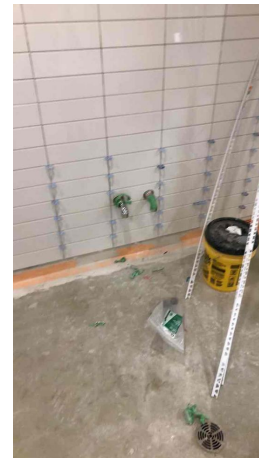
### #453 60.2.10 - Int - Steam Room Progress

| Description | Tiling of the steam room in progress. Wall tiling almost complete. Benches have been waterproofed, and are to be tiled. Steam pipe installed, awaiting shroud installation. |

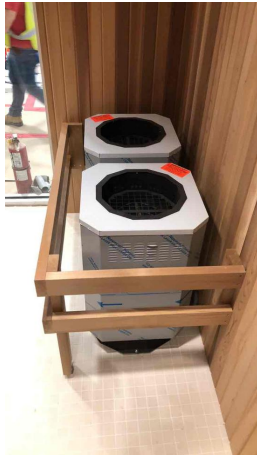
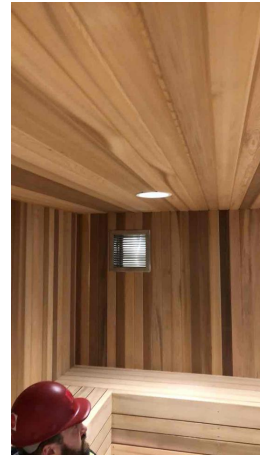
## #454 60.2.11 - Int - Sauna Progress

| <i>Description</i> | Sauna interior wood work installation complete. Sauna heater installation complete. |

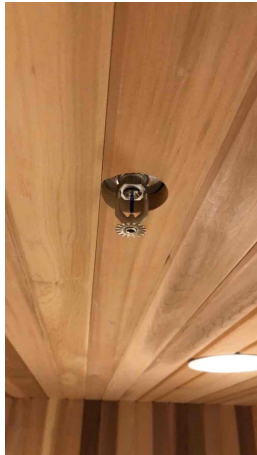
## #455 60.2.12 - Int - Sauna Sprinkler

| <i>Description</i> | Provide escutcheon plate around sprinkler head. |

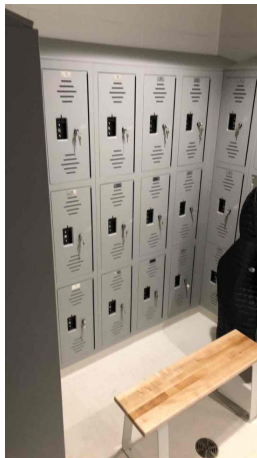
### #456 60.2.13 - Int - Locker Progress

| <i>Description</i> | Lockers have been installed in male, female and staff pool change rooms. Installation in universal is almost complete. |

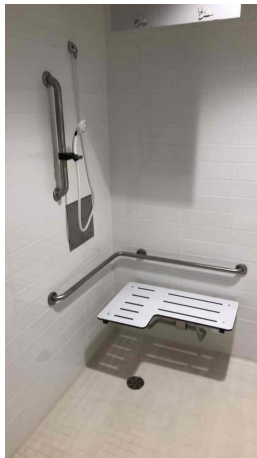
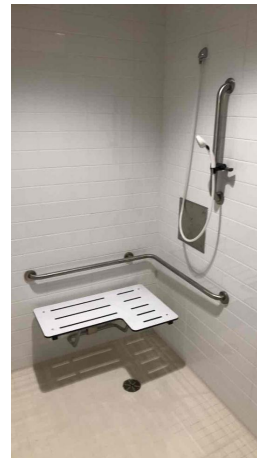
### #457 60.2.14 - Int - Accessible Shower Stalls

| Description | Accessible shower head, bench and grab bar have been installed as shown in the architectural drawings. |

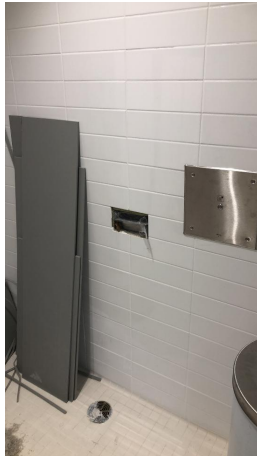
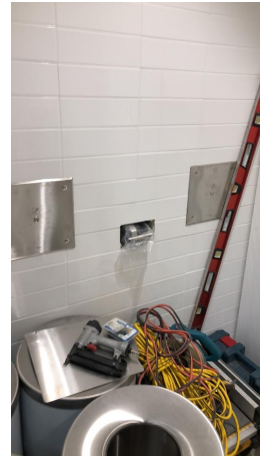
## #465 60.2.15 - Int - Soap Dish Installation in Progress

| Description | Soap dishes in universal change room showers have been located but are awaiting installation. |

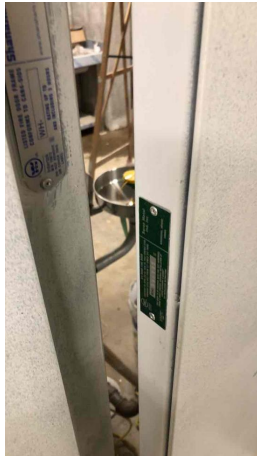
## #461 60.2.16 - Int - Door Fire Rating Label

| <i>Description</i> | Fire rated doors have been observed as installed based on the labels on doors and frames. |

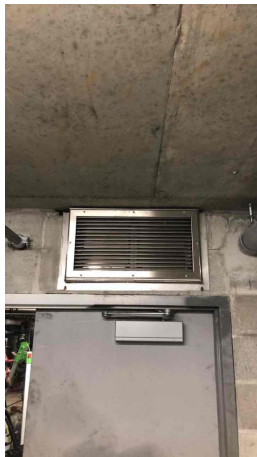
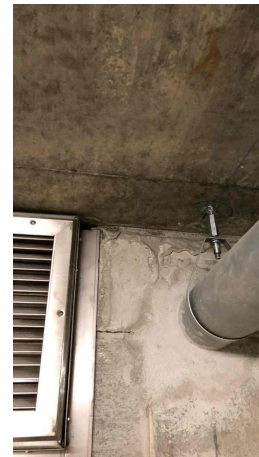
### #463 60.2.18 - Int - Address Fire Stopping

| <i>Description</i> | Address holes and slumped firestopping application, repair, fill holes and make good. |

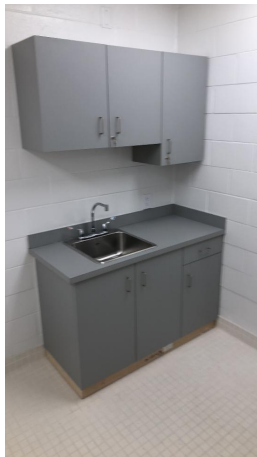
| Description | Cabinets and sink have been installed within 1C132. Toe kick to be installed. |

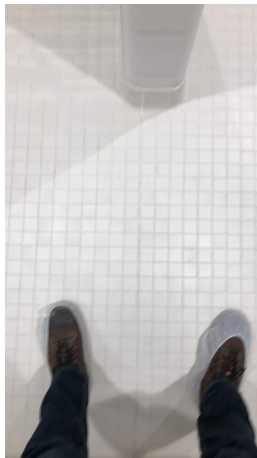
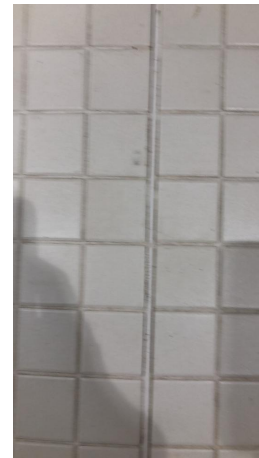
| <i>Description</i> | Check for even surface at tiling control joints. To be smooth so as to prevent tripping hazards. |

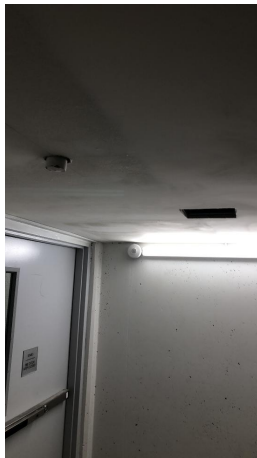
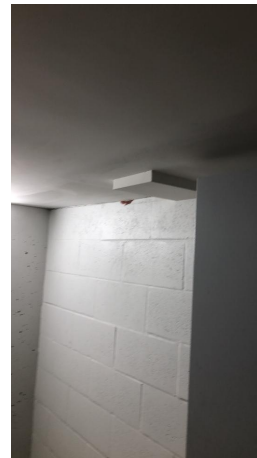
| <i>Description</i> | Shaft ceiling within the exit vestibule is in progress. Sprinkler, access hatch, and painting to be completed. |

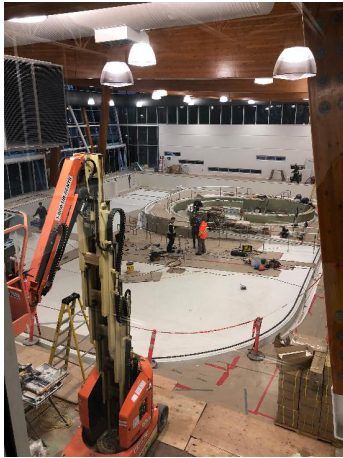
## #472 60.2.25 - Overall View of Pool Progress

| <i>Description</i> | View of the pool area looking southwest from the second floor access to the dehumidifier roof. |

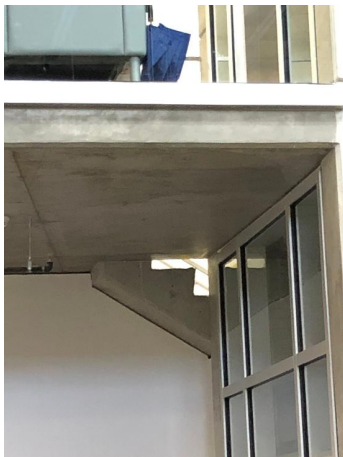
### #386 57.2.08 - Close Gap at Stair

Advised by VCC on Nov. 25, 2019 that cover was removed by City. VCC to advise the City that cover was installed to eliminate potential fall hazard at stair opening.

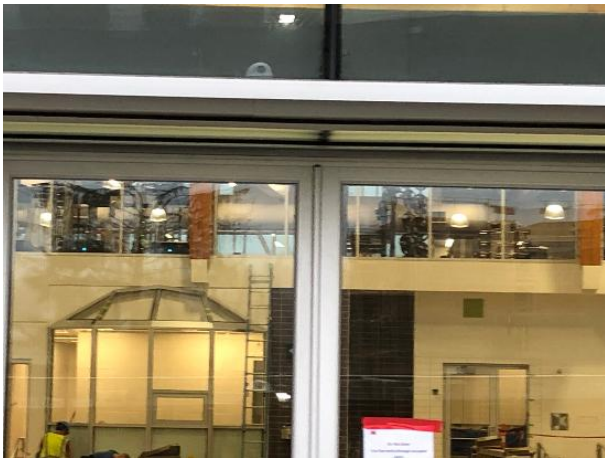
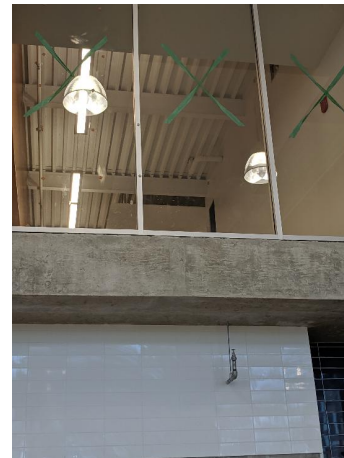
## #336 55.2.15 - Int - Concrete Edge to be Repaired and Made Good

| <i>Description</i> | Repair and make good concrete edge at base of level 2 glazing between pool and fitness centre. |

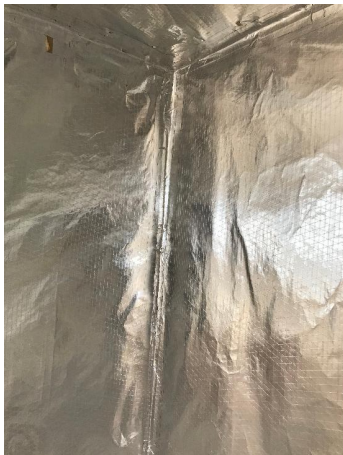
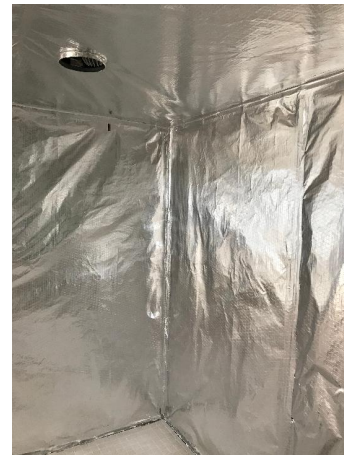
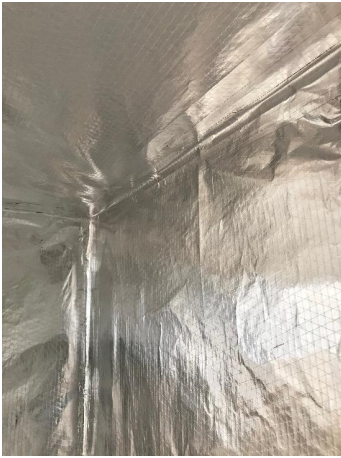
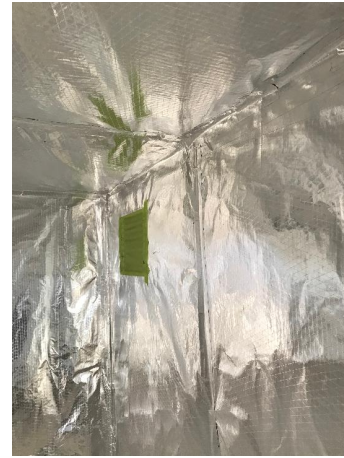
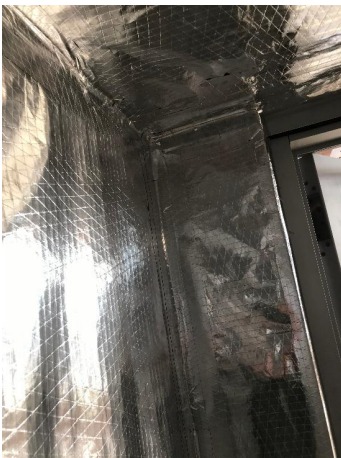
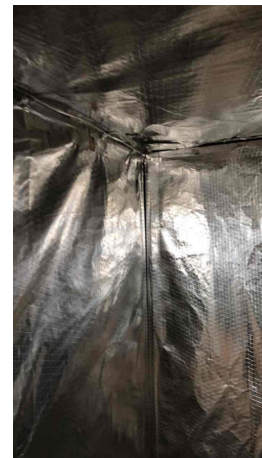
### #331 55.2.10 - Int - Repair Holes and Seams in Foil Face Membrane

| Description | Review and repair holes in foil faced membrane in sauna. |

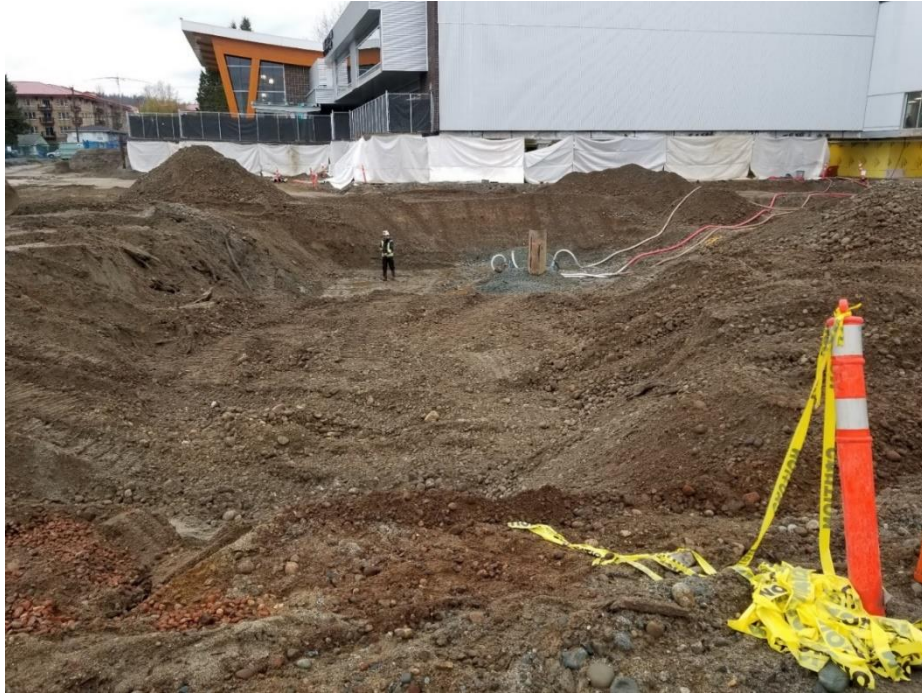
**Photo 1** – Looking west. During subgrade approval of the new excavation in the north parkade area (Item 2).  
[photo taken by JAL and dated 20191203]

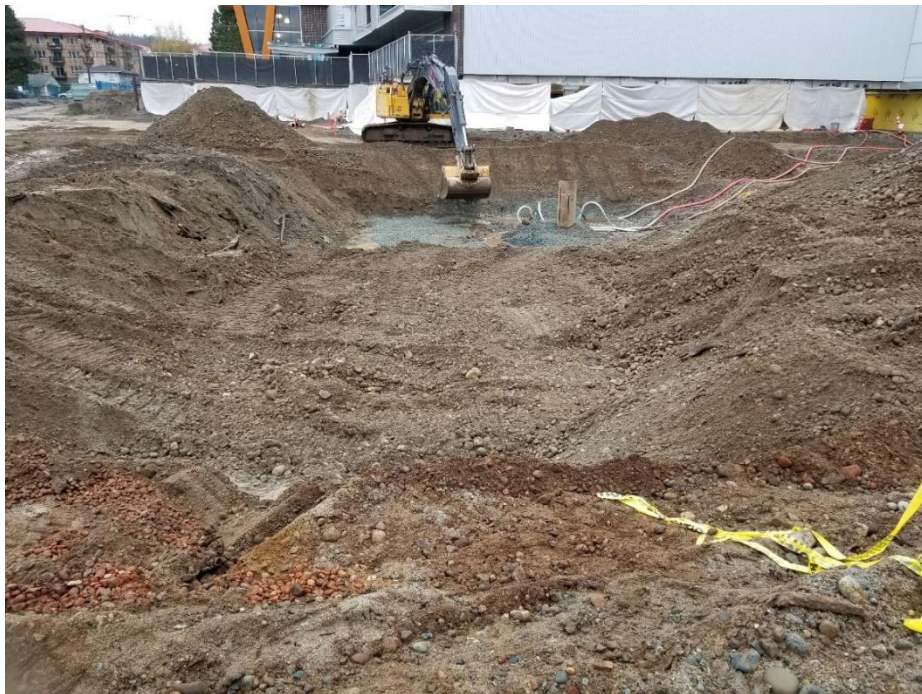
**Photo 2** – Looking west. Locally placing 19 mm minus clear crush at the base of the excavation (Item 3).  
[photo taken by JAL and dated 20191203]

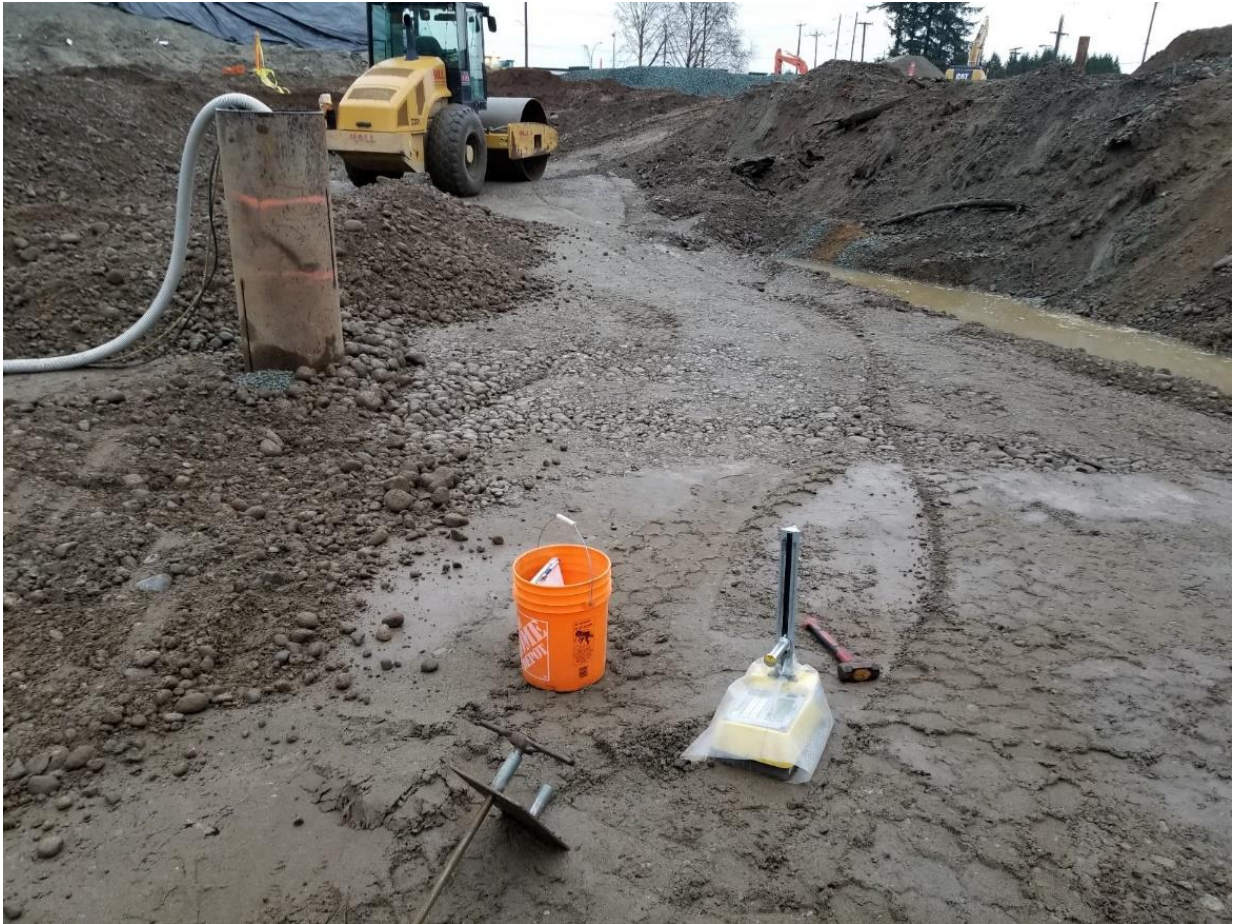
**Photo 3** – Looking southeast. During compaction testing of 1st lift (FDR 019-2).  
[photo taken by JAL and dated 20191203]
