TREE EVALUATION REPORT 3455 OXFORD STREET, PORT COQUITLAM, B.C.

PREPARED BY: STICKLEBACK ENVIRONMENTAL MARCH 2019

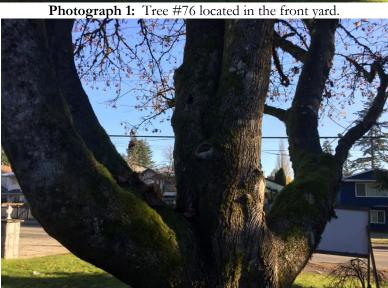
| Tag | Species | DBH | Ht | LCR | Drip | Recommendation | Condition Assessment |
|---|---|---|---|---|---|---|--|
| 76 | Acer macrohyllum | 70 | 14 | 75 | 7 | Remove | Multi-stemmed x 3 at 1.4m height. Some moisture at stem union. Healed cracks on stems. Heavy overweight stems with horizontal attachment. In construction footprint. |

Photograph 2: Tree #76 multi-stemmed at 1.4 m height.

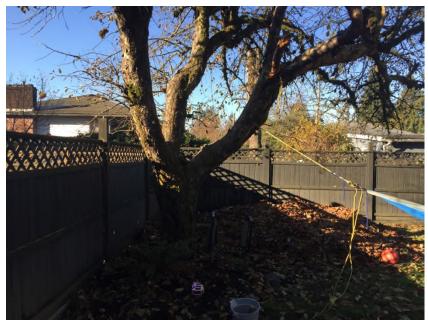
| Tag | Species | DBH | Ht | LCR | Drip | Recommendation | Condition Assessment |
|---|---|---|---|---|---|---|--|
| 77 | Prunus sp. | 31,30,36 | 8 | 35 | 5 | Remove | Multi-stemmed x 3. Decay in upper canopy. Decay at stem union and decay column up southeast side of stem. Bark peeling. Poor health and structure. No retention value. |

Photograph 3: Tree #77 with decaying canopy in the rear yard.

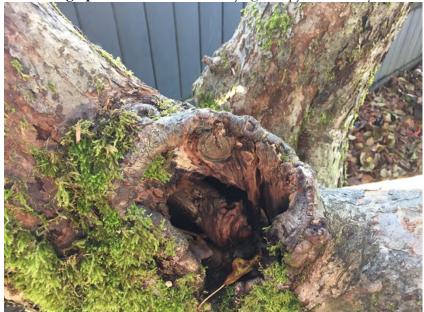
Photograph 4: Decay at the stem union of tree #77.

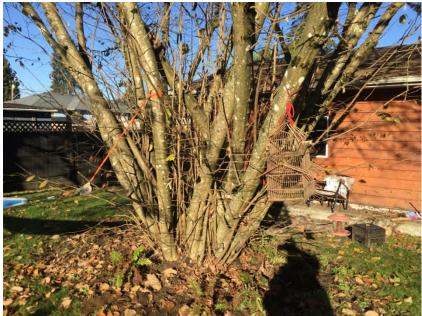
| Tag | Species | DBH | Ht | LCR | Drip | Recommendation | Condition Assessment |
|---|---|---|---|---|---|---|--|
| 78 | Corylus cornuta | 6x15 | 8 | 45 | 6 | Remove | Multi-stemmed x 13. Moss load in canopy. Sucker growth at base. Fair condition. Unappealing species in landscape, may wish to replace with a more aesthetic species. |

Photograph 5: Tree #78 was a multi-stemmed beaked hazelnut in the center of the rear yard.

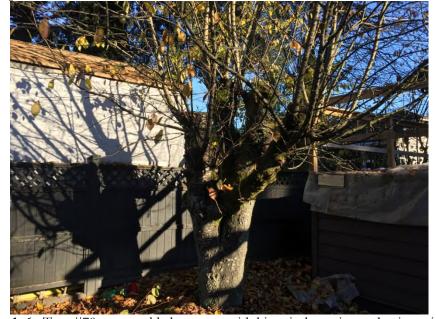
| Tag | Species | DBH | Ht | LCR | Drip | Recommendation | Condition Assessment |
|---|---|---|---|---|---|---|--|
| 79 | Prunus sp. | 20,40,42 | 8 | 55 | 4 | Remove | Triple stemmed, topped at 4 m with epicormic re-growth. Poor form. Low retention value. In construction footprint. |

Photograph 6: Tree #79 was an old cherry tree with historical pruning and epicormic growth.
