**Tree Evaluation Report for:
Kingsway Affordable Housing
Kingsway Avenue and Gately Avenue
Port Coquitlam, BC**

**Mike Fadum and Associates Ltd.
#105, 8277-129 Street
Surrey, BC
Phone 778-593-0300
Fax 778-593-0302**

**Date: April 22, 2020
Revised: September 28, 2020**

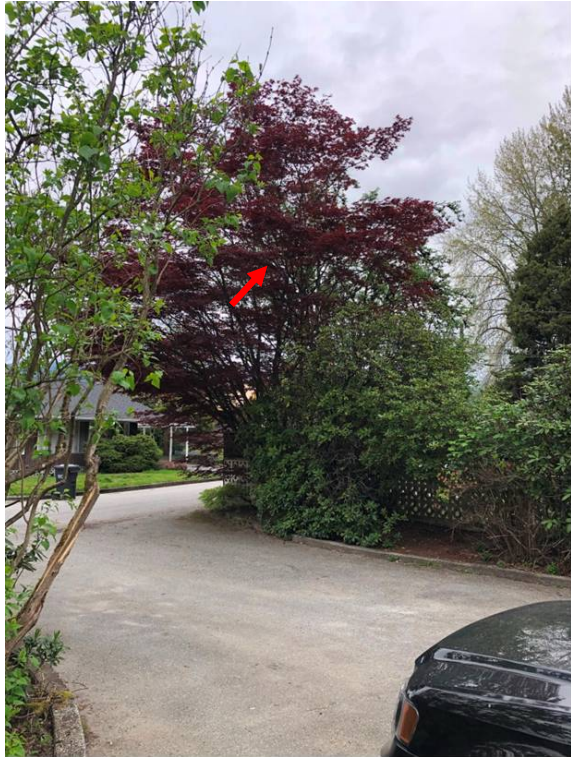
Tree #	Type	DBH (cm)	Structure	Health	LCR (%)	Observations	Recommendation / Tree Protection Zone Radii
4530	Japanese Maple (<i>Acer palmatum</i>)	10/6/16/8 /16/8/17	G	G	NA	5m dripline.	Remove. 4.0m
4531	Dogwood (<i>Cornus florida</i>)	15/8/ 5/6	M	M	NA	All major leaders headed back previously. Growing under a soffit. Extensive sucker growth. 3m dripline.	Remove. 2.5m
4532	Japanese Maple (<i>Acer palmatum</i>)	12/14/4/5 /3/19/ 10	MG	MG	NA	Not identified at the time of survey. Location approximate. 4m dripline. Includes 4 unsurveyed rhododendrons between 3-4m tall in this area.	Remove. 2.5m
4533	Mountain Ash (<i>Sorbus americana</i>)	20/8/ 18/8/7	MG	MG	NA	Multi stemmed base. 3m dripline.	Remove. 3.0m
4534	Sawara Falsecypress (<i>Chamaecyparis pisifera</i>)	37/27/ 23/43	M	MG	80	4m dripline. Some stems topped previously for overhead utility line clearance. Multi stemmed base.	Remove. 5.0m
4535	Threadleaf Falsecypress (<i>Chamaecyparis pisifera</i>)	17	MG	MG	60	2m dripline. Canopy weighted to the south west. Slight pistol butt base.	Remove. 2.0m

Figure 1. 4530 with rhododendrons.

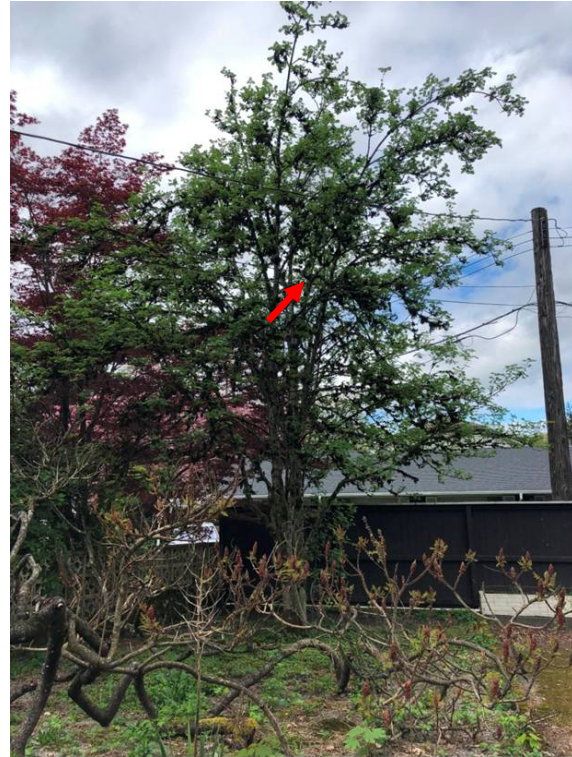
Figure 2. 4533 with sumac in the foreground.

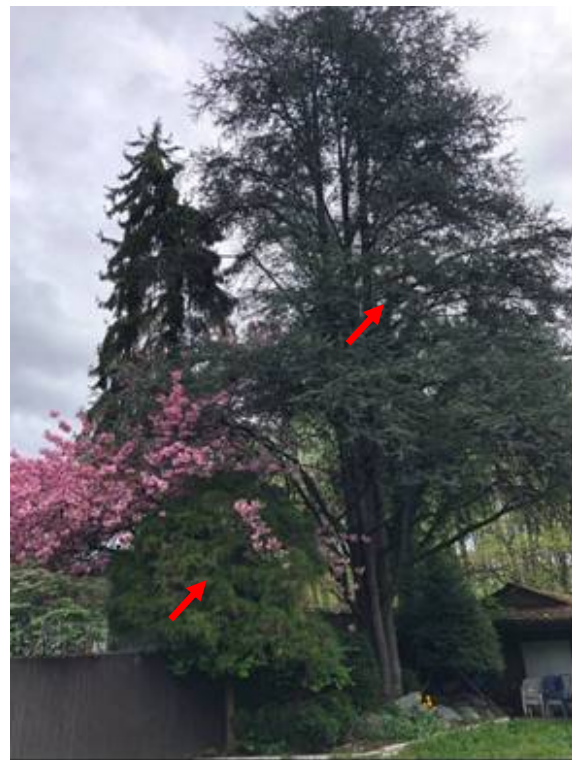
Figure 4. 4535 and 4763.

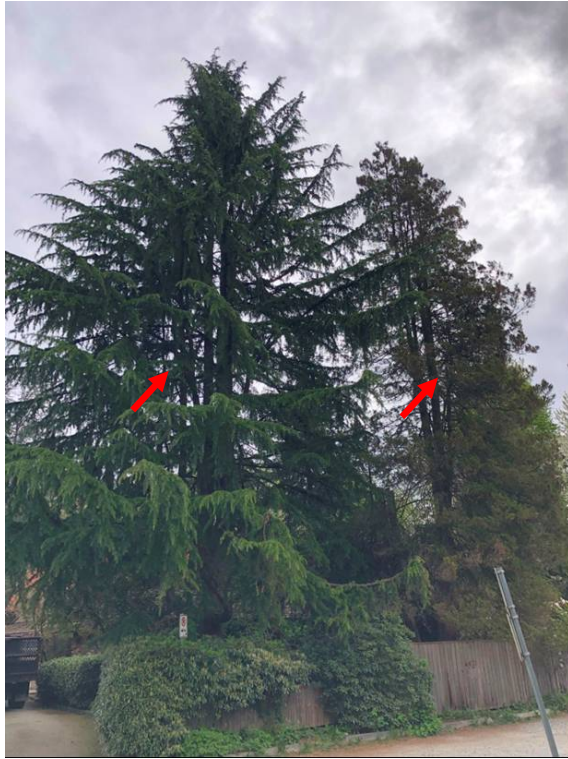
4536	Deodar Cedar (<i>Cedrus deodara</i>)	75	MG	MG	70	Pistol butt base. Multi stemmed at 5m. Canopy weighted to the southwest. 7m dripline.	Remove. 5.0m
4537	Grand Fir (<i>Abies grandis</i>)	38	G	MG	90	3m dripline. No observed defects.	Remove. 3.0m
4538	Hiba (<i>Thujopsis dolabrata</i>)	28	MG	MG	80	3m dripline. No observed defects.	Remove. 2.5m

Tree #	Type	DBH (cm)	Structure	Health	LCR (%)	Observations	Recommendation / Tree Protection Zone Radii
4539	Sawara Falsecypress (<i>Chamaecyparis pisifera</i>)	61/48	P	M	95	Significant lower stem phototropic sweep. Northern stem has been topped at 5m with no regrowth. Canopy weighted to the south. 4m dripline.	Remove. 5.0m
4540	Magnolia (<i>Magnolia sp.</i>)	15/10/8/16 /12/17/8	MG	M	NA	Shade suppressed. 4m dripline.	Remove. 3.0m
4541	Pine (<i>Pinus sp.</i>)	14/16/ 12/6	M	M	20	Leggy form. High canopy. Four stemmed coppice base. 2.5m dripline.	Remove. 2.5m
4542	Photinia (<i>Photinia sp</i>)	~14/ 14/6/9/ 8/6/5	MP	M	NA	Topped at 3m with multiple stem small diameter regrowth. 1.5m dripline.	Retain. 2.5m
4543	Flowering Cherry (<i>Prunus sp</i>)	43	M	MG	NA	Most major leaders and scaffold headed back at 4m. Open grown symmetrical canopy. Decay cavity at point of past leader failure. 4m dripline.	Retain. 3.5m

Figure 5. 4536 (left) and 4539.

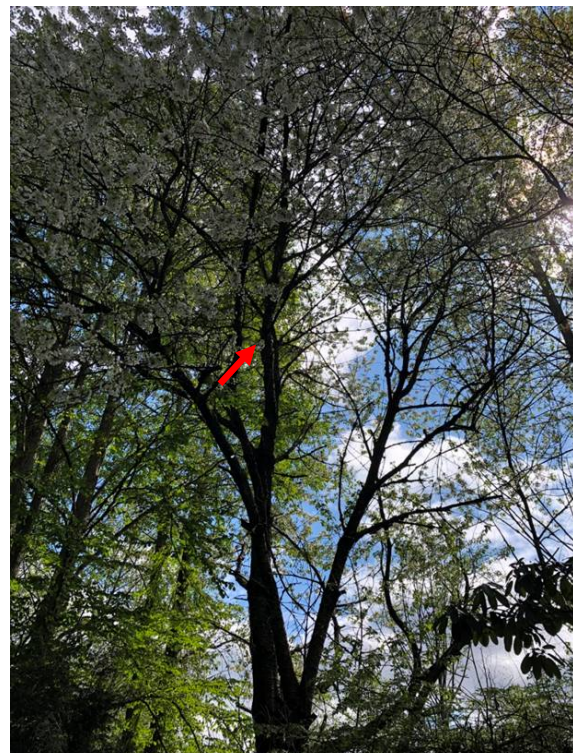
Figure 8. 4545.

4544	Norway Maple (<i>Acer platanoides</i>)	42	M	M	NA	Well calloused rib on the north side. Leggy form. Canopy weighted to the west. 7m dripline.	Retain. 3.5m
4545	Flowering Cherry (<i>Prunus sp</i>)	48	MP?	MG	NA	Decay cavity at base with large conk. Leggy form. High canopy. 7m dripline.	Retain. 3.5m
4546	Katsura (<i>Cercidiphyllum japonicum</i>)	~35/36/ 28/35/ 20/15/19	MG	G	NA	8m dripline. No observed defects.	Retain. 5.0m
4547	Persian Ironwood (<i>Parrotia persica</i>)	3-17 X40	M	G	NA	Multi stemmed base. 6m dripline.	Retain. 5.0m

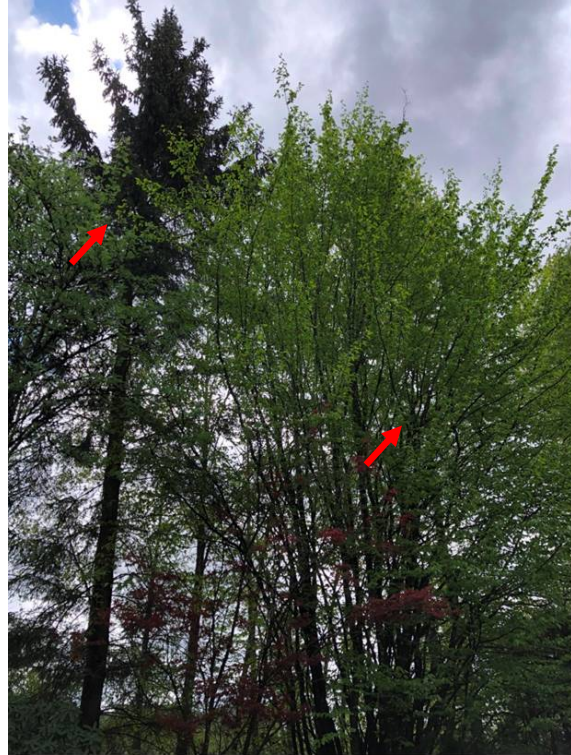
Tree #	Type	DBH (cm)	Structure	Health	LCR (%)	Observations	Recommendation / Tree Protection Zone Radii
4548	Norway Spruce (<i>Picea abies</i>)	34	M	MG	40	Limited trunk taper. 3m dripline.	Retain. 3.0m
4549	Japanese Maple (<i>Acer palmatum</i>)	8/5/9	M	M	NA	Dieback throughout canopy. Shade suppressed - leggy form. 3m dripline.	Retain. 2.0m
4550	Mountain Ash (<i>Sorbus americana</i>)	31	MP	M	NA	Multiple stems cut or fail at 2-4m. Leggy form. 3.5m dripline.	Retain. 2.5m
4551	Sycamore Maple (<i>Acer pseudoplatanus</i>)	42	M	MG	NA	Canopy weighted to the south. Large pile of debris and concrete at the base prevented a thorough assessment. 6m dripline.	Retain. 3.5m
4552	Sycamore Maple (<i>Acer pseudoplatanus</i>)	40	M	MG	NA	Canopy weighted to the north. Phototropic sweep to the north. Large stem removed from the base with sucker growth. 5m dripline.	Retain. 3.0m
4553	Sycamore Maple (<i>Acer pseudoplatanus</i>)	~60	M	M	NA	Heavy ivy growth. 6m dripline.	Remove. 4.5m

Figure 10. 4547 (right) and 4548.

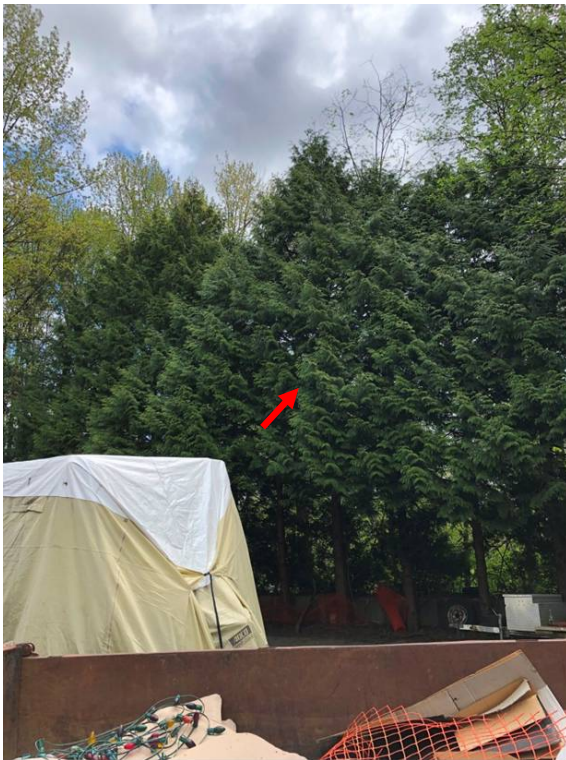
Figure 11. Row 1.

4762	Apple (<i>Malus sp</i>)	10/15/10/ 10/10	M	M	NA	Open grown canopy. Lack of access prevented thorough assessment. 4m dripline.	Remove. 2.5m
4763	Atlas Cedar (<i>Cedrus atlantica</i>)	24/ ~45/35	MG	M	80	Canopy weighted to the south. Multi stemmed base. 8m dripline.	Remove. 5.0m
ROW1	Western Redcedar (<i>Thuja plicata</i>) X12	24,19,22,26 ,20,18,23, 22,20,11,8, 24	G	G	60	Many trees not surveyed. 3m dripline.	Retain. 2.5m

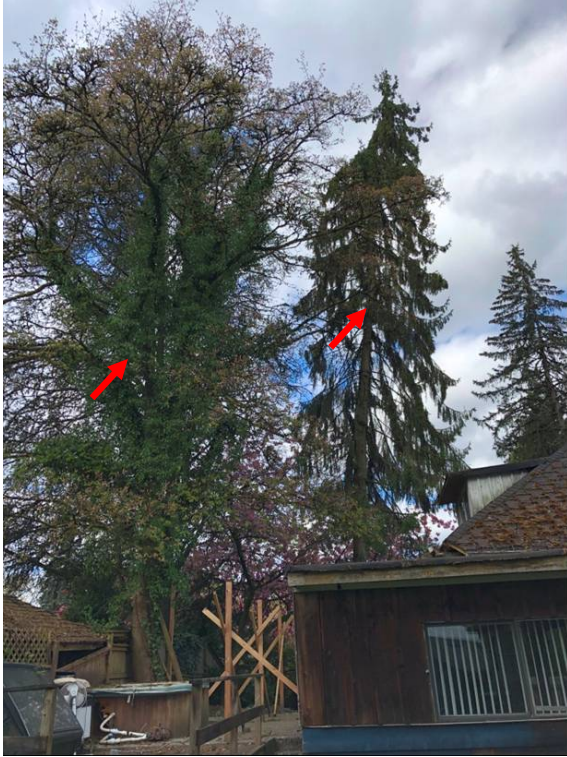
4554	Cherry (<i>Prunus sp.</i>)	33	M	G	NA	Significant sweep to the west. Decay column at 1m. 8m dripline.	Remove. 2.5m
4555	Spruce (<i>Picea sp.</i>)	47	M	MG	80	Sweep to the north. Old wound at 1m north side. 5m dripline.	Remove. 4.0m
4556	Colorado Blue Spruce (<i>Picea pungens</i> <i>Glauca Group</i>)	41	M	M	NA	Dieback throughout. Codominant leader at 3m has failed at 8m.	Remove. 3.0m
4557	Colorado Spruce (<i>Picea pungens</i>)	29	M	MP	75	Canopy weighted to the south. Pruned north side for utility line clearance. 3m dripline.	Remove. 2.5m

Figure 13. 4553 (left) and 4555.

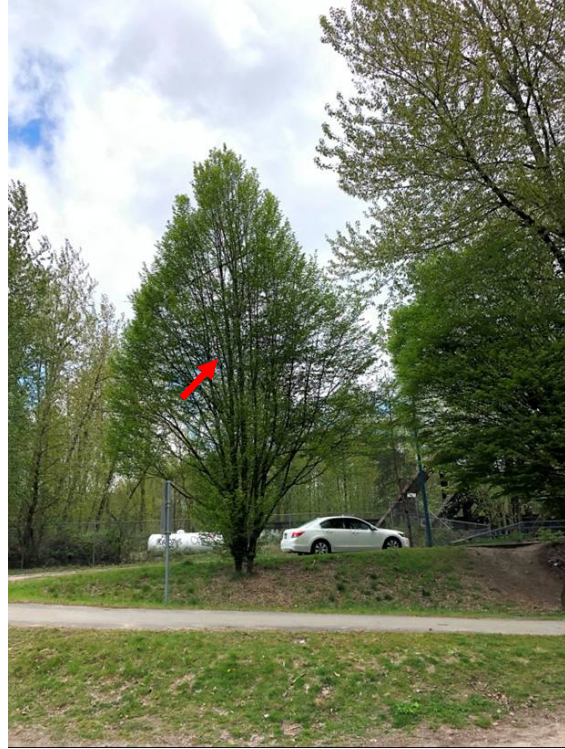
Tree #	Type	DBH (cm)	Structure	Health	LCR (%)	Observations	Recommendation / Tree Protection Zone Radii
C1	European Hornbeam (<i>Carpinus betulus</i>)	22/15 /15/5	G	G	NA	Phototropic sweep to the west. Canopy weighted to the west. 5m dripline.	Retain. 3.0m
C2	European Hornbeam (<i>Carpinus betulus</i>)	5-15 x11	MG	G	NA	4m dripline. No observed defects.	Retain. 3.0m
C3	European Hornbeam (<i>Carpinus betulus</i>)	5-10 X12	M	MG	NA	Stems pruned on north side for sidewalk clearance. 2.5m dripline.	Retain. 3.0m
C4	European Hornbeam (<i>Carpinus betulus</i>)	3-6 X7	M	MG	NA	Stems pruned on north side for sidewalk clearance. 2m dripline.	Retain. 3.0m
C5	European Hornbeam (<i>Carpinus betulus</i>)	3-8 X11	MG	MG	NS	2.5m dripline. No observed defects.	Retain. 3.0m
C6	European Hornbeam (<i>Carpinus betulus</i>)	3-16 X22	MG	MG	NA	2.5m dripline. Typical.	Retain. 3.0m
ADDITIONAL RECOMMENDATIONS							
<ul style="list-style-type: none"> In order to prevent root damage, which may adversely affect the health and or stability of the retained trees, any ground disturbance or grade alteration within the recommended Tree Protection Zone provided in the table above shall be under the direction of the project arborist if permissible.

Figure 14. Typical boulevard hornbeam.

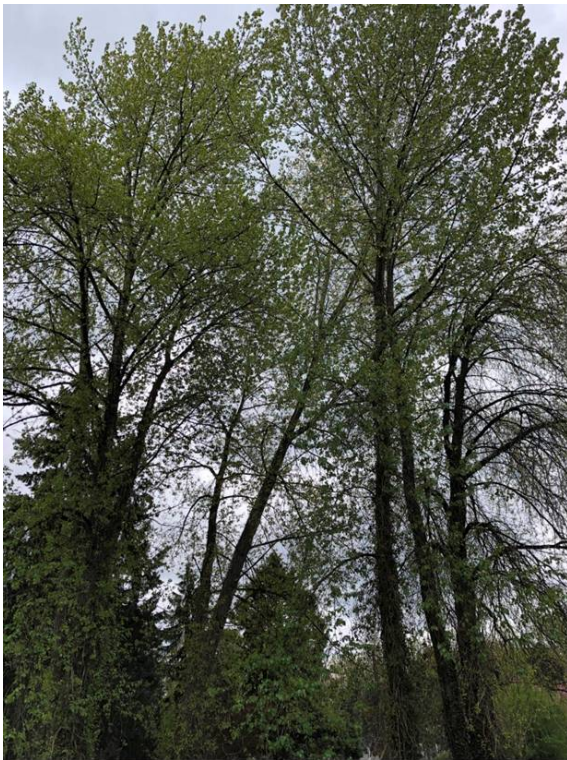
Tree #	Type	DBH (cm)	Structure	Health	LCR (%)	Observations	Recommendation / Tree Protection Zone Radii
4558	Colorado Spruce (<i>Picea pungens</i>)	29	MG	M	80	Pruned north side for utility line clearance. Canopy weighted to the south. 3m dripline.	Remove. 2.5m
4559	Black Cottonwood (<i>Populus trichocarpa</i>)	~20	G	G	NA	Typical.	Retain. 2.0m
4560	Black Cottonwood (<i>Populus trichocarpa</i>)	~60/50 /60	M	MG	NA	3 stems fused to the base with phototropic sweeps. Ivy across lower 10m and recently removed. 11m dripline.	Remove. 7.5m
4561	Black Cottonwood (<i>Populus trichocarpa</i>)	55	M	MG	NA	Tree grows to about 60 degrees angle to the south then corrects to vertical. Ivy across lower 10m recently removed. 10m dripline.	Remove. 4.5m
4562	Black Cottonwood (<i>Populus trichocarpa</i>)	56	M	MG	NA	Ivy recently removed. Significant sweep to the west. 10m dripline.	Remove. 4.5m
4563	Black Cottonwood (<i>Populus trichocarpa</i>)	53	M	MG	NA	Ivy across lower 10m and recently removed. 8m dripline.	Remove. 4.0m

4564	Black Cottonwood (<i>Populus trichocarpa</i>)	~100	M	MG	NA	2 stems fused across lower 2m. Ivy across lower 10m and recently removed. 8m dripline.	Remove. 7.0m
4565	Emerald Cedar (<i>Thuja occidentalis</i>) 'Smargd'	8/10/12 /8/5	MP	M	80	Tree leans to the south – possibly supported by the Douglas fir. Top has corrected to vertical. 2m dripline.	Remove. 2.0m
4566	Colorado Blue Spruce (<i>Picea pungens</i> <i>Glauca Group</i>)	36	M	M	50	Significant phototropic sweep to the west. Shade suppressed. 5m dripline.	Remove. 2.5m

Figure 15. 4560-4564.

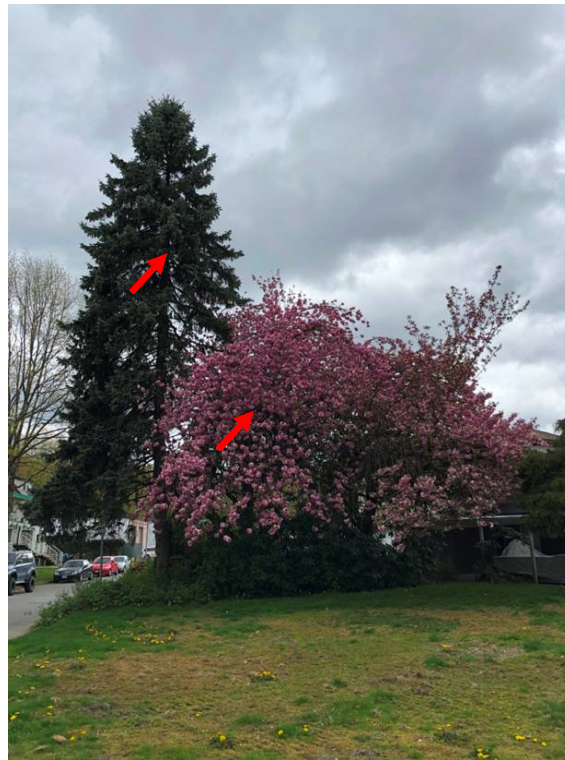
Figure 16. 4569 (left) and 4570.

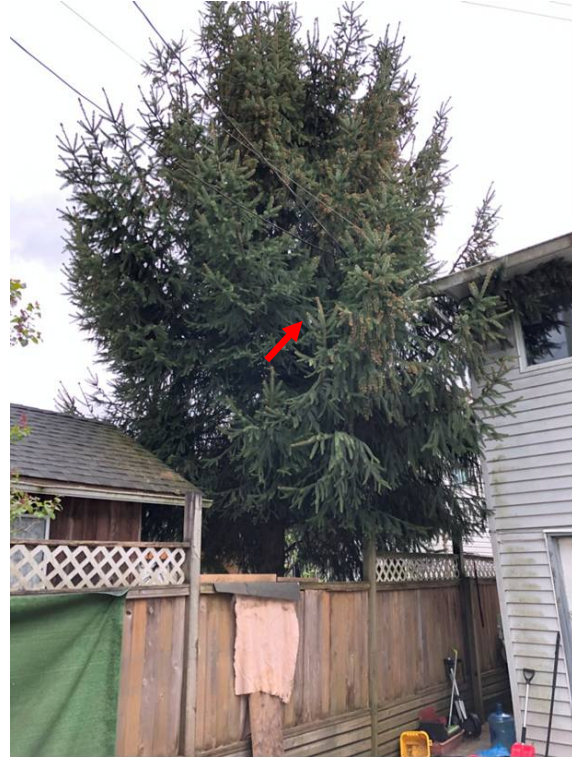
Figure 18. 4761.

Tree #	Type	DBH (cm)	Structure	Health	LCR (%)	Observations	Recommendation / Tree Protection Zone Radii
4756	Magnolia (<i>Magnolia sp.</i>)	15/12	MP	MG	NA	Leaders cut at 2m with multiple stem small diameter regrowth. Decay at points of cutting. 2m dripline.	Remove. 2.0m
4757	Cherry (<i>Prunus sp.</i>)	10/6/ 11	MP	M	NA	Dieback lower mid canopy. Shade suppressed. 1m dripline.	Remove. 2.5m
4758	Norway Maple (<i>Acer platanoides</i>)	58	M	MG	NA	Well calloused crack on the south side. Some leaders have been topped previously. 6m dripline.	Remove. 4.5m
4759	Apple (<i>Malus sp</i>)	10/10/ 13/17	M	MG	NA	3 stems fused at the base. 3m dripline.	Remove. 2.5m
4760	Laburnum (<i>Laburnum sp</i>)	12/5/ 4/2	MG	MG	NA	Multi stemmed. Canopy weighted to the north.	Remove. 2.0m
4761	Norway Spruce (<i>Picea abies</i>)	~25	MG	MG	70	Lack of access prevented thorough assessment. Possibly topped previously. 3m dripline.	Remove. 2.5m

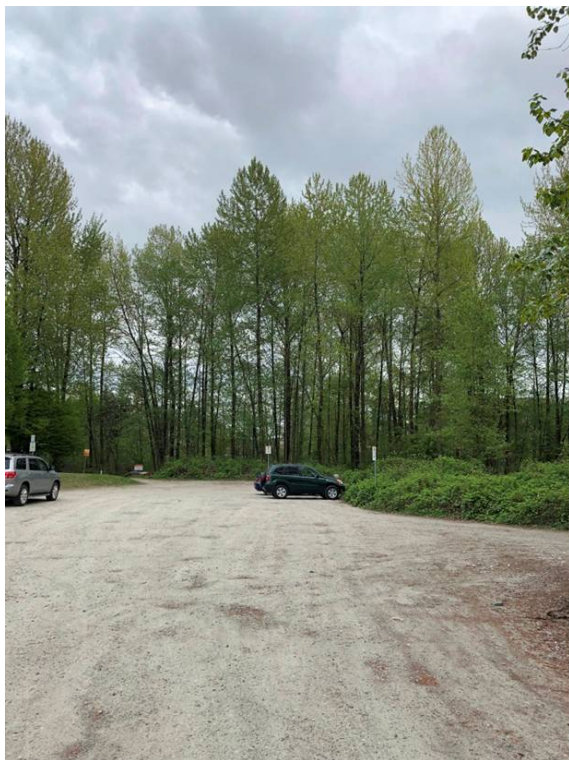
Figure 19. Riparian are black cottonwoods at northeast corner.

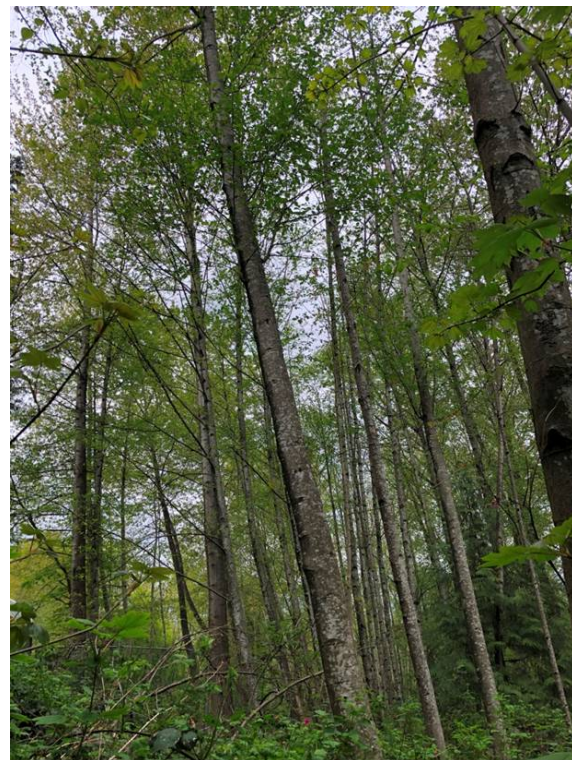
Figure 20. Interior of riparian zone.
