RE: Arborist Report for 1273508 B.C. LTD - For property located at 3390 Lancaster St., Port Coquitlam, BC

Further to the Arborist Report dated February 10, 2022, this is to serve as another revision. Due to a rezoning application and a townhouse development proposal, it was requested that a report be compiled discussing trees located at and adjacent to the address named above. This site was inspected on November 4, 2020. Thirty-one trees were assessed; they have been numbered 1 – 31 for the purpose of this report. Twelve photographs, a copy of the site survey, site plan, landscape plan, a preliminary tree replacement plan and civil drawings have been included as part of this report. The feasibility of retaining any trees will need to be reassessed once all the details of the development have been provided.

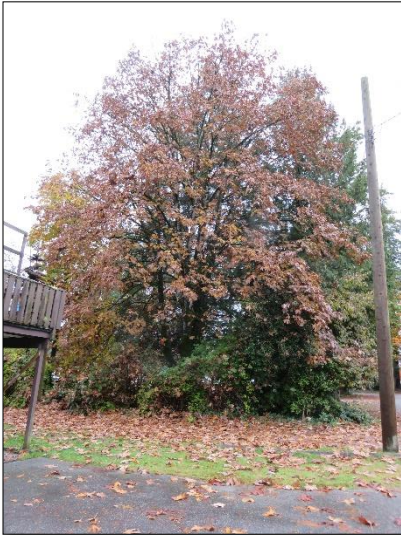
Tree #1

1	Bigleaf maple (<i>Acer macrophyllum</i>)	70/survey	15	14.1'	Good	
---	---	-----------	----	-------	------	--

This tree has three stems commencing at 8ft. It has a low and wide spreading canopy. The crown is asymmetrical and is heavily weighted to the east; it lacks canopy spread on the west side due to the encroaching canopy of the adjacent tree. There is minimal branch and twig dieback throughout the canopy. There is also blackberry surrounding the base of the stem. There is an existing fence 6ft from the west of the stem; it is to be removed. The Critical Root Zone radius is 14.1ft. The proposed building is 19ft from the west side, the proposed new watermain is 13ft from the east side and the proposed electrical room is 16ft from the south side of the stem, not including the excavation required. The road dedication and new laneway are 3ft from the east side, the proposed corner cut is 4ft from the northeast side, the proposed patio is 5ft from the west side and there is also a proposed fence, lawn and landscaping within the Critical Root Zone; the laneway will likely require grading.

RETAIN. One large zone shall protect Trees #1, #30 and #31. Install Tree Protection Zone fencing 16ft from the base of the stem on the south and west sides of Tree #1, 14ft from the base of the stem on the south and west sides of Tree #30, adjacent to Gail Ave, on the north side of Trees #1, #30 and #31 and adjacent to the laneway on the east side of Tree #1.

Any excavation for the proposed building, electrical room and staircase that encroaches into the TPZ must be supervised by a Certified Arborist; all exposed roots will be pruned.

The proposed courtyard that encroaches into the TPZ must installed at or near existing grade and must consist of a permeable surface; no further excavation can occur. Geogrid or geotextile fabric must be laid down first, then three to five inches of 3/4" - 1.5" clear crushed gravel and then the permeable surface installed over top.

Any excavation into the TPZ for the proposed landscaping and pillar must be performed manually; if large roots (1.5" diameter and larger) are encountered, the posts and planting must be shifted to accommodate and placed offset from the stems of the retained tree. The proposed lawn that encroaches into the TPZ must installed at or near existing grade; the landscaping and lawn must be installed at least 3 ft from the base of the stem of the retained tree. No more than 3" of additional good quality landscape soil (not construction grade fill) may be added into this Zone. Absolutely no further grade changes are to occur within this zone; the exiting grade cannot be altered (raised or lowered).

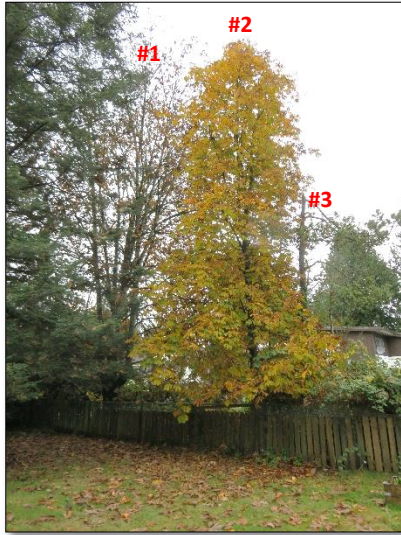
Trees #1 - #3

3	Pine (<i>Pinus sp.</i>)	25/survey	7	5'	Declining	<p>This tree is in decline. The top of the stem has failed at 25ft. The canopy is sparse and lacks vigor. There is branch dieback throughout the canopy and the foliage has begun to shed. There is blackberry surrounding the base of the stem. There is an existing fence 6.5ft from the west of the stem. The Critical Root Zone radius is 5ft. This tree is within the proposed visitor parking.</p> <p>RECOMMENDATIONS: REMOVE. Remove tree, it is in decline. Removal is also necessary to enable the proposed parking.</p>
4	Apple (<i>Malus sp.</i>)	21	4	4.3'	Poor	<p>This tree has a moderate corrected lean to the northeast. The crown has been significantly modified. It has been previously topped at multiple heights and cut back hard on all sides to contain. The crown is sparse and lacks vigor. There is branch and twig dieback throughout the canopy. There is a large wound on the north side of the trunk commencing at the base to where the tree has been topped; the wound has not callused over and the exposed wood is desiccated. There are fungal fruiting bodies present along several limbs. The Critical Root Zone radius is 4.3ft. This tree is within the proposed drive isle. Also, the proposed building is 6ft from the north side of the stem, not including the excavation required.</p> <p>RECOMMENDATIONS: REMOVE. Remove tree due to poor structure and condition. The canopy has been mutilated to the extent that it is beyond restorative pruning and is likely to suffer from disease or die prematurely. Also, the presence of fungal activity puts this tree at risk of failure. Removal is also necessary to enable</p>

<u>TREE</u>	<u>SPECIES</u>	<u>DBH</u>	<u>HEIGHT</u>	<u>CRZ</u>	<u>Condition</u>	<u>OBSERVATIONS & RECOMMENDATIONS</u>
#		(cm)	(m) est.	radius (ft.)		
						<p>manually, if large roots (1.5" diameter and larger) are encountered, then the posts must be shifted to accommodate and placed offset from the stems of the retained trees.</p> <p>Any excavation for the proposed watermain and proposed new laneway within the CRZ of Tree #1 on City property must be performed as directed by City staff.</p>
2	Horse Chestnut (<i>Aesculus hippocastanum</i>)	30/survey	12	6.2'	Fair	<p>This tree has a corrected lean and an asymmetrical and heavily weighted canopy to the southwest. There is minimal branch and twig dieback throughout the canopy. There are multiple large diameter surface roots exposed, which have sustained damage likely due to lawn maintenance equipment; these wounds have not callused over and decay is present. There is blackberry surrounding the base of the stem. There is also evidence of sapsucker damage. There is an existing fence adjacent west of the stem. The Critical Root Zone radius is 6.2ft. This tree is within the proposed visitor parking.</p> <p>RECOMMENDATIONS: REMOVE. Removal is necessary to enable the proposed parking.</p>

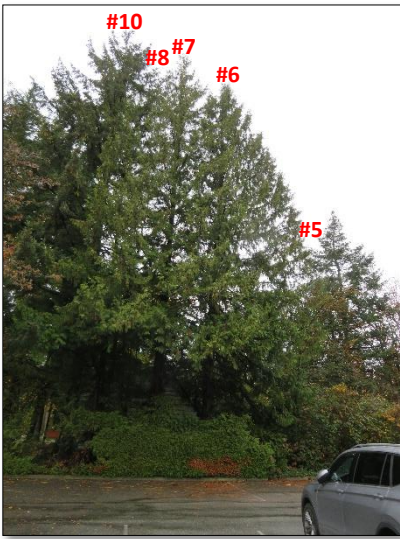
Trees #5 - #8, #10

<u>TREE</u>	<u>SPECIES</u>	<u>DBH</u>	<u>HEIGHT</u>	<u>CRZ</u>	<u>Condition</u>	<u>OBSERVATIONS & RECOMMENDATIONS</u>
#		(cm)	(m) est.	radius (ft.)		
						the lines of excavation, the proposed building and drive isle.
5	Mountain ash (<i>Sorbus sp.</i>)	20/survey	8	4.1'	Fair	<p>This tree is tall and spindly and has been suppressed due to the spreading canopy of the adjacent tree. It has a phototropic lean and an asymmetrical canopy to the east. There is minor branch dieback throughout the crown. There is evidence of sapsucker damage. There is also blackberry surrounding the base of the stem. The existing fence is 3.6ft from the north side of the stem. The Critical Root Zone radius is 4.1ft. This tree is within the proposed drive isle. There is also a proposed fence adjacent to the south side of the stem.</p> <p>RECOMMENDATIONS: REMOVE. Removal is necessary to enable the proposed drive isle. The stump cannot be removed with excavation equipment. The stump must be cut to grade and the remainder removed using a stump grinder.</p>

6	Cedar (<i>Thuja plicata</i>)	52	16	10.7'	Good	<p>These trees belong to the neighbouring property. They are somewhat stressed. They form part of a group. Tree #7 has been slightly suppressed due to the proximity of the adjacent trees. Trees #6 - #8 have a slight corrected lean to the south. The south side of the lower canopies have been cut and trimmed back to provide clearance to the adjacent parking lot on the neighbouring property. The north side of the canopies have also been pruned back to provide clearance to the existing building, which is 14.5ft – 15ft from the stems. The foliage of each tree is somewhat pale and chlorotic. The Critical Root Zone radius for each tree has been indicated in the CRZ radius column. The proposed drive isle is 2 – 2.5ft away and there is also a proposed fence adjacent to the north side of the stem of each tree.</p> <p>RECOMMENDATIONS: RETAIN. One large zone shall protect Trees #6 - #8. Install Tree Protection Zone fencing 13ft from the base of the stem on the north side and 15ft from the base of the stem on the east side of Tree #6 and 13ft from the base of the stem on the north side and 15ft from the base of the stem on the west side of Tree #8. Demolition of the existing foundation adjacent to this zone must be supervised by a Certified Arborist.</p> <p>The proposed drive isle that encroaches into the TPZ must be installed at or near existing grade and must consist of a permeable surface; no further excavation can occur. The existing organics within this zone must be removed manually and must be supervised by a Certified Arborist; no further excavation can occur. Geocells must be laid down first, then three to five (or more) inches of ¾" – 1.5" clear crushed gravel and then the permeable surface installed over top. Any grading, levelling and sloping of the drive isle must be achieved by using gravel (not construction fill); gravel is to be compacted using a vibrating plate tamper only. No</p>

7	Cedar	60	16	12.4'	Good	
8	Cedar	63 combined (46+17)	17	12.9'	Good

<u>TREE</u>	<u>SPECIES</u>	<u>DBH</u>	<u>HEIGHT</u>	<u>CRZ</u>	<u>Condition</u>	<u>OBSERVATIONS & RECOMMENDATIONS</u>
#		(cm)	(m) est.	radius (ft.)		
						<p>other grade changes (increase or decrease in grade) can occur within this Zone. All prep work and installation of material for the proposed drive isle that encroaches into the Tree Protection Zone must be supervised by a Certified Arborist.</p> <p>Any excavation into the TPZ for fence posts must be performed manually; if large roots (1.5" diameter and larger) are encountered, then the posts must be shifted to accommodate and placed offset from the stems of the retained trees.</p> <p>The feasibility of retaining any trees will need to be reassessed once all the details of the development have been provided.</p>
9	Maple (<i>Acer sp.</i>)	31	10	6.4'	Good/fair	<p>This tree is tall and spindly and has been suppressed due to the proximity of the adjacent trees. The stem of this tree has a slight torqued form. It has a phototrophic lean and an asymmetrical and heavily weighted canopy to the north. The crown has been raised to provide clearance to the existing building and raised concrete patio, which are 8ft from the north side of the stem; there is a 2ft grade difference between the base of the stem and the top of the patio. The crown is somewhat sparse and there is branch dieback throughout the canopy. The Critical Root Zone radius is 6.4ft. This tree is within the proposed drive isle.</p> <p>RECOMMENDATIONS: REMOVE. Removal of Trees #9 & #10 is necessary to enable the proposed drive isle. The stumps cannot be removed with excavation equipment. The stumps must be cut to grade and the remainder removed using a stump grinder.</p>

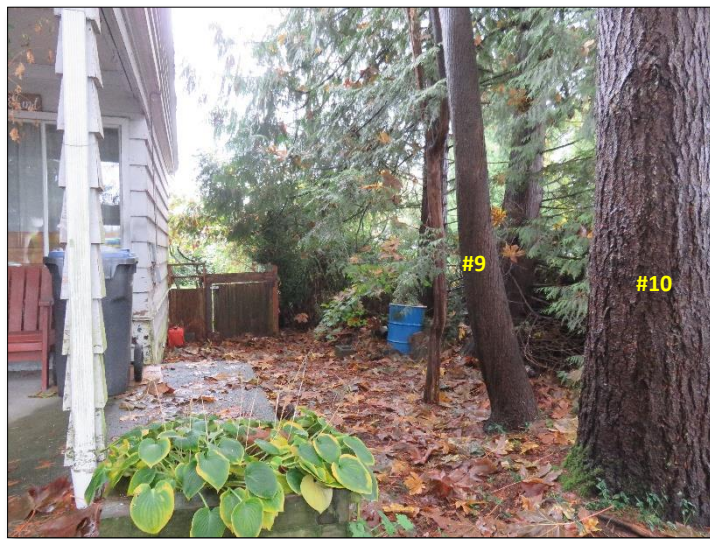
Trees #9 & #10

10	Douglas fir (<i>Pseudotsuga menziesii</i>)	66	20	13.6'	Good	<p>This tree forms part of a group. The crown has been raised to provide clearance to the existing building, which is 8.5ft away and the existing raised concrete patio, which is about 5ft from the north side and the adjacent parking lot on the neighbouring property on the south side of the stem; the grade difference between the base of the stem and the top of the patio is about 2ft. The foliage is slightly pale and chlorotic. There is minor branch dieback and limb shed throughout the canopy; heavy coning was also observed. The Critical Root Zone radius is 13.6ft; this is inadequate considering the height of this tree. This tree is within the proposed drive isle.</p> <p>RECOMMENDATIONS: REMOVE. See recommendations for Tree #9.</p>
11	Dogwood (<i>Cornus sp.</i>)	19	10	3.9'	Fair	<p>This tree is tall and spindly and has been suppressed due to the canopy spread of the adjacent trees. This tree has a phototrophic lean and an asymmetrical and heavily weighted canopy to the south. The crown has been raised to provide clearance to the adjacent parking lot on the neighbouring property on the south side of the stem. The crown is sparse and lacks vigor. There is minor branch dieback throughout the canopy. The Critical Root Zone of</p>

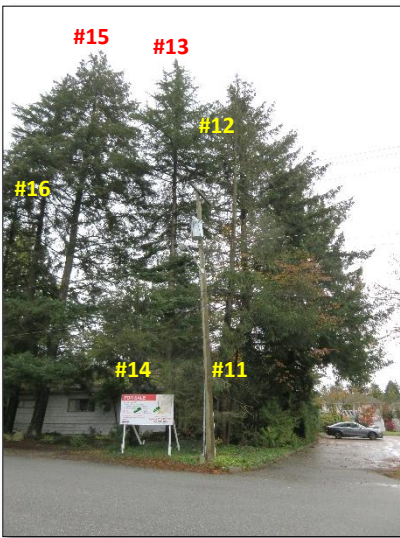
Trees #11- #16

<u>TREE</u>	<u>SPECIES</u>	<u>DBH</u>	<u>HEIGHT</u>	<u>CRZ</u>	<u>Condition</u>	<u>OBSERVATIONS & RECOMMENDATIONS</u>
#		(cm)	(m) est.	radius (ft.)		
						<p>the tree is 3.9ft. The proposed BC Hydro Transformer is 2.5ft from the north side of the stem, not including the excavation required; it is within the lines of excavation. Also, the existing watermain is also to be replaced and installed 6.5ft from the west side of the stem, not including the excavation required.</p> <p>RECOMMENDATIONS: REMOVE. Removal is necessary to enable the lines of excavation, proposed transformer and replacement of the watermain.</p>
12	Spruce (<i>Picea sp.</i>)	43	16	8.7'	Declining	<p>This tree is mostly dead. It has a moderate corrected lean to the southwest. The west side of the canopy has been cutback to provide clearance to the single-phase Hydro line, reduction lines and communication cables. The canopy is sparse and lacks vigor; the foliage in the upper and mid-section of the canopy has shed exposing the branches, which are desiccated. The top of the stem is dead and there is extensive branch dieback throughout the remaining canopy. The bark is also cracked and sloughing on the trunk. The Critical Root Zone is 8.7ft. The proposed BC Hydro Transformer is adjacent to the north side of the stem, not including the excavation required; it is within the lines of excavation.</p> <p>RECOMMENDATIONS: REMOVE. Remove tree, it is almost dead. Also, its removal is necessary to enable the lines of excavation and the proposed transformer.</p>

13	Atlas Cedar (<i>Cedrus sp.</i>)	47	20	9.7'	Good/fair	<p>This tree forms part of a group. It is tall and spindly due to the proximity of the adjacent trees. This tree has a dogleg bend in the stem at 25ft. The west side of the canopy has been cutback to provide clearance to the single-phase Hydro line, reduction lines and communication cables. There is an existing walkway 8ft from the north side the stem. The Critical Root Zone is 9.7ft; this is inadequate considering the height of this tree. It is within the footprint of the BC Hydro Transformer. Also, the existing watermain is to be replaced and installed 4.9ft from the west side of the stem, not including the exaction requires.</p> <p>RECOMMENDATIONS: REMOVE. Removal of this tree is necessary to enable the lines of excavation, the proposed transformer and replacement of the watermain.</p>
14	Spruce (<i>Picea sp.</i>)	40	6	8.2'	Dead	<p>This tree belongs to the City. It is dead; the foliage has shed, and the exposed branches are completely desiccated.</p> <p>RECOMMENDATIONS: REMOVE. Obtain consent from the City and remove tree; it is dead.</p>

15	Douglas fir (<i>Pseudotsuga menziesii</i>)	66	21	13.6'	Fair	<p>These trees form part of a group. Both trees have a corrected lean to the southeast. They somewhat lack basal flare. They are within a slightly raised garden bed that has been contained by a rock border, which</p>

<u>TREE</u>	<u>SPECIES</u>	<u>DBH</u>	<u>HEIGHT</u>	<u>CRZ</u>	<u>Condition</u>	<u>OBSERVATIONS & RECOMMENDATIONS</u>
#		(cm)	(m) est.	radius (ft.)		
16	Atlas Cedar (<i>Cedrus sp.</i>)	54	21	11.1'	Fair	<p>is within the Critical Root Zone on all sides of the stems; there is less than a 1ft grade difference. The west side of the canopies have been cutback to provide clearance to the single-phase Hydro line, reduction lines and communication cables. There is minimal branch dieback throughout the canopies. There are multiple large diameter surface roots exposed due to soil erosion; several roots have sustained minor surface bark damage. The Critical Root Zone radius for Tree #15 is 13.6ft and 11.1ft for Tree #16; this is inadequate considering the height of each tree. The existing water main is to be replaced and installed 4.5-6.5ft from the west side of the stems, not including the excavation required. The proposed City sidewalk is 11.5ft from the west side of the stem of each tree; this will likely require grading. The proposed drive aisle is 13ft from the south side of Tree #15. There is a proposed walkway 12.5ft – 13.5ft from the east side of the stems. Both trees are within the proposed play area. There is also a proposed fence, lawn and landscaping within the Critical Root Zones.</p> <p>RECOMMENDATIONS: REMOVE. Removal of Trees #15 and #16 is necessary to enable site grading, the new watermain and the proposed City sidewalk. The excavation required for the watermain would result in extensive Critical Root loss causing instability and will also likely cause this tree to decline over time.</p>

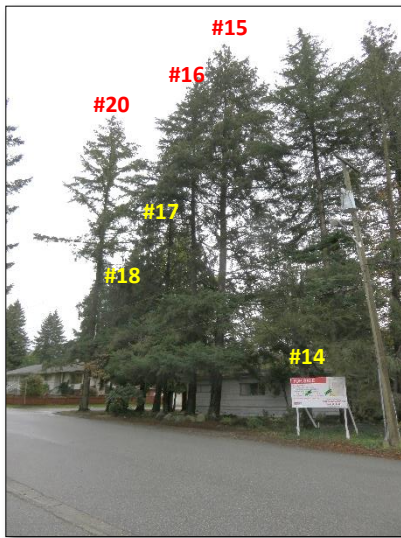
Trees #14 - #18, #20

17	Spruce (<i>Picea sp.</i>)	31	17	6.4'	Fair	<p>This tree forms part of a group. It has been suppressed due to the proximity of the adjacent trees. This tree has a corrected lean to the northwest. It somewhat lacks basal flare. It is within a slightly raised garden bed that has been contained by a rock border, which is within the Critical Root Zone on all sides of the stem; there is less than a 1ft grade difference. The west side of the canopy has been cut back to provide clearance to the single-phase Hydro line, reduction lines and communication cables. The canopy is sparse and there is branch and twig dieback throughout the crown. There are multiple large diameter surface roots exposed due to soil erosion; several roots have sustained minor surface bark damage. The Critical Root Zone radius is 6.4ft; this is inadequate considering the height. The existing watermain is to be replaced and installed 4.9ft from the west side of the stem, not including the excavation required. The proposed City sidewalk is 6.5ft from the west side of the stem; this will likely require grading. There is a proposed fence, play area, lawn and landscaping within the Critical Root Zone.</p> <p>RECOMMENDATIONS: REMOVE. Removal of this tree is necessary to enable site grading, the new watermain and the proposed City sidewalk. The excavation required for the watermain would result in extensive Critical Root loss causing instability and will also likely cause this tree to decline over time.</p>

<u>TREE</u>	<u>SPECIES</u>	<u>DBH</u>	<u>HEIGHT</u>	<u>CRZ</u>	<u>Condition</u>	<u>OBSERVATIONS & RECOMMENDATIONS</u>
#		(cm)	(m) est.	radius (ft.)		
18	Spruce (<i>Picea sp.</i>)	48	16	9.9'	Fair/poor	<p>This tree forms part of a group. It is tall and spindly and has been suppressed. It has a corrected lean to the southeast. The west side of the canopy has been cutback to provide clearance to the single-phase Hydro line, reduction lines and communication cables. The crown is sparse and lacks vigor. There is moderate branch dieback and limb shed throughout the canopy. There are multiple large diameter surface roots exposed due to soil erosion; several roots have sustained minor damage. There is an existing asphalt driveway 9ft from the north side of the stem; the roots have caused the surface to heave and crack. The Critical Root Zone radius is 9.9ft; this is inadequate considering the height. The existing watermain is to be replaced and installed 10ft from the west side of the stem, not including the excavation required. The proposed staircase is 12ft from the east side and the proposed pillars are 5ft from the west and northwest sides of the stem, not including the excavation required. The proposed walkway is adjacent to the north side of the stem and there is also a proposed play area, fence, lawn and landscaping within the Critical Root Zone.</p> <p>RECOMMENDATIONS: REMOVE. Removal of this tree is necessary to enable the new watermain. The excavation required would result in extensive Critical Root loss causing instability and will also likely cause this tree to decline over time.</p>

20	Douglas fir (<i>Pseudotsuga menziesii</i>)	67	26	13.8'	Fair/poor	<p>This tree forms part of a group. It is stressed. The west side of the canopy has been raised and cutback to provide clearance to the single-phase Hydro line, reduction lines and communication cables. The canopy is sparse and lacks vigor. The foliage is pale and chlorotic and has begun to shed. There is moderate branch dieback and limb shed throughout the canopy. A bird's nest was observed within the</p>

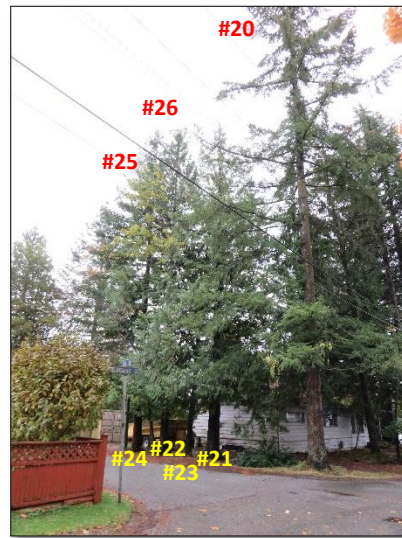
Trees #20 - #26

<u>TREE</u>	<u>SPECIES</u>	<u>DBH</u>	<u>HEIGHT</u>	<u>CRZ</u>	<u>Condition</u>	<u>OBSERVATIONS & RECOMMENDATIONS</u>
#		(cm)	(m) est.	radius (ft.)		
						<p>west side of the lower canopy. The existing asphalt driveway 8.9ft from the south side of the stem; the roots have caused the surface to heave and crack. The Critical Root Zone radius is 13.8ft; this is inadequate considering the height. This tree is within the proposed corner cut/road dedication. The existing watermain is to be replaced and installed at 8ft from the west side of the stem, not including the excavation required. The proposed City sidewalk is 6.5ft from the west side of the stem; this will likely require grading. There is also a proposed fence, lawn and landscaping within the Critical Root Zone.</p> <p>RECOMMENDATIONS: REMOVE. Removal of this tree is necessary to enable site grading, the new watermain and the proposed City sidewalk. The excavation required for the watermain would result in extensive Critical Root loss causing instability and will also likely cause this tree to decline over time.</p>

25	Dogwood (<i>Cornus sp.</i>)	17	12	3.5'	Fair	<p>This tree is tall and spindly and has been suppressed due to the proximity of the adjacent trees. It has a phototropic lean and an asymmetrical and heavily weighted canopy to the east. There is an existing asphalt driveway 4.9ft – 6.9ft from the south side of the stem; the roots have caused the surface to heave and crack. The Critical Root Zone radius is 3.5ft.</p>

<u>TREE</u>	<u>SPECIES</u>	<u>DBH</u>	<u>HEIGHT</u>	<u>CRZ</u>	<u>Condition</u>	<u>OBSERVATIONS & RECOMMENDATIONS</u>
#		(cm)	(m) est.	radius (ft.)		
						<p>This tree is within the proposed road dedication. There is also a proposed fence, lawn and landscaping within the Critical Root Zone.</p> <p>RECOMMENDATIONS: REMOVE. Remove tree to allow space for the adjacent trees to thrive. The stump cannot be removed with excavation equipment. The stump must be cut to grade and the remainder removed using a stump grinder.</p>
26	Sequoia (<i>Sequoia sempervirens</i>)	50	18	10.9'	Good	<p>This tree forms part of a group. It appears typical of the species. There is an existing asphalt driveway 6ft from the south and east sides of the stem. The Critical Root Zone radius is 10.9ft. This tree is within the proposed road dedication. The proposed staircase is 12ft from the south side and the proposed pillars are 6ft and 8ft from the southeast side of the stem, not including the excavation required. The proposed walkway is 3.5ft from the east side and the proposed landing is 7ft from the south side of the stem. There is also a proposed fence, lawn and landscaping within the Critical Root Zone.</p> <p>RECOMMENDATIONS: RETAIN. See recommendations for Tree #21. One large zone shall protect Trees #21 - #23 and #26.</p>

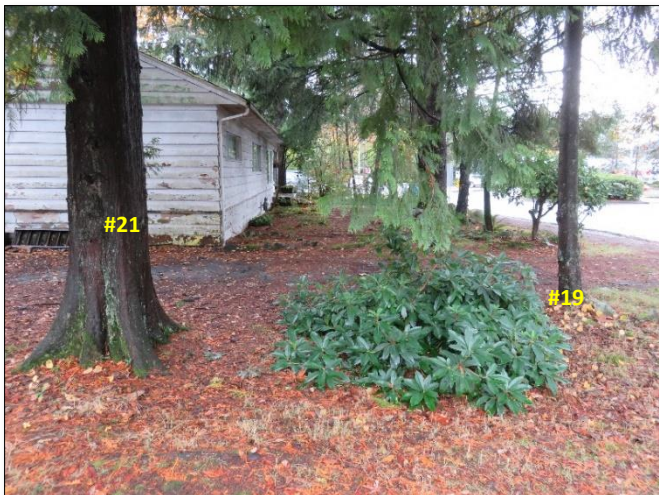
Trees #19 & #21

19	Spruce (<i>Picea sp.</i>)	22	15	4.5'	Fair/poor	<p>This tree forms part of a group. It is tall and spindly and has been suppressed. It has a corrected lean to the southeast. The west side of the canopy has been cutback to provide clearance to the single-phase Hydro line, reduction lines and communication cables. The crown is sparse and lacks vigor. There is moderate branch dieback and limb shed throughout the canopy. There are multiple large diameter surface roots exposed due to soil erosion; several roots have sustained minor damage. There is an existing asphalt driveway 2.5ft from the south side of the stem; the roots have caused the surface to heave and crack. The Critical Root Zone radius is 4.5ft; this is inadequate considering the height of each tree. It is within the proposed corner cut/road dedication. There is also a proposed fence, lawn and landscaping within the Critical Root Zone.</p> <p>RECOMMENDATIONS: REMOVE. Remove tree due to poor condition. Also, the adjacent trees are proposed for removal; once these trees are removed, this tree will be newly exposed and prone to failure, due to windthrow.</p>

21	Cedar (<i>Thuja plicata</i>)	61	18	12.6'	Good	<p>These trees form part of a group. The lower stem of each tree is somewhat abnormal and swollen. There are several roots from each tree exposed due to soil erosion. The existing asphalt driveway is 8.5ft – 9ft from the south side of the stems; the roots have caused the surface to heave and crack. The Critical Root Zone of Tree #21 is 12.6ft and 10.1ft for Tree #22. These trees are within the proposed road dedication. The proposed building is 17ft from the south side of both trees, not including the excavation required. The proposed patio is 7ft from the south side of Trees #21 and #22 and there is also a proposed fence, lawn and landscaping within the Critical Root Zone of both trees.</p> <p>RECOMMENDATIONS: RETAIN. One large zone shall protect Trees #21 - #23 and #26. Install Tree Protection Zone fencing 13ft from the base of the stem on the south and west sides of Tree #21, 13ft from the base of the stem on the south side and 11ft from the base of the stem on the east side of Tree #26, and adjacent to the Gail Ave., on the north side of Trees #21 - #23 and #26.</p> <p>Removal of the existing driveway and any excavation for the proposed building and staircases that encroach into the TPZ must be supervised by a Certified Arborist; all exposed roots will be pruned.</p> <p>The proposed patio and walkways that encroach into the TPZ must be install at or near existing grade and must consist of a permeable surface; no further excavation can occur. Geogrid or geotextile fabric must be laid down first, then three to five inches of ¾” – 1.5” clear crushed gravel and then the permeable surface installed over top.</p> <p>Any excavation into the TPZ for the proposed landscaping, pillar and fence posts must be performed manually; if large roots (1.5” diameter and larger) are encountered, then the posts and plantings must be shifted to accommodate and</p>

<u>TREE</u>	<u>SPECIES</u>	<u>DBH</u>	<u>HEIGHT</u>	<u>CRZ</u>	<u>Condition</u>	<u>OBSERVATIONS & RECOMMENDATIONS</u>
#		(cm)	(m) est.	radius (ft.)		
						<p>placed offset from the stems of the retained trees. The proposed lawn that encroaches into the TPZ must be installed at or near existing grade; the landscaping and lawn must be installed at least 3ft from the base of the stem of any retained tree. No more than 3" of additional good quality landscape soil (not construction grade fill) may be added into this Zone. Absolutely no further grade changes are to occur within this zone; the existing grade cannot be altered (raised or lowered).</p> <p>Raise the canopy of these trees to 7m, to allow more light into the complex and provide sufficient clearance for construction activities and the new building. This must be performed by a Certified Arborist using spurless climbing and prior to any construction.</p>

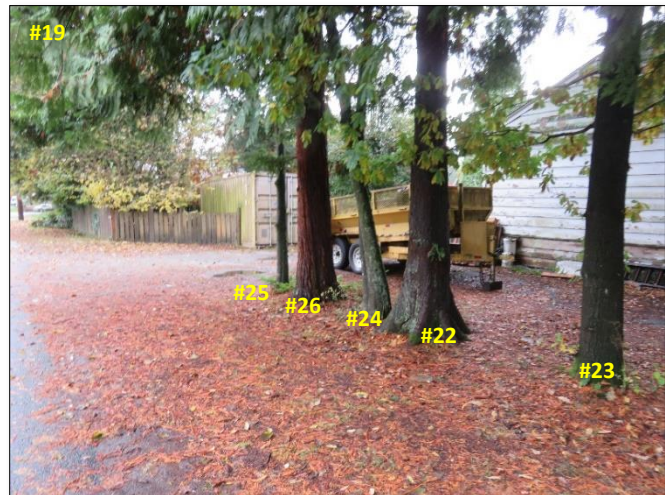
Trees #22 - #23

22	Cedar	49	18	10.1'	Good

23	White oak (<i>Quercus alba</i>)	30	16	6.2'	Good/fair	<p>This tree is tall and spindly and has been suppressed due to the proximity of the adjacent trees. This tree lacks adequate trunk taper and basal flare. It has a phototropic lean and an asymmetrical and heavily weighted canopy to the south. The existing asphalt driveway 8.5ft the south side of the stem; the roots have caused the surface to heave and crack. The Critical Root Zone of the tree is 6.2ft; this is inadequate considering the height. This tree is within the proposed road dedication. The proposed patio is 8ft from the south side of the stem and there is also a proposed fence, lawn and landscaping within the Critical Root Zone.</p> <p>RECOMMENDATIONS: RETAIN. See recommendations for Tree #21. One large zone shall protect Trees #21 - #23 and #26.</p>
24	Dogwood (<i>Cornus sp.</i>)	37 combined (19+18)	12	7.6'	Fair	<p>This tree is tall and spindly and has been suppressed due to the proximity of the adjacent trees. This tree has a phototropic lean and an asymmetrical and heavily weighted canopy to the north. There is an existing asphalt driveway 4.9ft – 6.9ft from the south side and 2.6ft from the east side of the stem; the roots have caused the surface to heave and crack. The Critical Root Zone radius is 7.6ft. This tree is within the proposed road dedication. There is also a proposed fence, lawn and landscaping within the Critical Root Zone.</p> <p>RECOMMENDATIONS: REMOVE. This tree is suppressed due to competition from adjacent trees. Removal will reduce competition for the adjacent retained trees. The stump cannot be removed with excavation equipment. The stump must be cut to grade and the remainder removed using a stump grinder.</p>

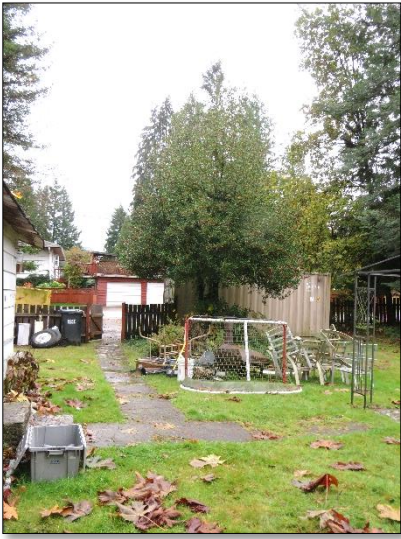
Tree #27

27	Holly (<i>Ilex sp.</i>)	39 combined (17+13+9)	7	8'	Good	<p>This tree has two stems commencing at base. It has been previously topped and maintained as a shaped specimen; otherwise, it appears typical of the species. The Critical Root Zone is 8ft. This tree is within the footprint of the proposed building.</p> <p>RECOMMENDATIONS: REMOVE. Removal is necessary to enable the proposed building.</p>
28	Fir (<i>Abies sp.</i>)	76	22	15.7'	Good/fair	<p>This tree appears to have shed its original top at 55ft; there is one stem commencing at this point, which has a dogleg bend in the stem above the union. It has a corrected lean to the northeast. The canopy is somewhat sparse; the foliage within sections of the crown has begun to shed. The Critical Root Zone radius is 15.7ft; this is inadequate considering the height. This tree is within the footprint of the proposed building.</p> <p>RECOMMENDATIONS: REMOVE. Removal is necessary to enable the proposed building.</p>

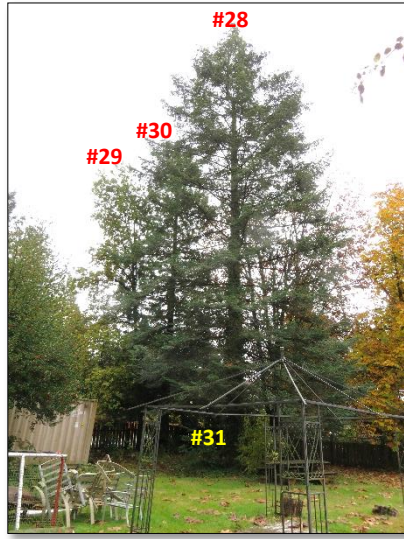
Trees #28 - #31

29	White oak (<i>Quercus alba</i>)	29	11	6'	Good	<p>This tree is tall and spindly and has been suppressed due to the proximity of the adjacent trees. This tree has a phototropic lean and an asymmetrical and heavily weighted canopy to the west. There is an existing fence 3.9ft from the north side of the stem. The Critical Root Zone is 6ft. The proposed service connection is 12ft from the west side, and the proposed staircase is 11ft away and the proposed pillar is 8ft from the southwest side of the stem, not including the excavation required. The proposed walkway is 6.5ft from the south side and the proposed walkway is 9ft from the west side of the</p>

stem. There is a proposed fence, lawn and landscaping within the Critical Root Zone. This tree is also within the proposed road dedication.

30	Cedar (<i>Thuja plicata</i>)	72	13	14.9'	Good	<p>This tree appears typical of the species. There is an existing fence 4.3ft from the north side of the stem. The Critical Root Zone of the tree is 15ft. The proposed building is 13.5ft away, the proposed staircase is 13.5ft away and the proposed pillar is 11ft from the southwest side of the stem, not including the excavation required. The proposed courtyard is 8ft from the south side, the proposed walkway is 13ft from west side and 7ft from the southwest side and there is a proposed fence, lawn and landscaping within the Critical Root Zone. This tree is also within the proposed road dedication.</p> <p>RECOMMENDATIONS: RETAIN. See recommendations for Tree #1. One large zone shall protect Trees #1, #30 and #31.</p>
----	-----------------------------------	----	----	-------	------	--

31	Dogwood (<i>Cornus sp.</i>)	22	12	4.5'	Good/fair	<p>This tree is tall and spindly and has been suppressed due the proximity of the adjacent trees. It has a phototropic lean and an asymmetrical canopy to the east. There is an existing fence 4.5ft from the north side and 5.5ft from the east side of the stem. The Critical Roo Zone of the tree is 4.5ft. There is a proposed fence, lawn and landscaping within the Critical Root Zone. This tree is within the proposed road dedication.</p> <p>RECOMMENDATIONS: RETAIN. See recommendations for Tree #1. One large zone shall protect Trees #1, #30 and #31.</p>
----	----------------------------------	----	----	------	-----------	--

RECOMMENDATIONS:
REMOVE. Remove tree to allow space for the adjacent trees to thrive.
