## CERTIFIED ARBORIST REPORT

1675 Pitt Rd, Port Coquitlam

August 29, 2022

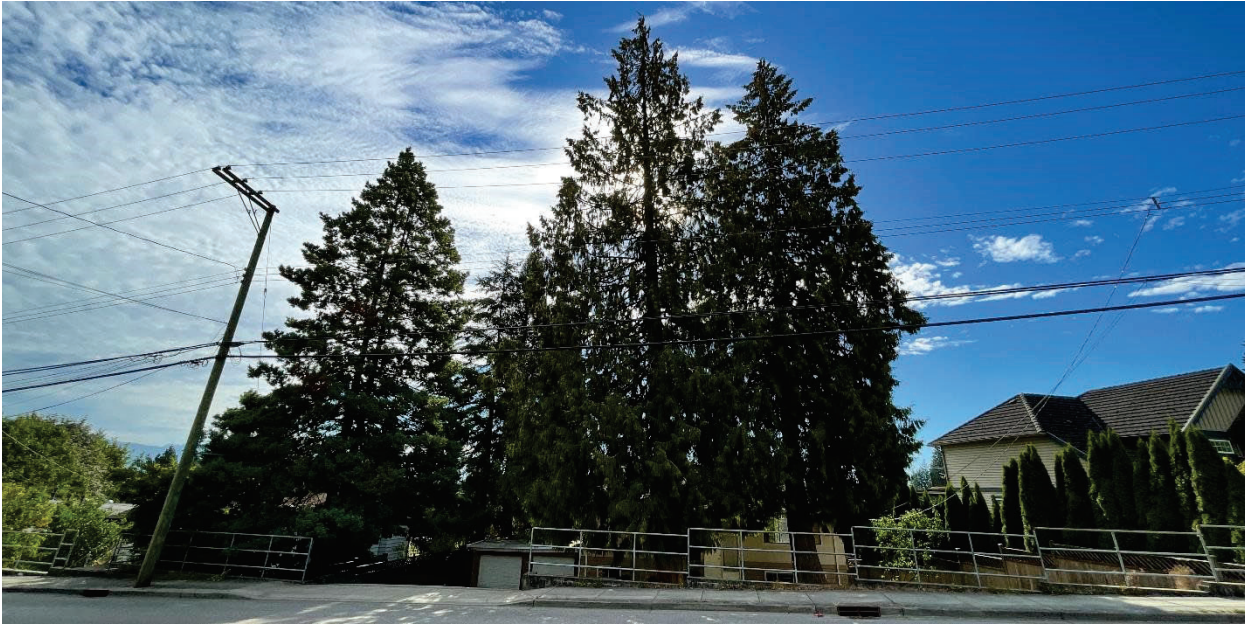
Photo 1 - Facing towards the frontage of the lot and of on-site trees #T1, #T2, and #T3

For the duration of the construction project, **on-site tree #T2 and T#3** has been recommended to be retained throughout the construction process. As the protected trees were examined to be situated near the limits of the proposed construction, the subject trees will require the placement of Tree Protection Barriers in order to protect their trunks, roots, and structures.

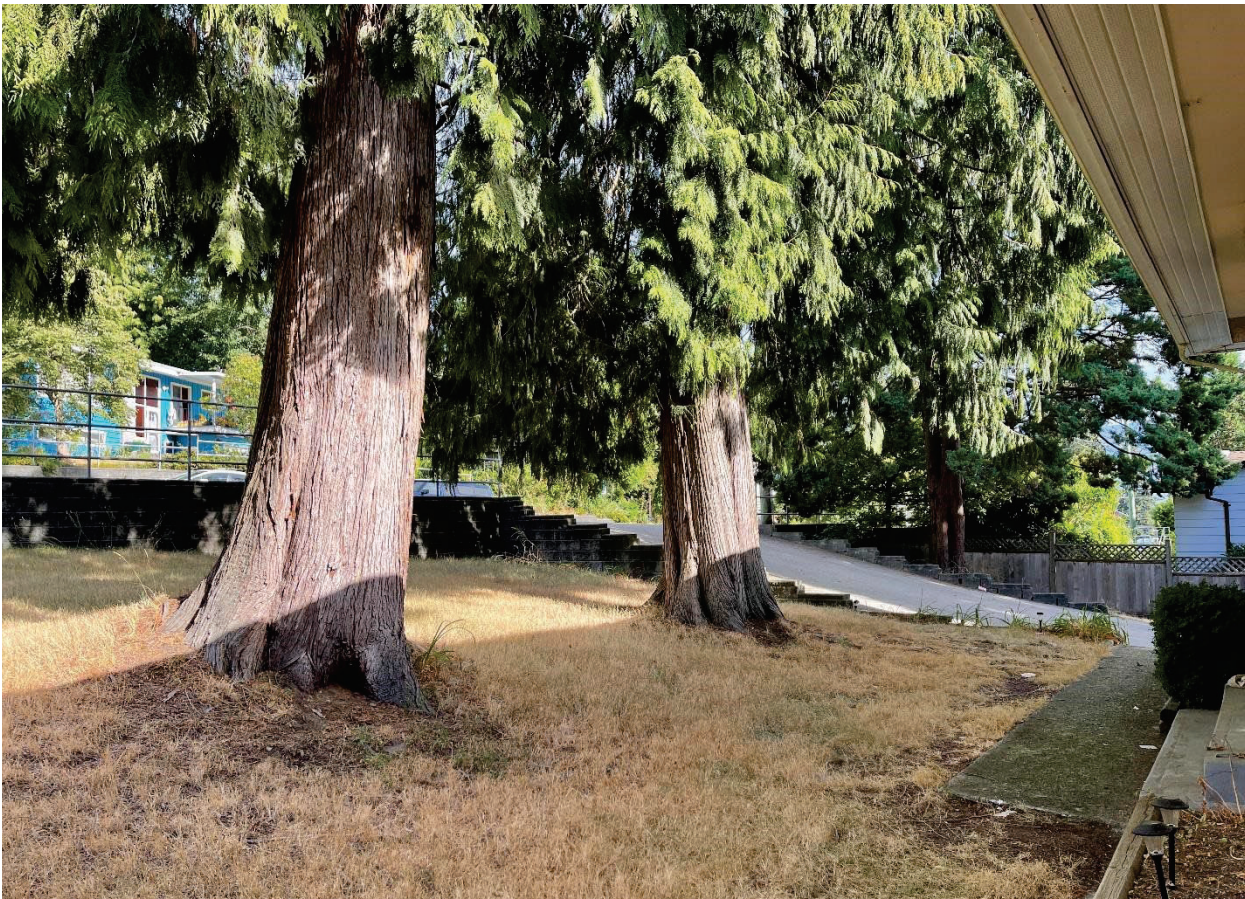
Photo 2 Facing towards the lower trunks of on-site trees #T2 and #T3

The proposed walkway required to be installed as part of the perimeter pathway for the main dwelling would encroach into the **TPZ of tree T#2 and T#3**. In order to limit the amount of grade disturbances occurring within the TPZ, the installation of the walkway is required to be performed under Arborist supervision and constructed on undisturbed grade.

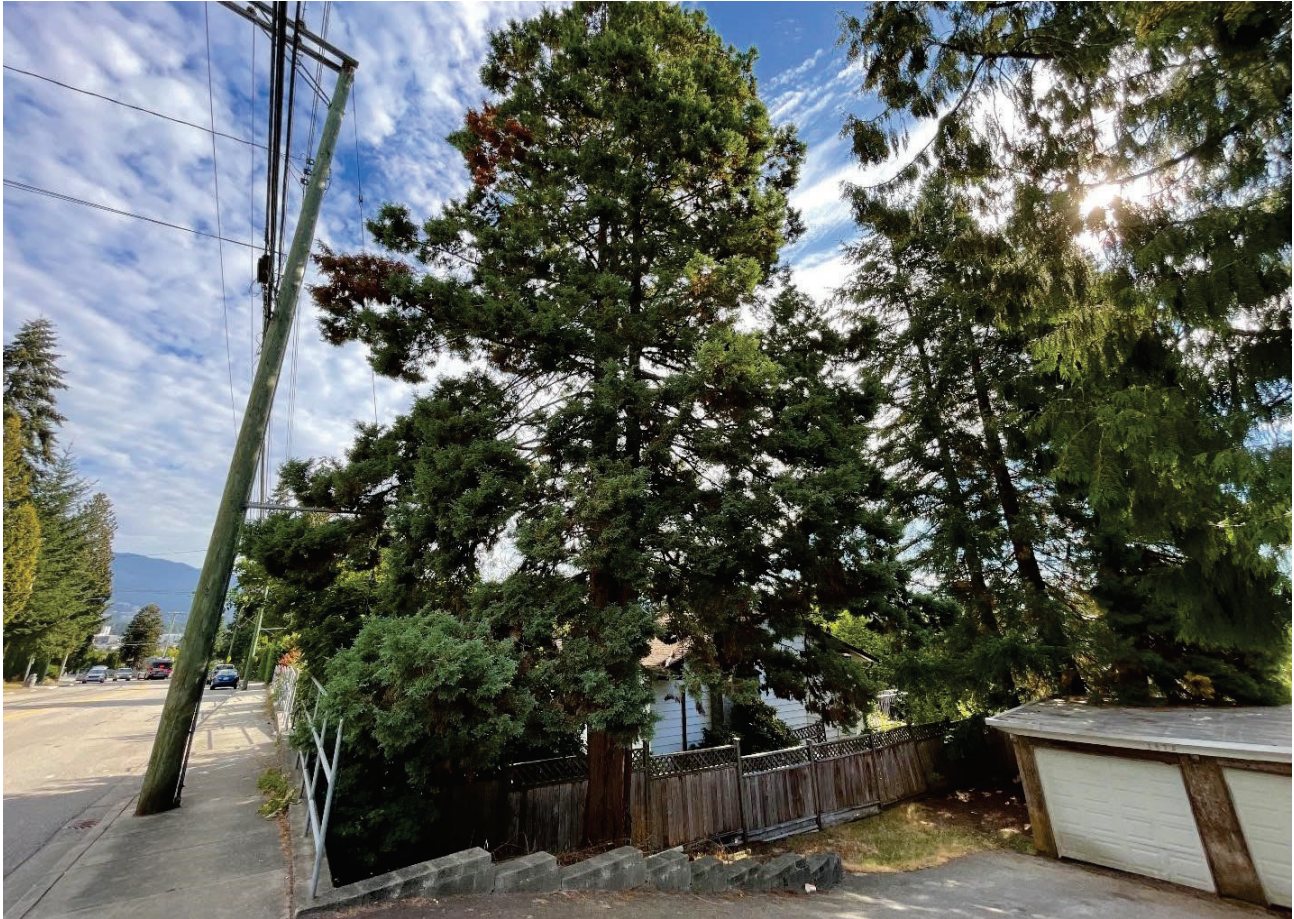
Table 1 - Off-site Tree Inventory												
Klimo & Associates Ltd.												
August 29, 2022												
1675 Pitt River Rd, Port Coquitlam												
ID#	Surveyed Y/N	On-site (ON) Off-site (OF) City (C)	Common name	Botanical name	DBH (cm)	LCR (%)	Canopy (Dia. M)	Condition	Comments	Retention Suitability	Retain / Remove	TPZ (m)
T1	No	On-site	Sawara cypress	Chamaecyparis	71	75	8	Subject tree was examined to have developed a co dominant stemmed structured overall growth form along with having a deeply imbedded union. Crown growth was observed. to have developed in common with its species. No other major defects and or signs of stress were to be examined. Subject tree is in fair to good condition.	Subject tree falls towards the edge of the proposed construction works occurring along the frontage of the lot and will be within the zone of the heaviest site disturbance & excavation related activities.	Marginal	Remove	4.2

Photo 3 - Facing towards the on-site tree #T1.

**On-site trees #T1**, will be in direct conflict with the proposed development as the subject trees would fall towards the edge of the proposed building footprint and would be located within an area requiring the heaviest excavation & grading related requirements. The subject trees would also be impacted and become structurally destabilized during the construction works as they would fall within an area requiring the heaviest grade disturbances related to the dwellings and of its site servicing requirements occurring along the frontage of the property.

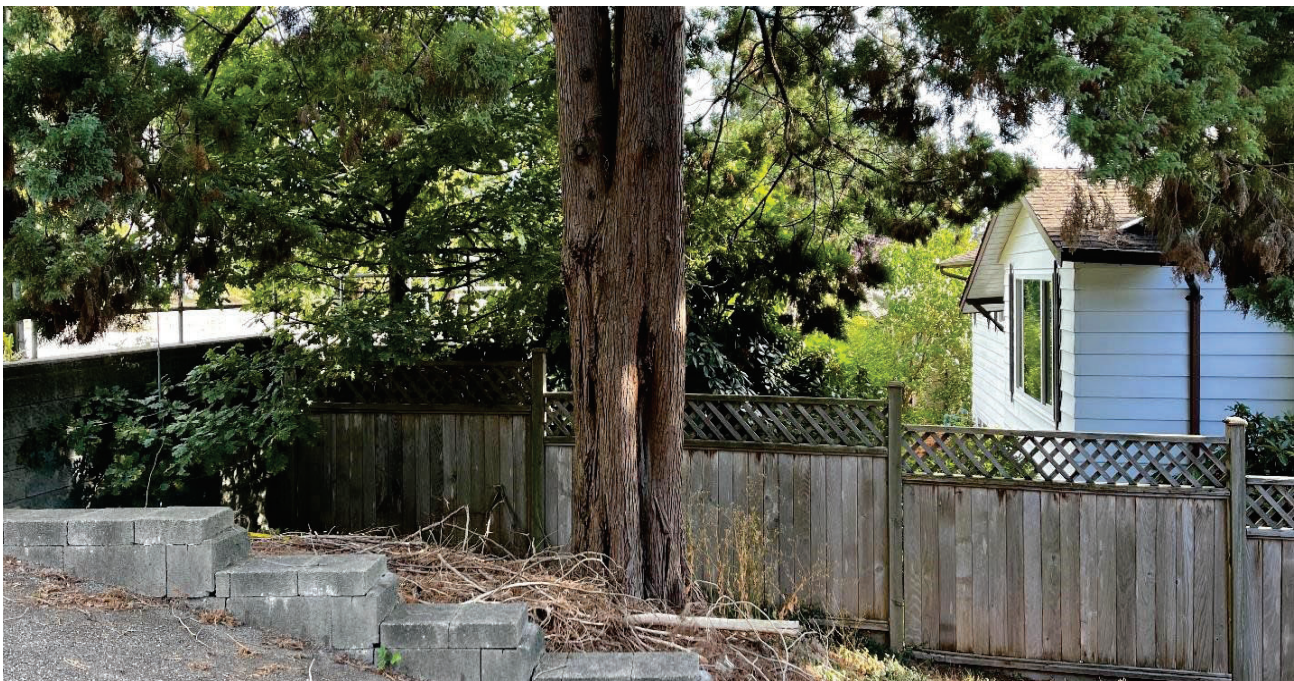
Photo 4 Facing towards the lower trunk of on-site tree #T1.

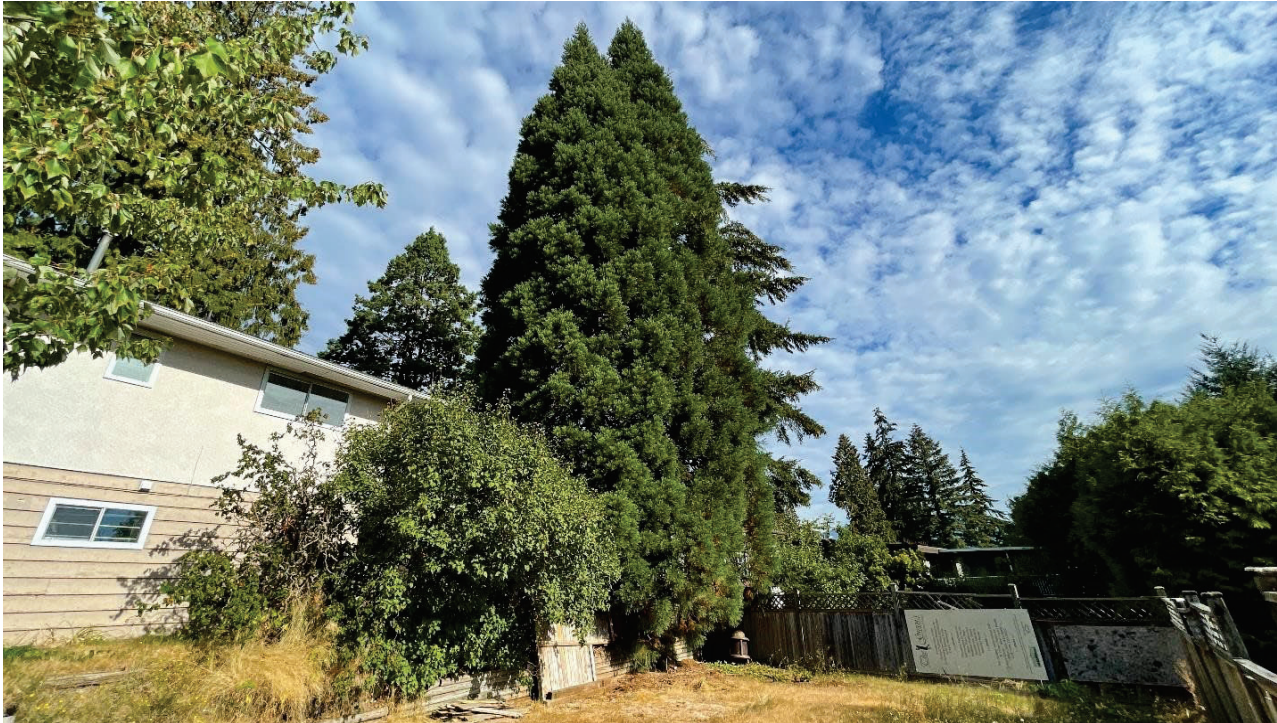
T4	No	On-site	Norway spruce	Picea abies	60	75	6	Situated alongside an existing retaining wall. The overall growth of the subject tree was examined to have developed an overall crown spread towards the north. No other major defects and or signs of stress were to be examined. Subject tree is in fair condition.	Subject tree falls towards the edge of the proposed building footprint and will be within the zone of the heaviest construction & excavation related activities.	Marginal	Remove	3.6
T5	No	On-site	Giant redwood	Sequoiadendron giganteum	78/71	85	6	Mature coniferous tree developing along the existing retaining wall. The overall growth of the subject tree was examined to have developed a co dominant structured base along with both stems having.	Subject tree falls towards the edge of the proposed building footprint and will be within the zone of the	Suitable / Marginal	Remove	8.9

**Photo 5 - Facing towards on-site trees #T4 and # T5.**

**On-site trees #T4 and #T5** will be in direct conflict with the proposed development as the subject tree would fall within the footprint of the proposed building footprint (*proposed building envelope*) and would be in direct conflict with the site preparation & its excavation related requirements occurring within the limits of the site. The subject tree would fall within an area of high disturbance requirements related to the subdivision project that would result in root loss & stability impacts.

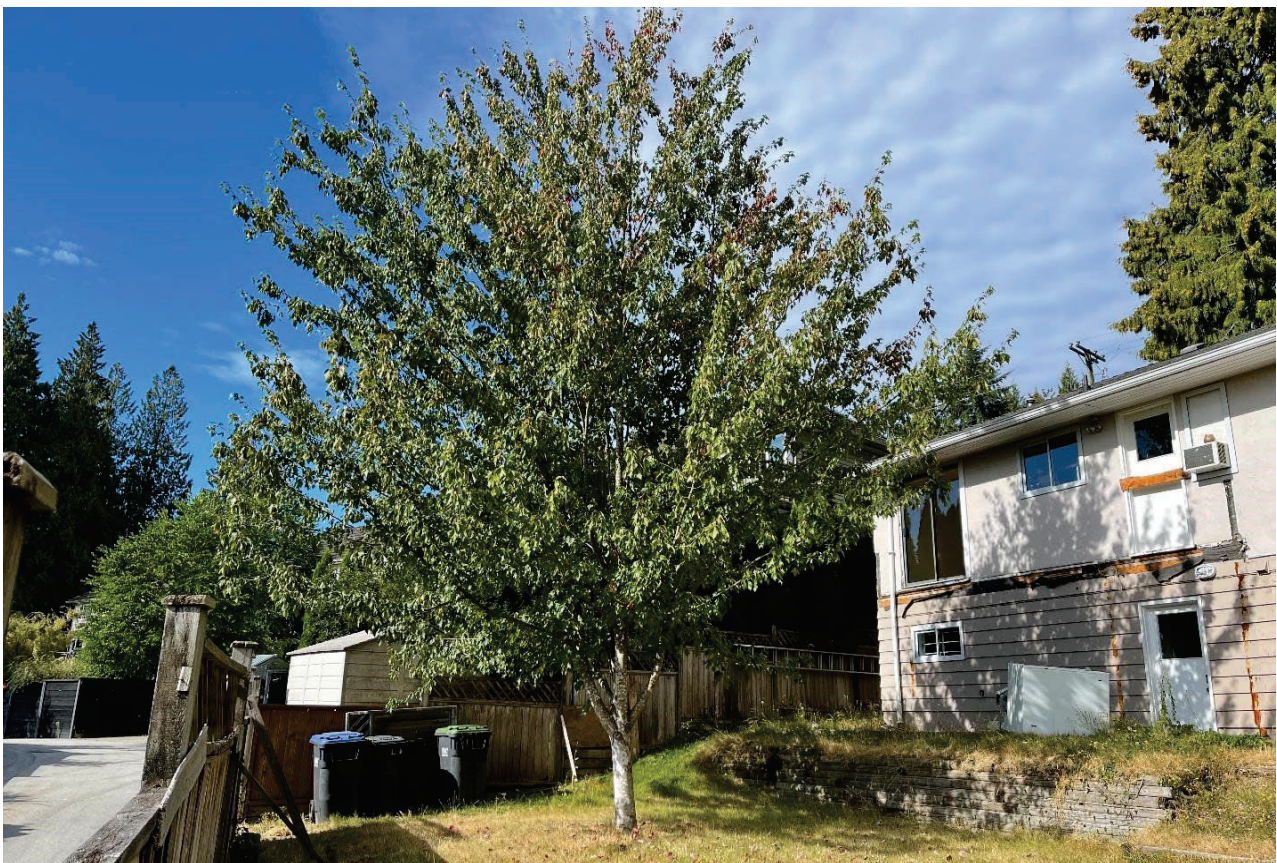
phototropic influenced growth form. The growth of the canopy was observed to be healthy. Subject tree is in fair to good condition.	heaviest construction & excavation related activities.			
T6	No	On-site	Maple	<i>Acer</i>	11/13/23	75	6	The overall growth of the subject tree was examined to have developed in common with its species. The overall crown was observed to have developed an overall crown spread in a symmetrical growth form. Subject tree is in good condition.	Subject tree falls towards the edge of the proposed garage envelope and will be within the zone of the heaviest construction & excavation related activities.	Suitable	Remove	2.8

**Photo 6 Facing towards on-site tree #6.**

**On-site tree #T6** will be in direct conflict with the proposed development as the subject trees would fall towards the edge of the proposed garage envelopes and would be located within an area requiring the heaviest excavation & grading related requirements. The subject trees would be impacted and become structurally destabilized during the construction works as they would fall within an area requiring the heaviest grade disturbances related to the construction of the new garage.
