## **Committee of Council Regular Agenda**

Council Chambers, 3<sup>rd</sup> Floor City Hall, 2580 Shaughnessy Street, Port Coquitlam, BC **Tuesday, March 5, 2019** Time: 2:00p.m.

### 4.1 1579, 1515 & 1491 Kingsway Avenue: Development Permit Amendment & Watercourse Development Permit Amendment Recommendation:

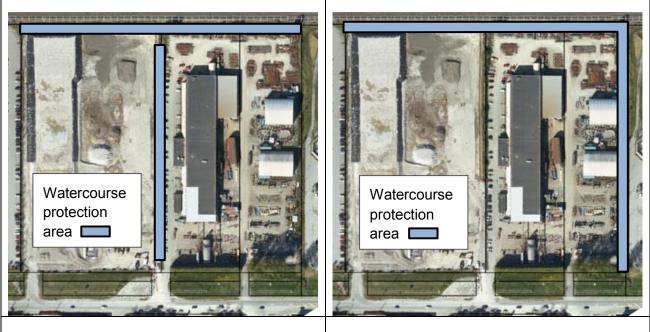
watercourse channels: a railway channel located along the northern property line and a central channel, which runs to an underground pipe near the south of the property and connects to the Kingsway Avenue stormwater sewer. These are both Class B watercourses, i.e. watercourses that are non-fish bearing but can provide food or nutrients downstream, and they are in poor condition. The proposed watercourse permit amendment relocates the central channel to the east edge of the new, consolidated property to allow for the construction of a single, large building. The 10m width of the watercourse protection areas and the length of the railway channel would remain as originally proposed. The central channel would be regraded to drain to the new eastern location. The amendment increases the total protected area by 232 m<sup>2</sup> compared to the approved plan.

Original location of watercourse

Proposed location of watercourse

does not impact site access. The proposed amendment to the watercourse protection area will improve the watercourses through an increase in both wetted habitat and overall protected area. Committee approval of both development permit amendments is recommended.

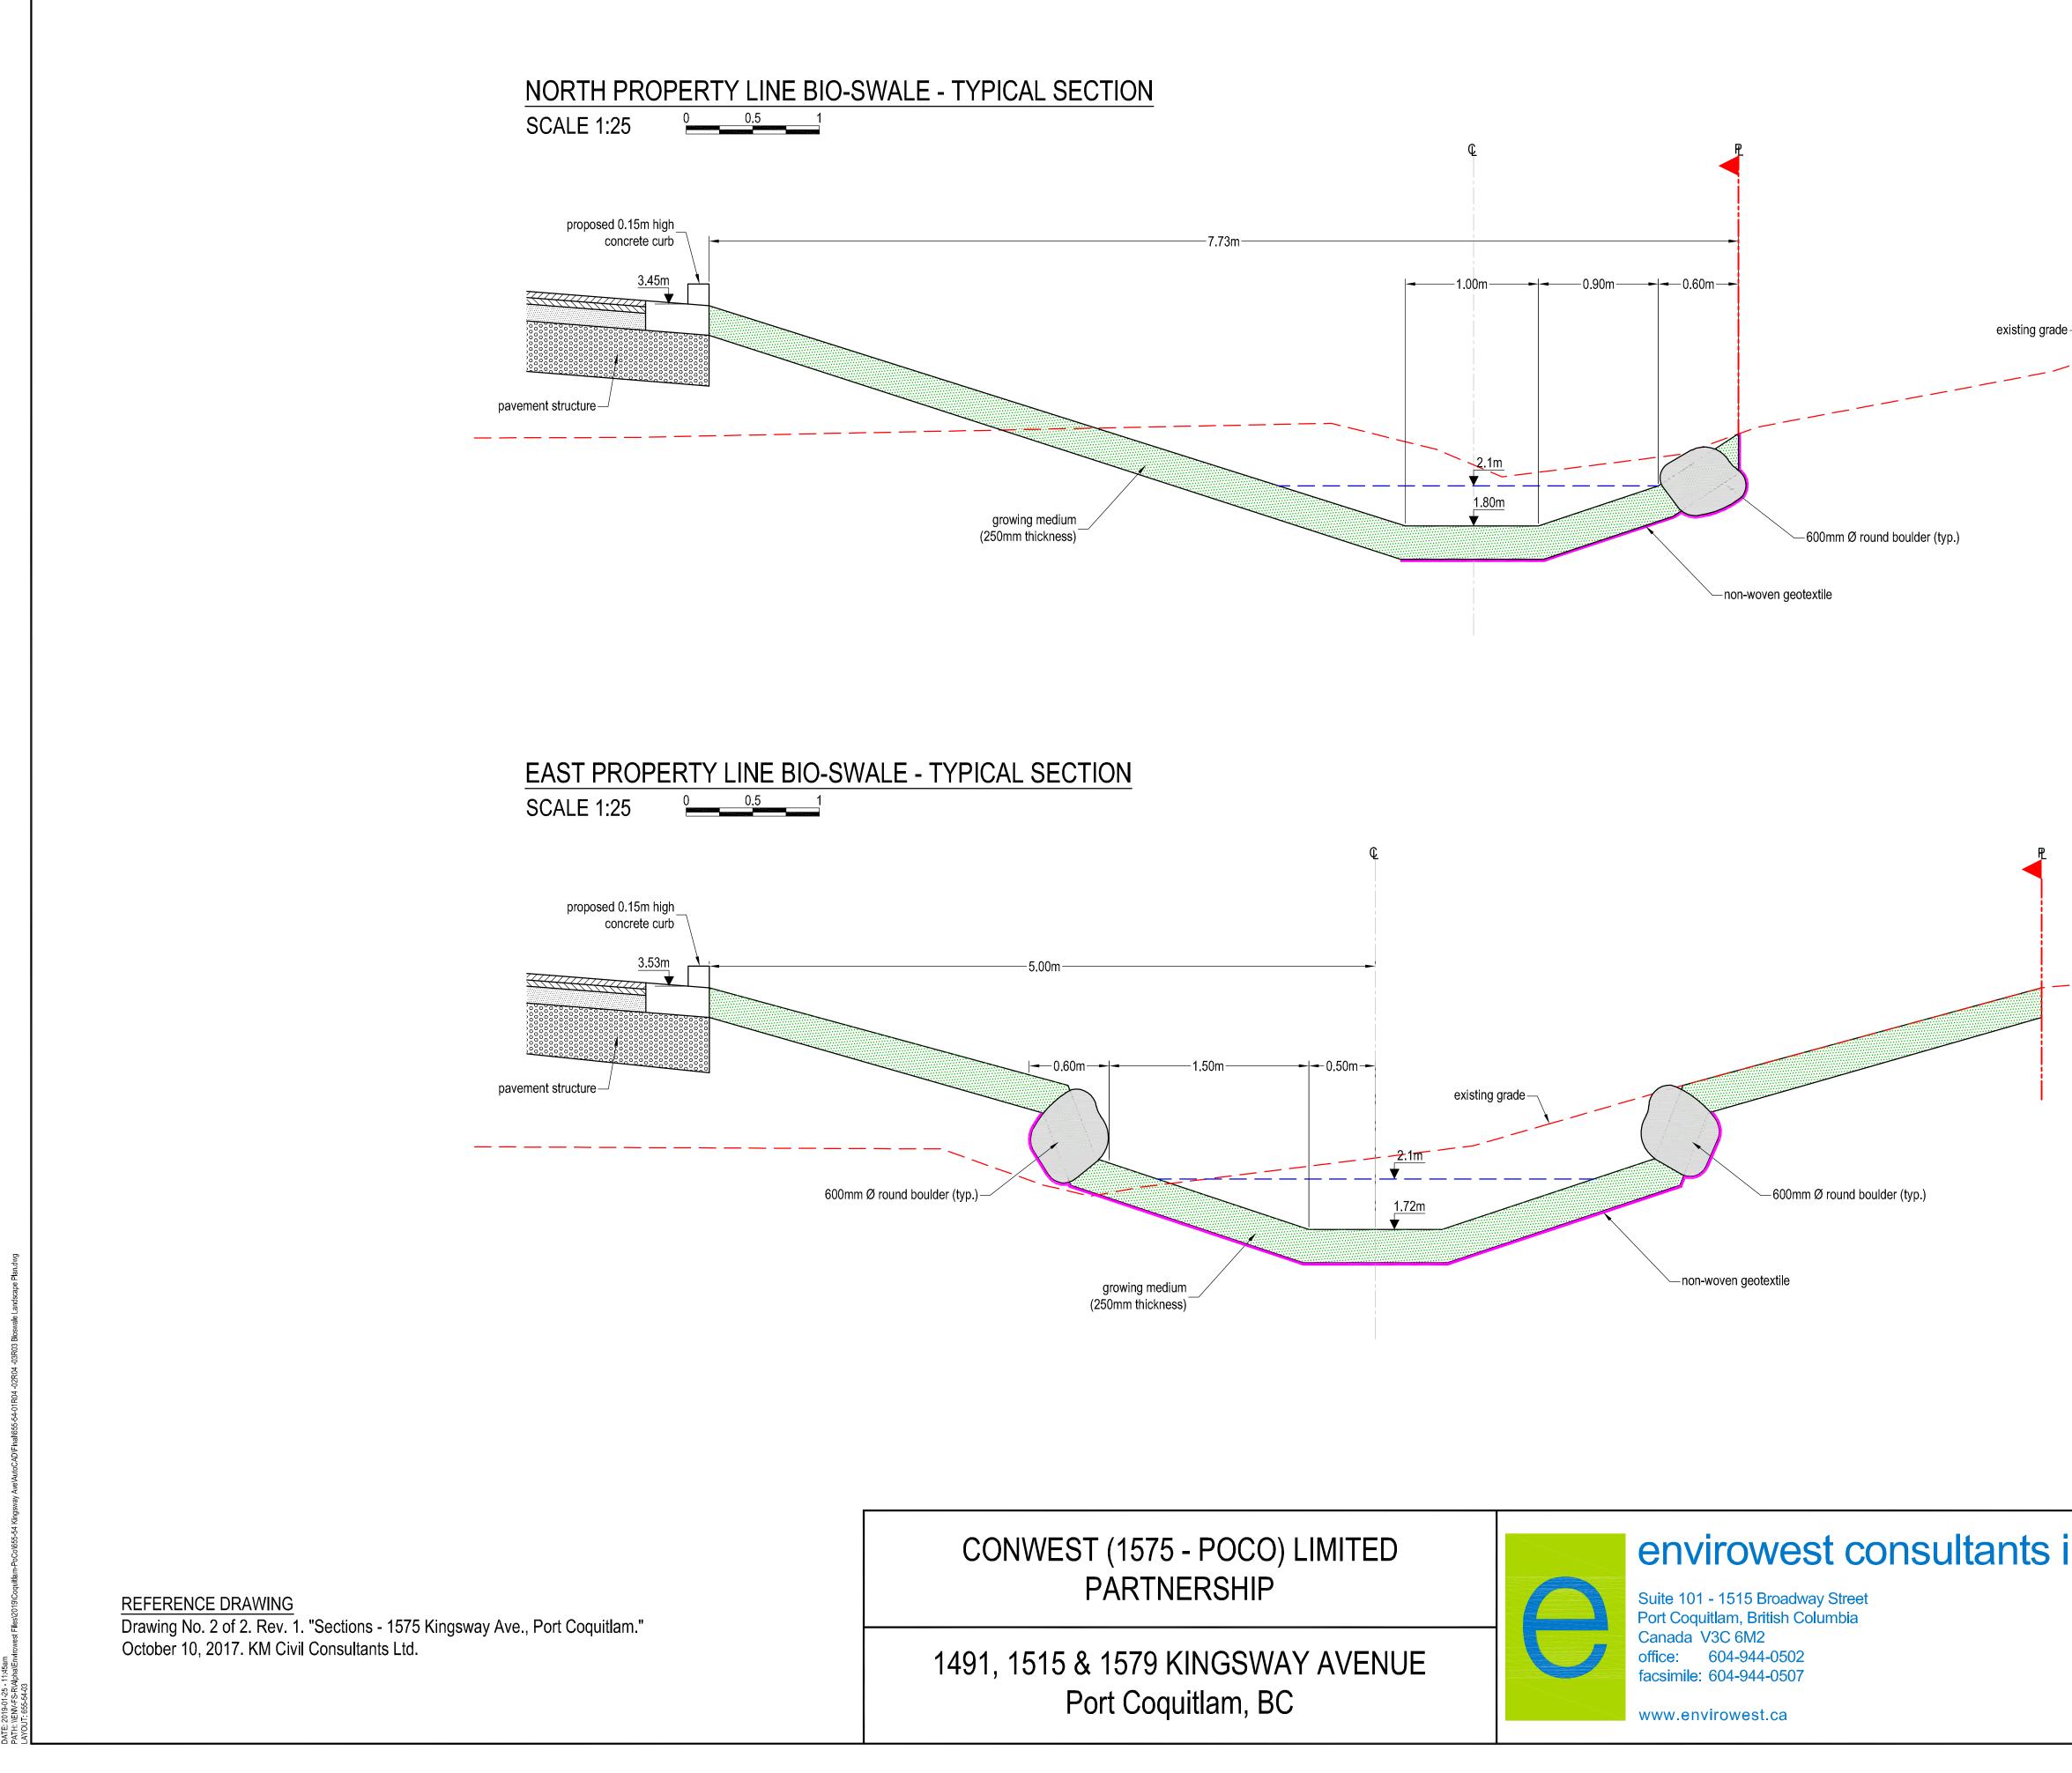
nts inc.		BIOS	WALE TY	PICAL SEC	TIONS
	DESIGN: MAA/IWW	drawn: SDJ/RK	CHECKED: MAA	REVISION: REVIS	ION DATE: January 25, 2019
	SCALE: AS S	Shown			55-54-03
	Oct	ober 19, 2017			00-04-00

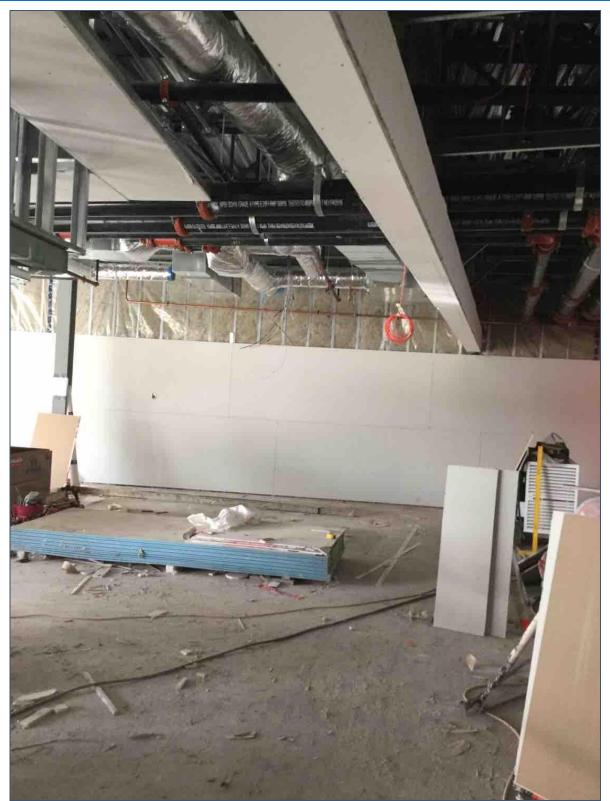
Phase 1A - Wall boarding to W wall of concessions

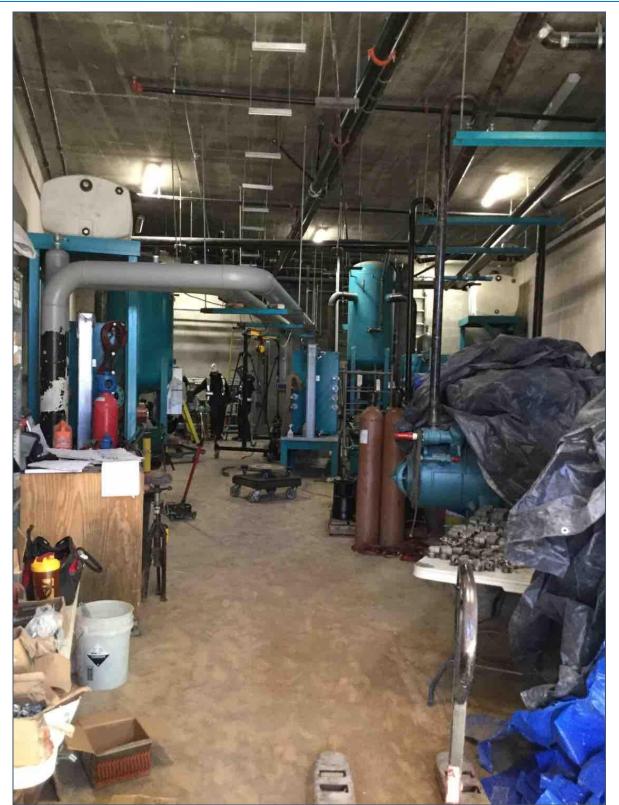
Phase 1A – Refrigeration ongoing

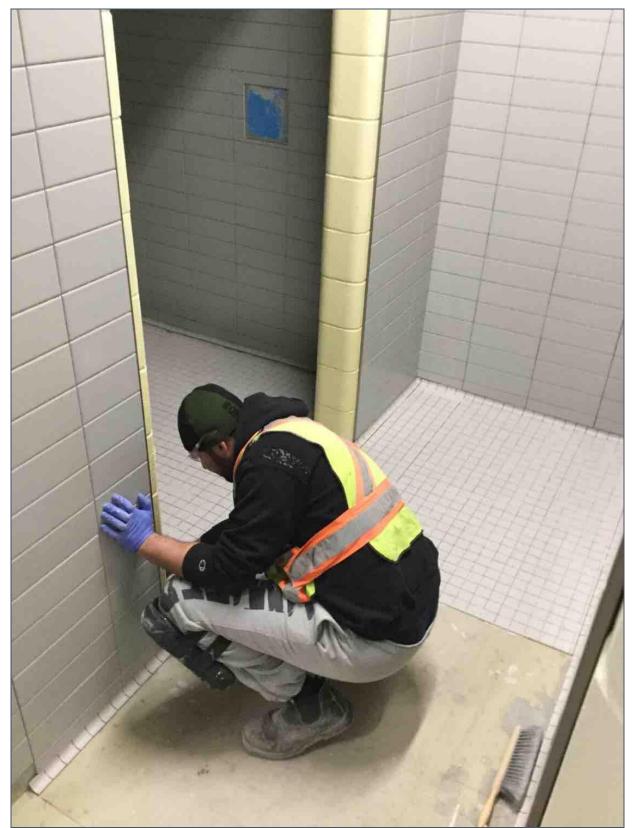
Phase1B – Cove base and floor tile to changeroom showers

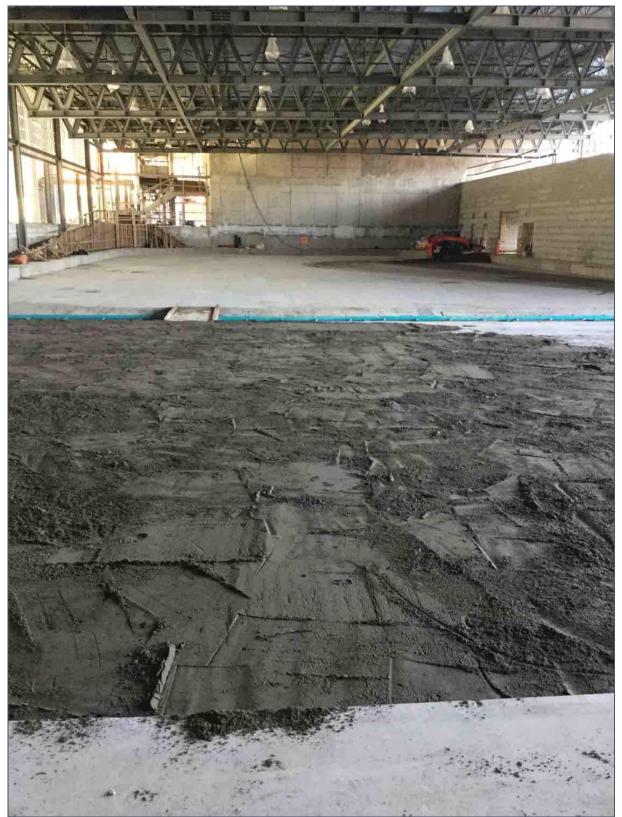
Phase 1B - View of rink from skate rental office

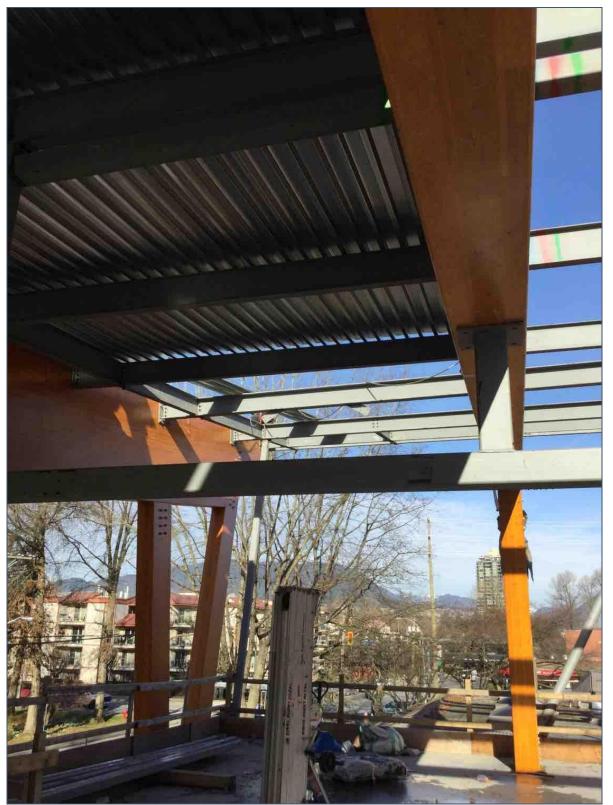
Phase 1C – Metal deck to roof commenced over weight room

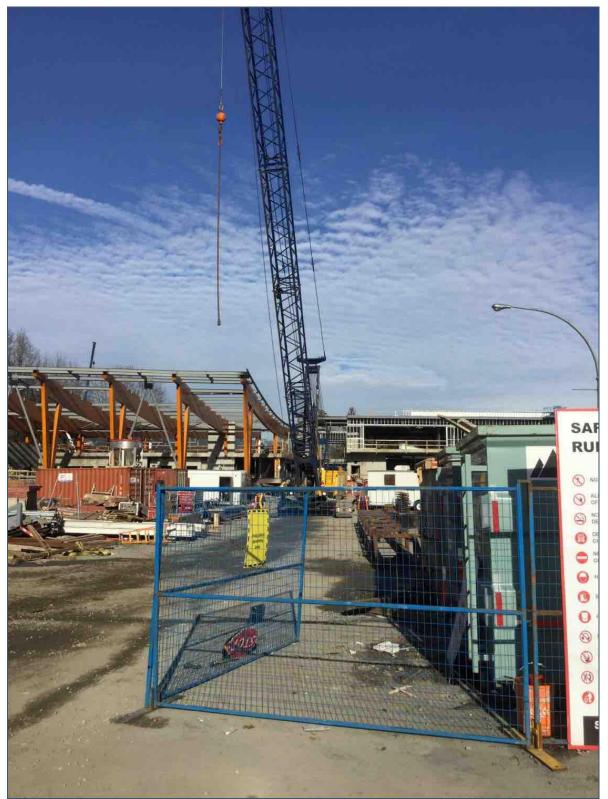
Phase 1C – Piling rig set up
