Committee of Council Agenda

Tuesday, May 25, 2021

5.1. Rezoning Application for 2650 Burleigh Avenue and 2634-2636 Kingsway Avenue

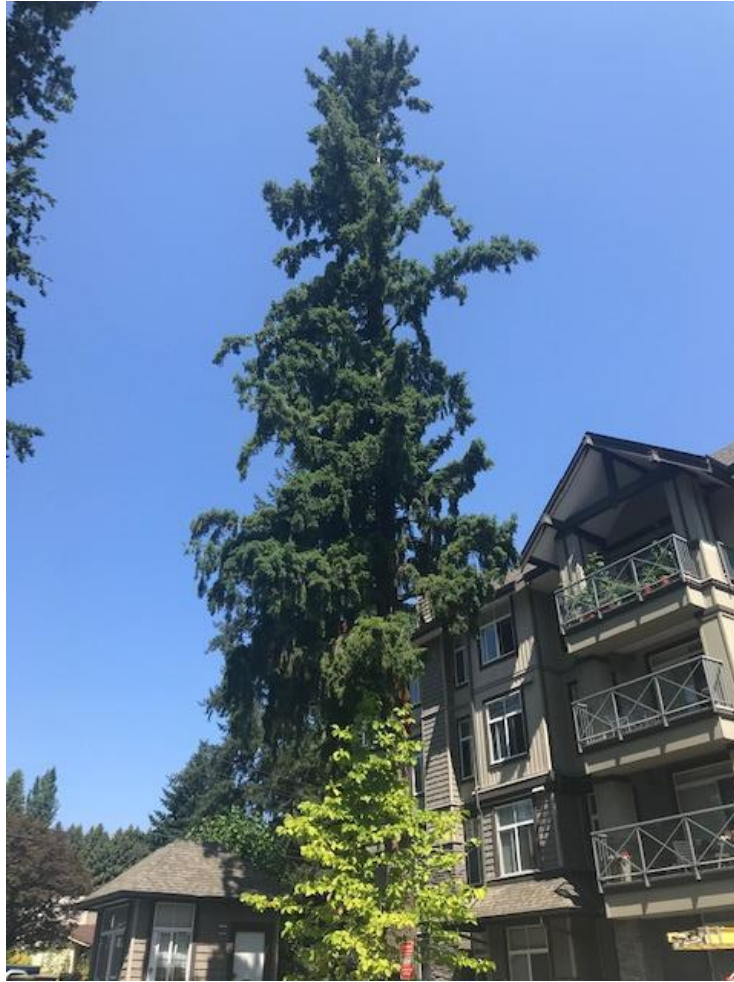
Example #1: This is an example of two cedar trees that were approximately 3m from a newly constructed apartment building with an underground parking area. This photograph was taken 5 years later and the tree shows no signs of decline.

Example 2: Fir tree at the same complex (3.0 meter from the building foundation). 5 years, later no signs of decline.

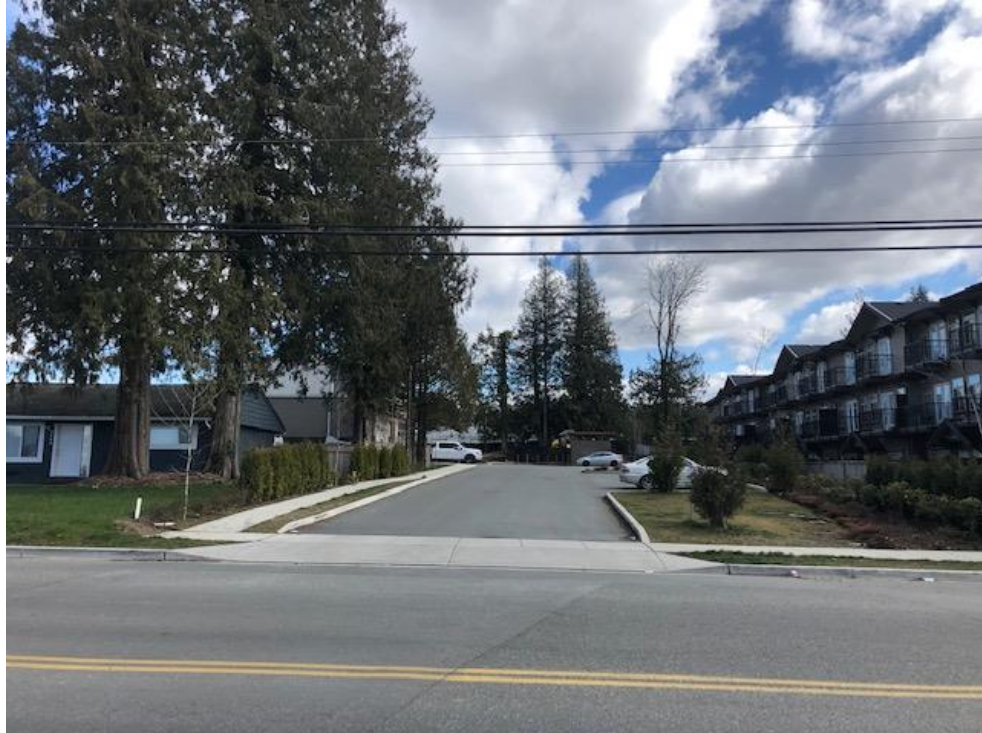
Example of new road and sidewalk well within critical root zone of neighboring trees. Tree show no signs of decline after 3 years.

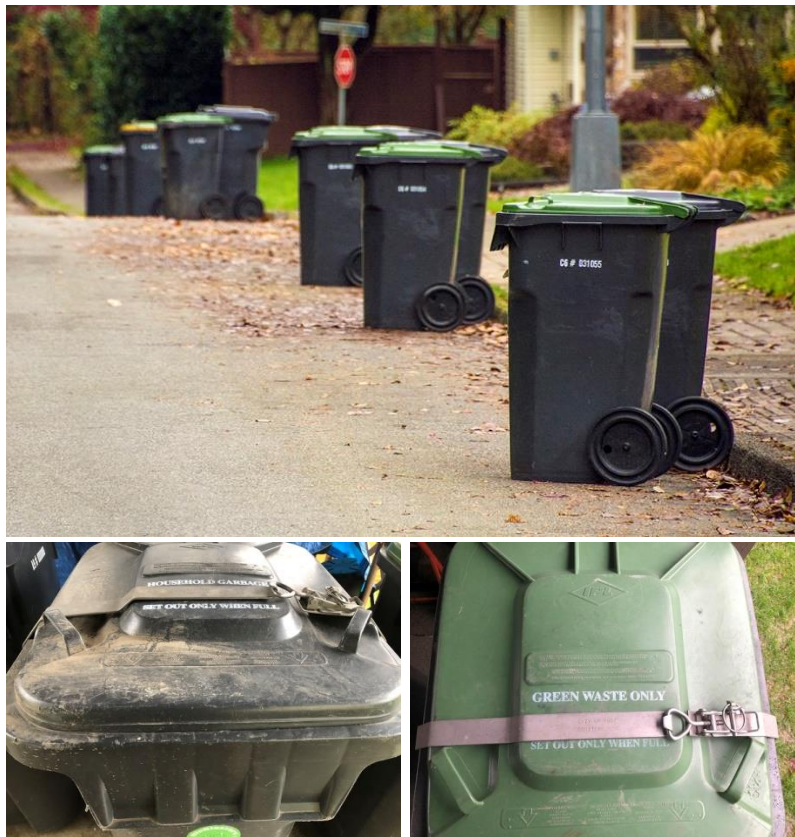
Figure 9 Garbage and green waste carts with locking mechanisms, provided by the City

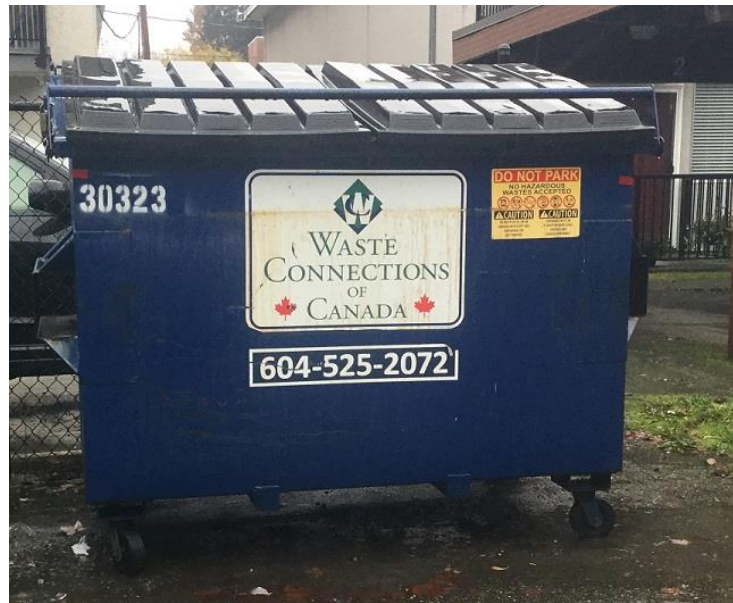
Figure 11. Bears can access dumpsters with plastic lids like this one, even when locked.

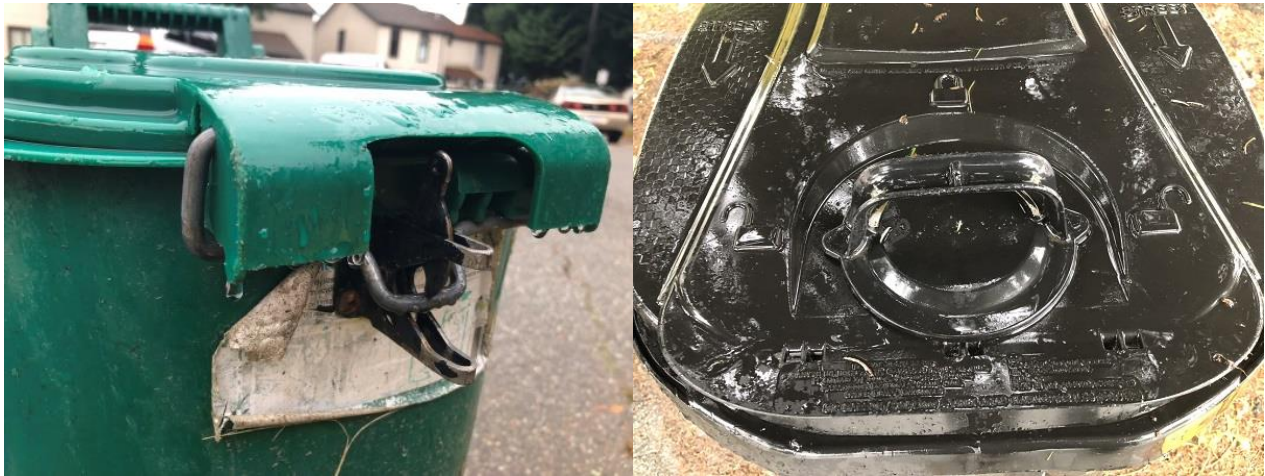
Figure 16. Bears are capable of learning how to open these locking mechanisms to access the green waste inside.

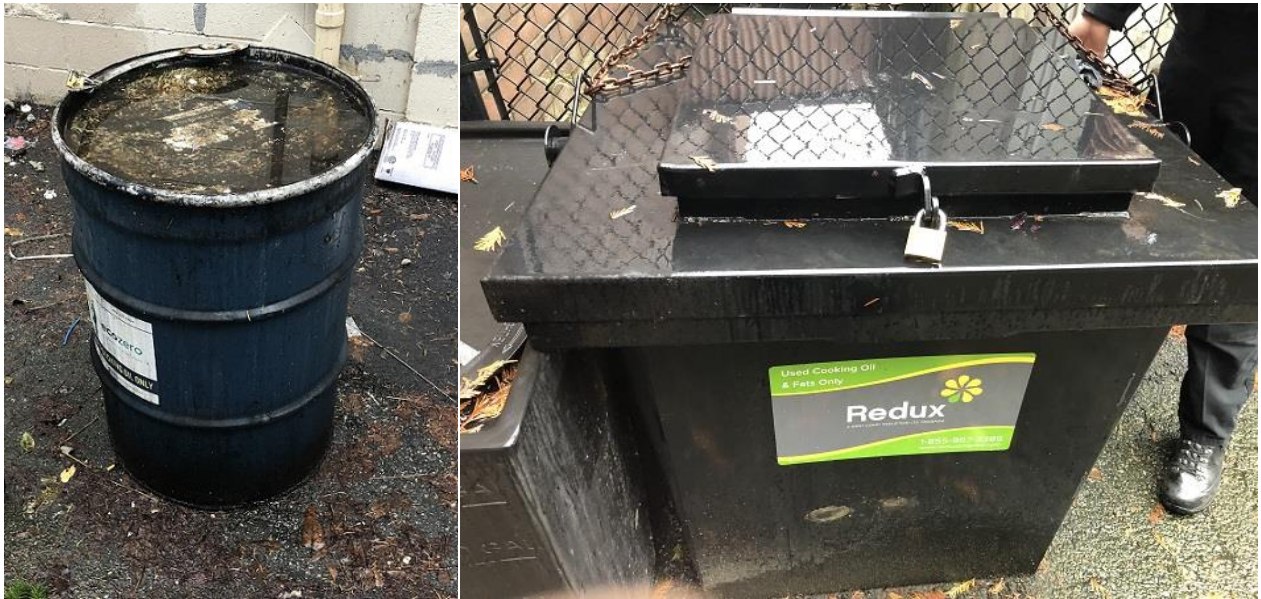
Figure 19. Example of a non-bear-resistant grease barrel (left) and a bear-resistant grease barrel (right) commonly found behind restaurants in Port Coquitlam.

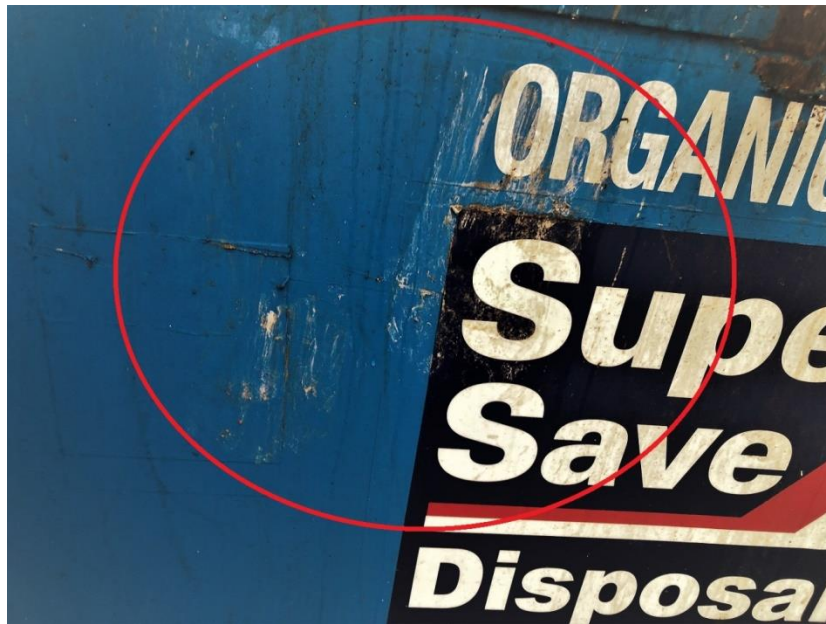
Figure 20. Grease coated paw prints on the side of an unlocked dumpster behind a restaurant.
