Rezoning Application for 3609 St. Thomas Street

**Construction Consulting - Tree Inventory and Management Report for
Juan Duque**

CITY OF PORT COQUITLAM
ZONING AMENDMENT BYLAW, 2023

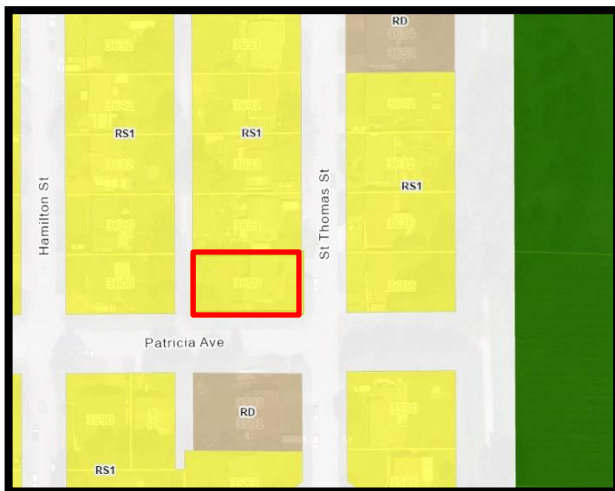
Current Zoning (RS1)

Policy and Regulations: The lot is currently zoned RS1 (Residential Single Dwelling 1) and has a R (Residential) OCP (Official Community Plan) designation, which allows for consideration of an RD zone. The OCP policies for housing allow for consideration of a rezoning of a property with a R land use designation for a duplex use if the property is a corner lot and if the rezoning would result in the dedication of lands for roads, the installation of off-site works and services, or design and construction of buildings and landscaping to achieve a superior quality of design and enhanced fit with the established neighbourhood character.

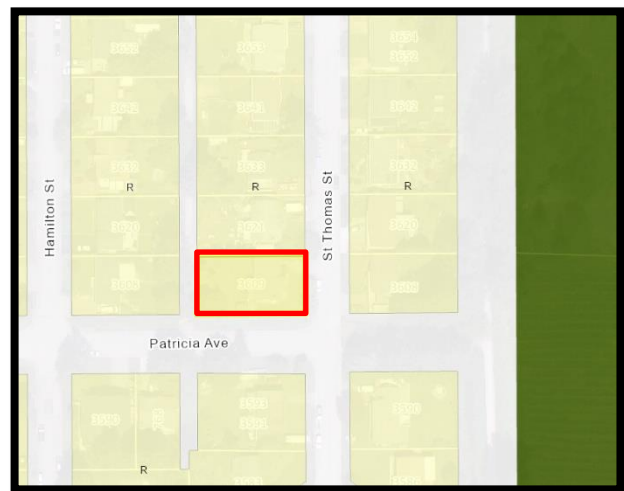
Current OCP Designation (R)

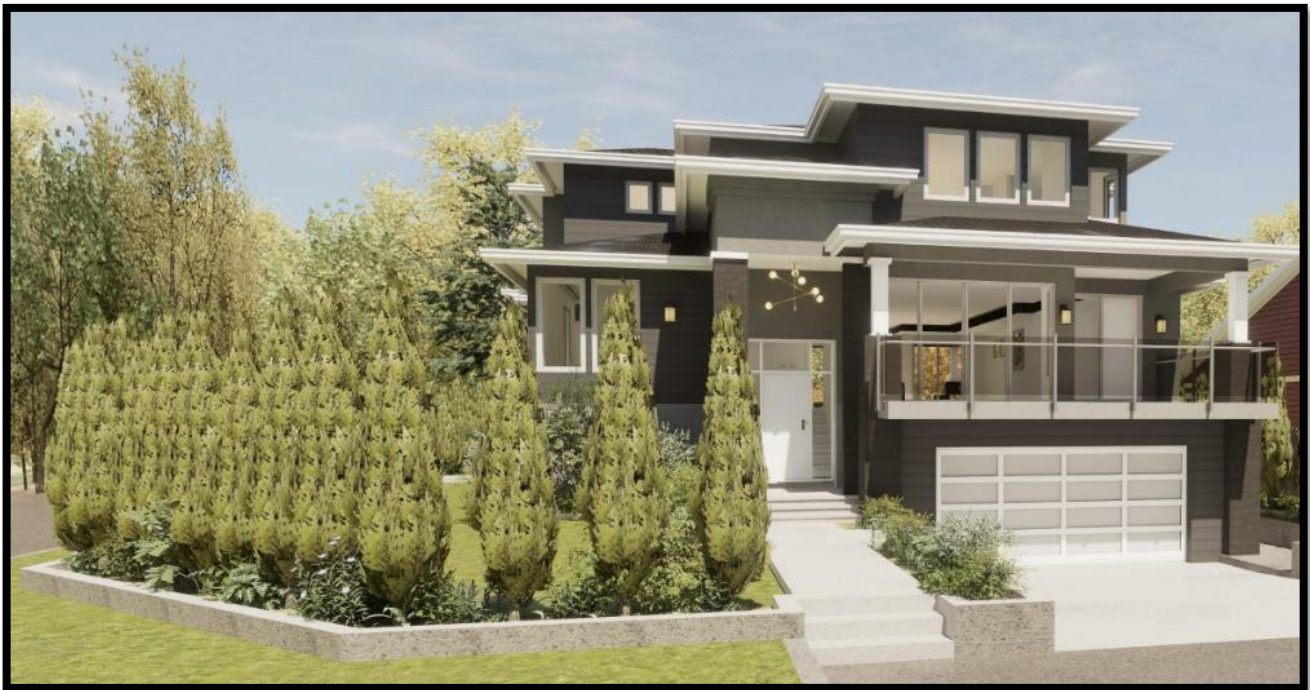
Rendering of the Unit 1 entrance as seen from St Thomas Street

Project Description: The proposed two-storey duplex is in a side-by-side configuration (drawings attached). As a corner lot, the units are oriented towards each adjacent street, with Unit 1 having its front entry and driveway off of St. Thomas Street, and Unit 2 having its front entry on Patricia Avenue with driveway access off the lane. Both units contain four bedrooms and three bathrooms with a den and two-car garage. Each unit has space on the driveway for two additional vehicles.

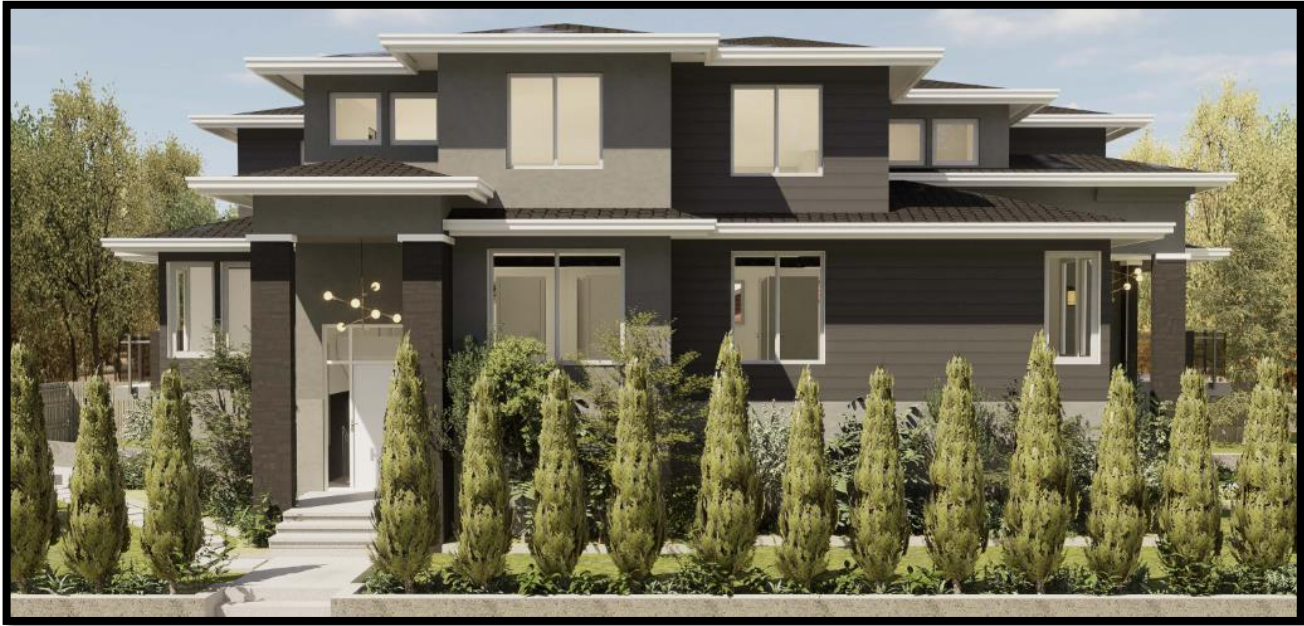
Rendering of the Unit 2 entrance as seen from Patricia Avenue

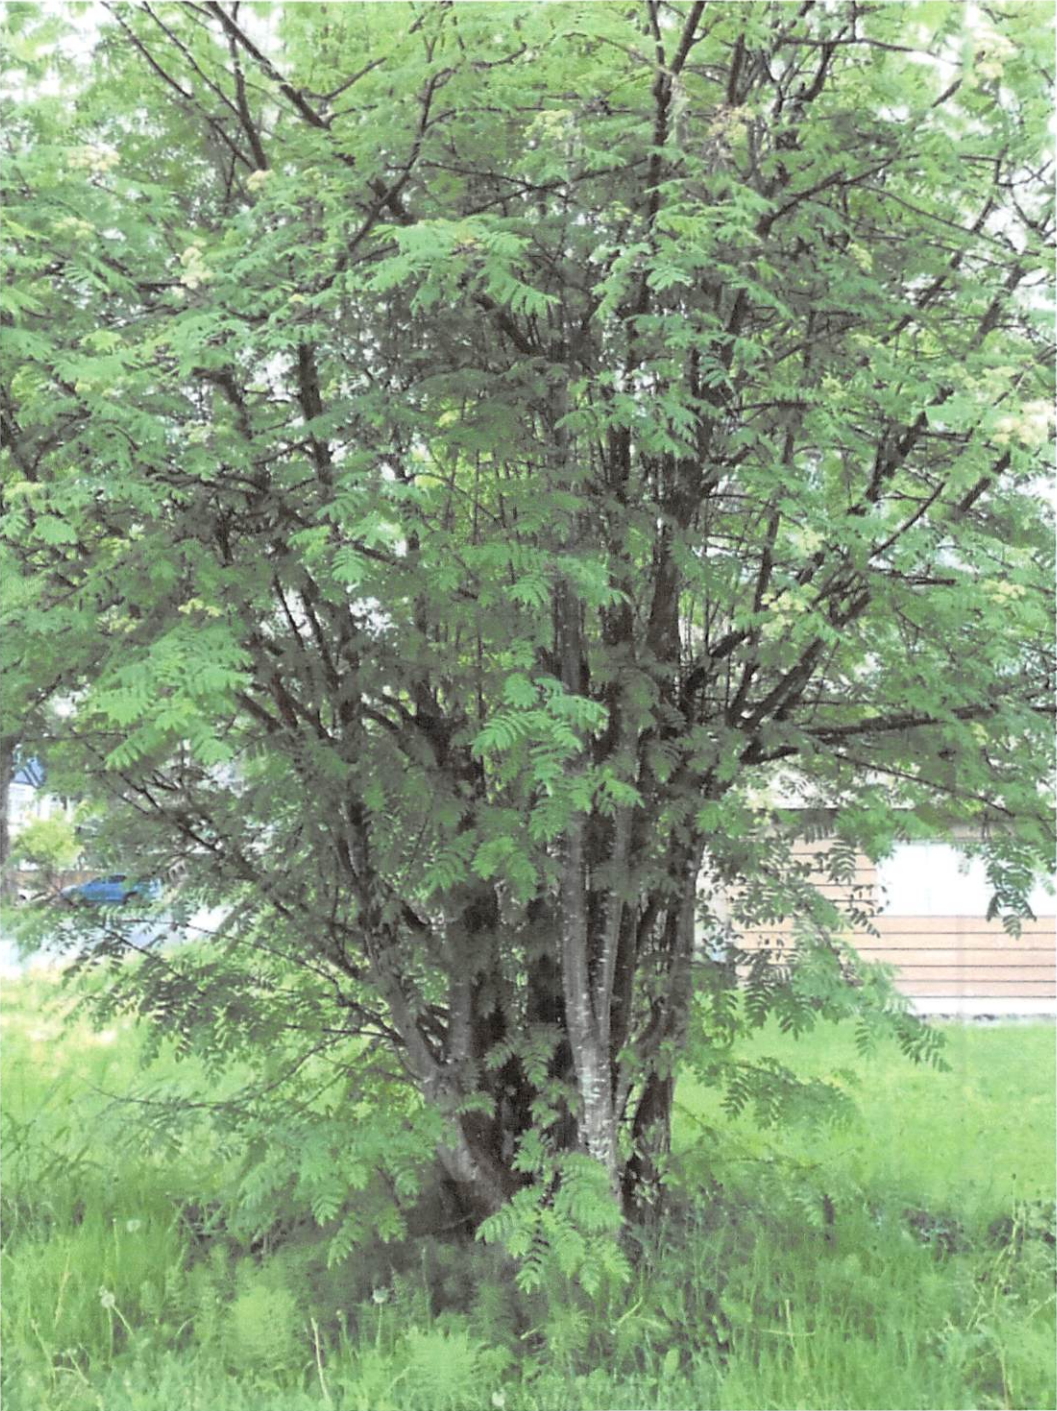
924 Cluster Shrub / Tree Mountain Ash is located on the City boulevard. Reference Figure 4.

Figure 4: Cluster 924

Due to the location, growth habit, and species, I recommend the City of Port Coquitlam consider replacing this Mountain Ash with a fruitless, single-trunk street tree suitable for growing under utility lines.

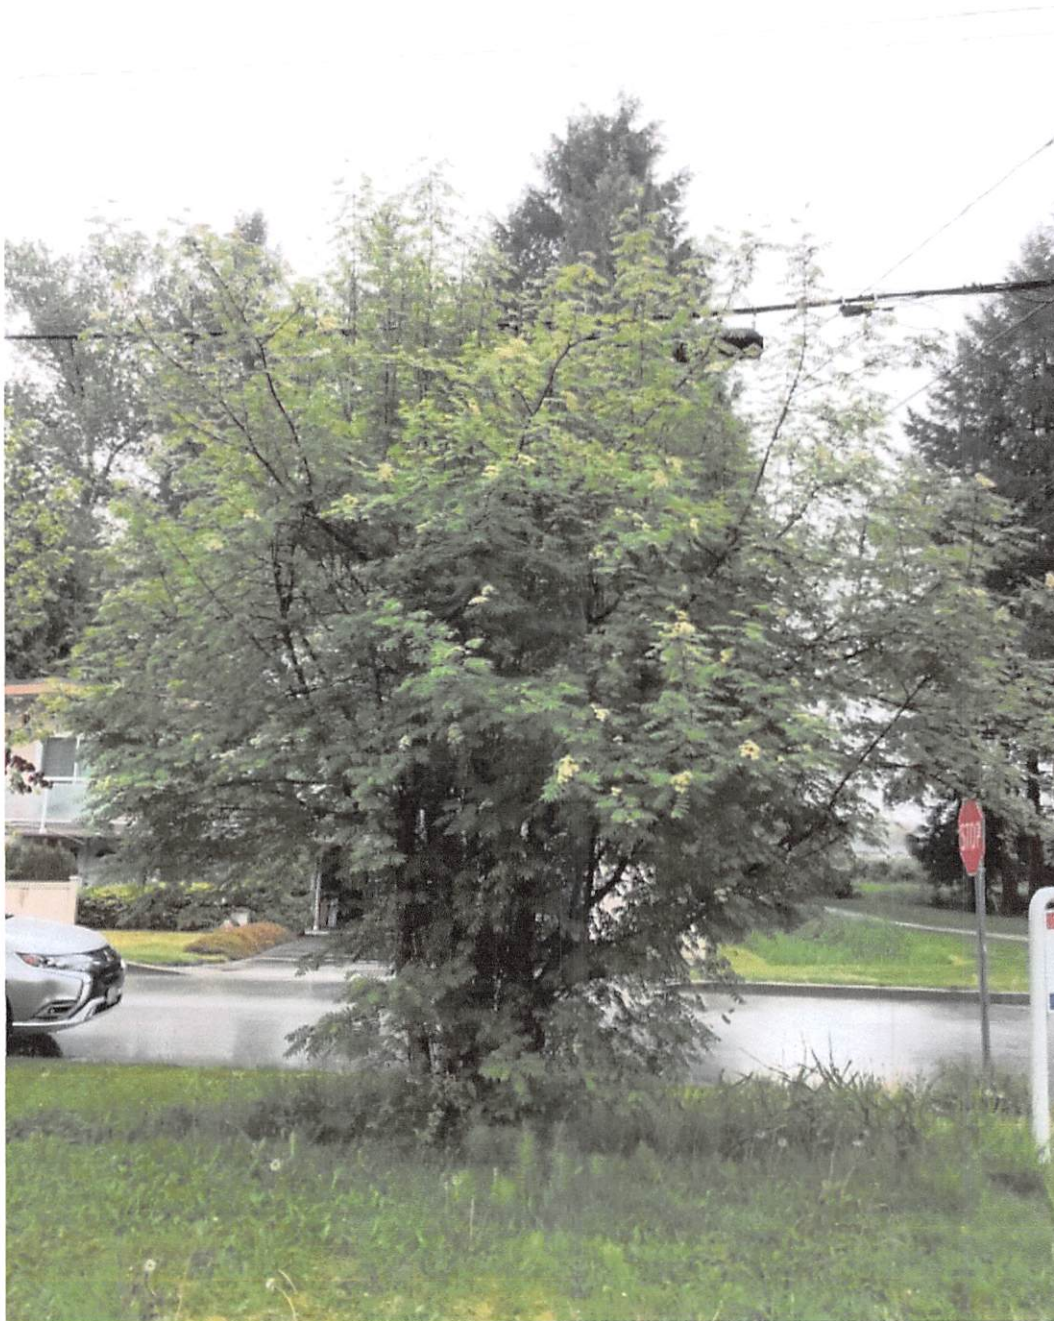
- Fair condition.
- This plant is interfering with the utility lines and requires clearance pruning. Reference Figure 5.
- Berries are a bear attractant.

Figure 5: Cluster 924 noting interference with utility lines

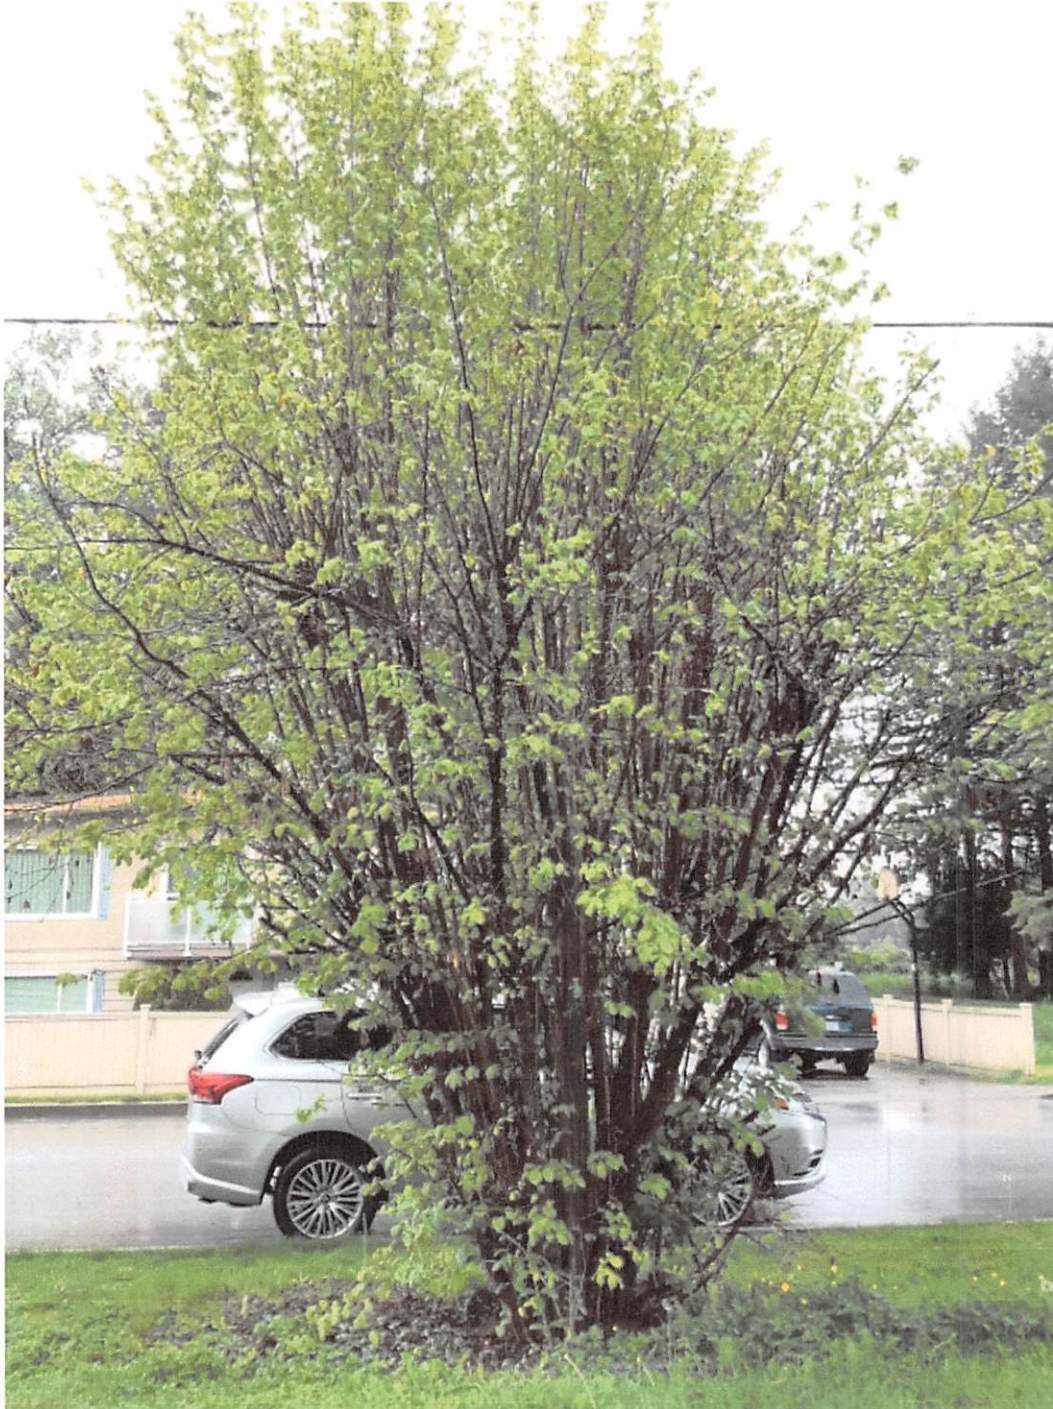
925 Cluster Shrub / Tree European Hazel is located on the City boulevard. Reference Figure 6.

- Poor condition.
- This plant is interfering with the utility lines and requires clearance pruning. Reference Figure 6.
- Plant appears to be infected with *Anisogramma anomala* / Filbert blight. Reference Figure 7.

Figure 6: Cluster 925 noting interference with utility lines

Due to the location, growth habit, and disease concerns, I recommend the City of Port Coquitlam consider replacing the Hazel with an alternative species street tree, suitable for growing under utility lines.

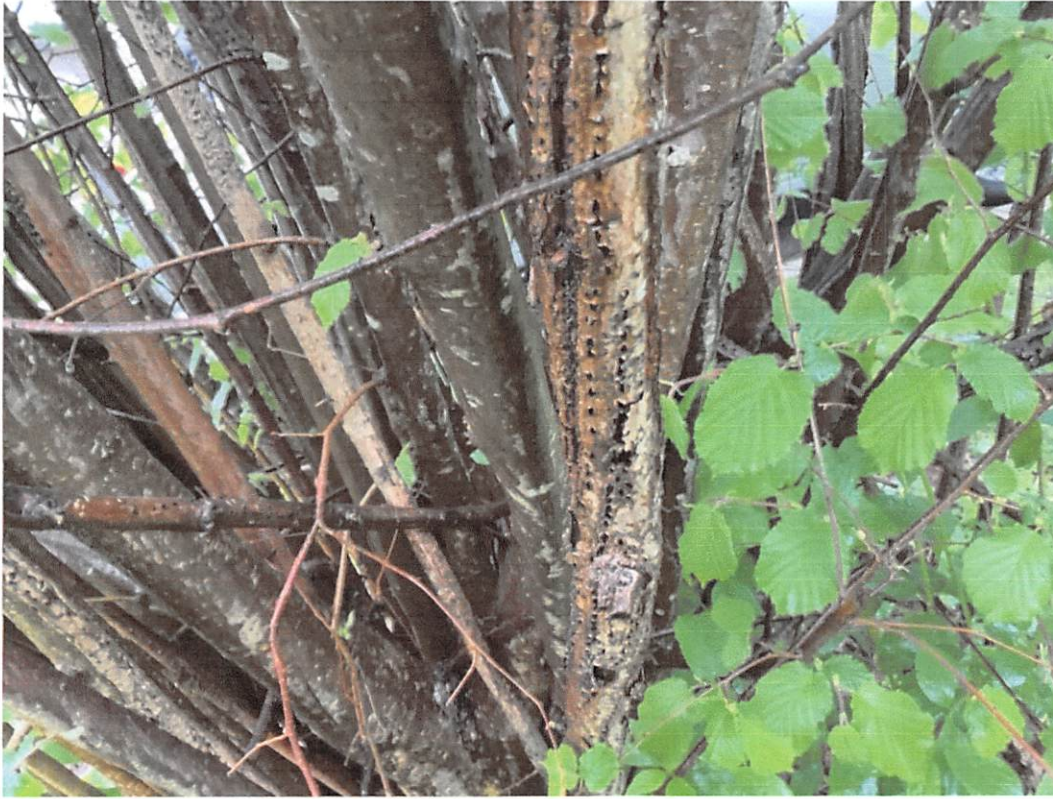
Figure 7: Cluster 925 noting *Anisogramma anomala* / Filbert blight cankers.

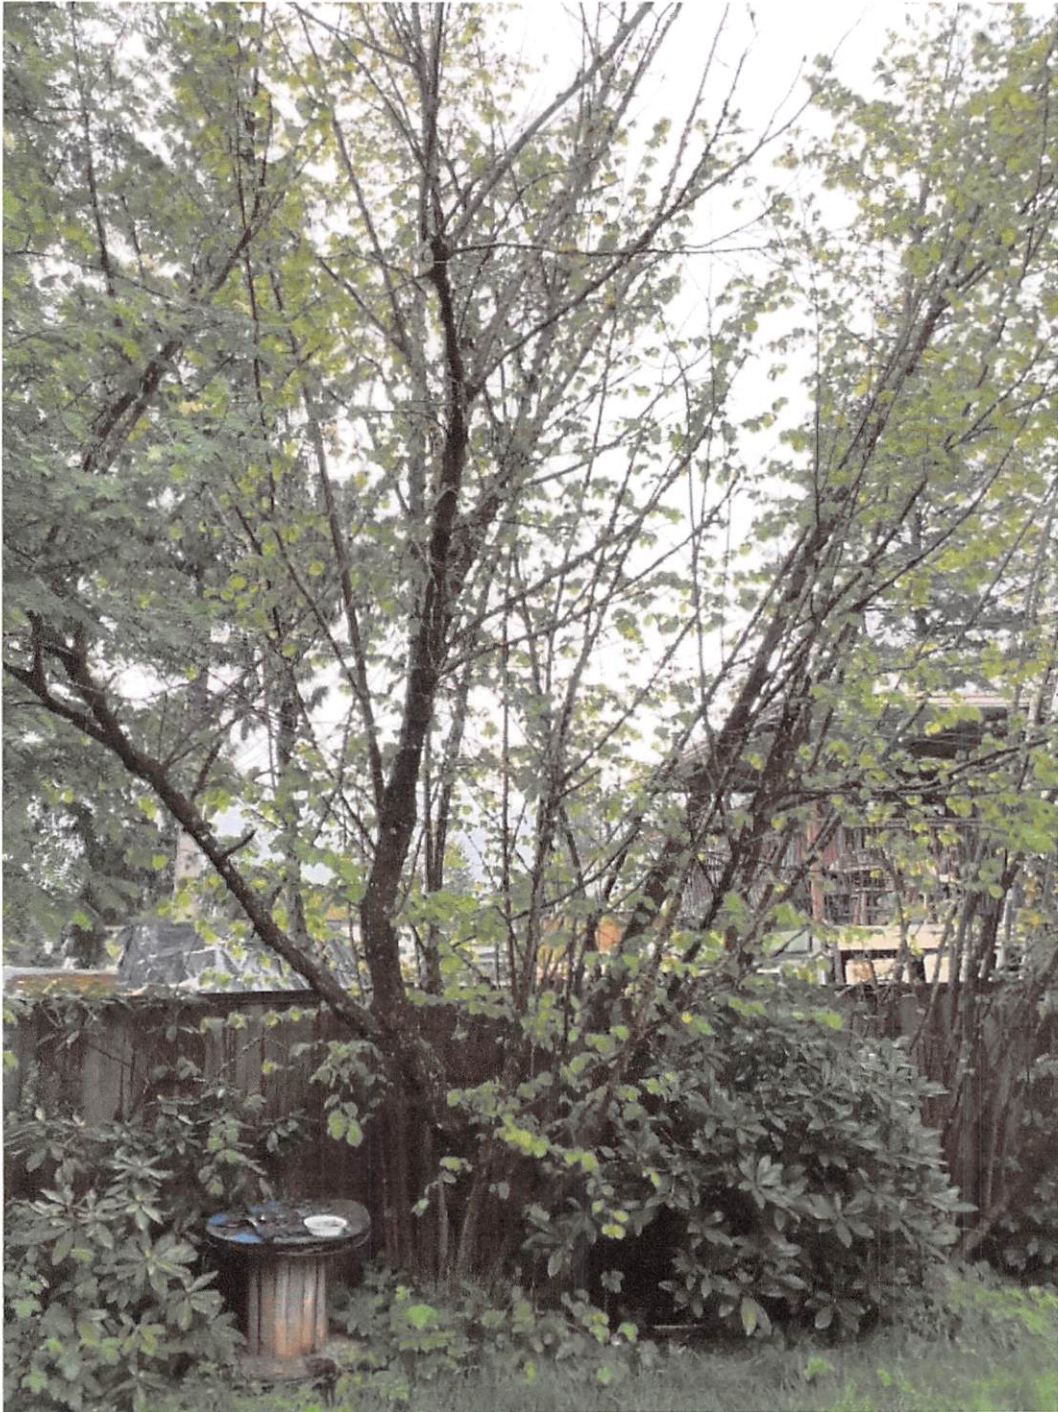
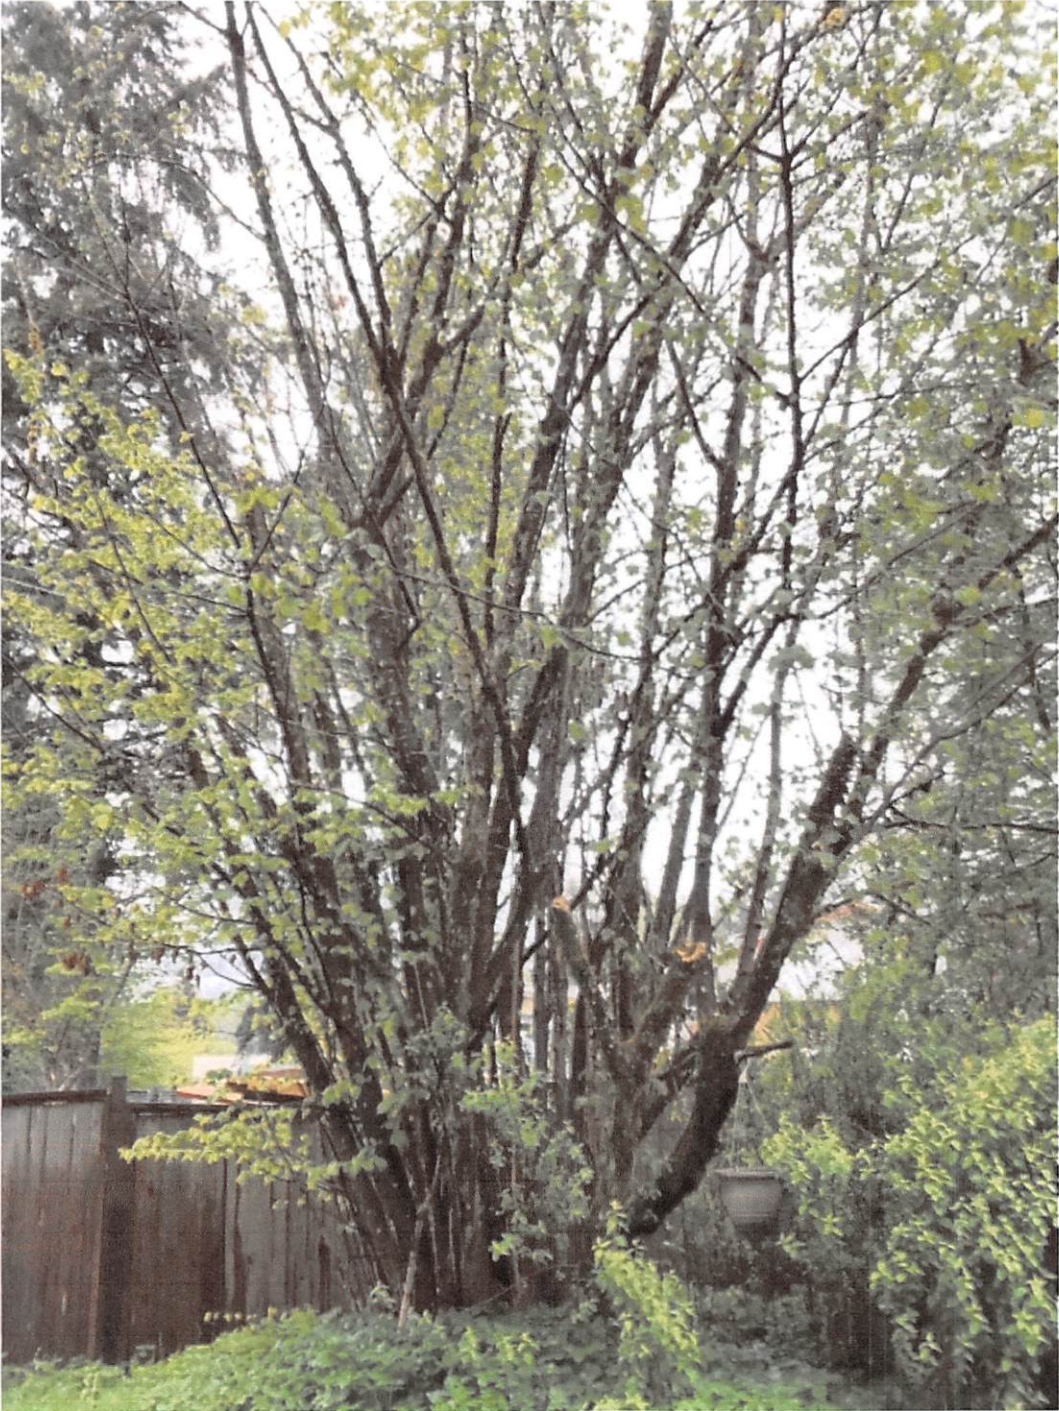
926 & 927 Cluster Shrubs / Trees European Hazel are along the North property line in the rear yard. Reference Figures 8 & 9.

- Poor condition.
- Plants appears to be infected with *Anisogramma anomala* / Filbert blight.
- Both have sparse crowns with medium and small deadwood.
- Critical root zones will be impacted by building footprint. Reference Figure 2.

Figure 8: Cluster 926

Figure 9: Cluster 927

Due to location and disease concerns, removal of these Hazels for the proposed construction is appropriate.

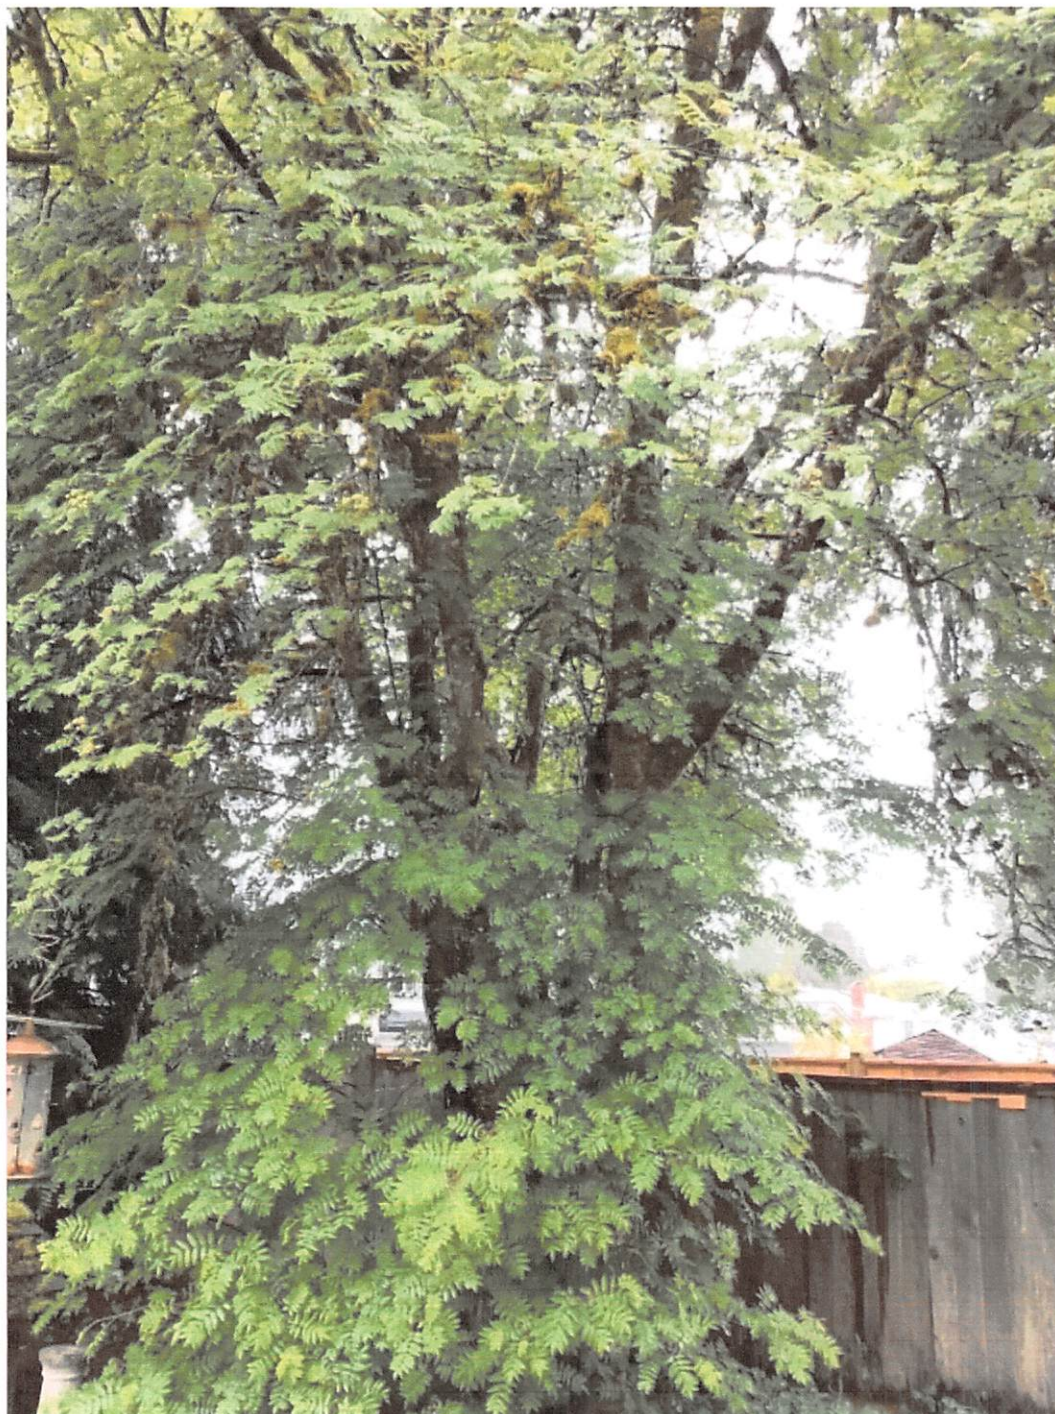
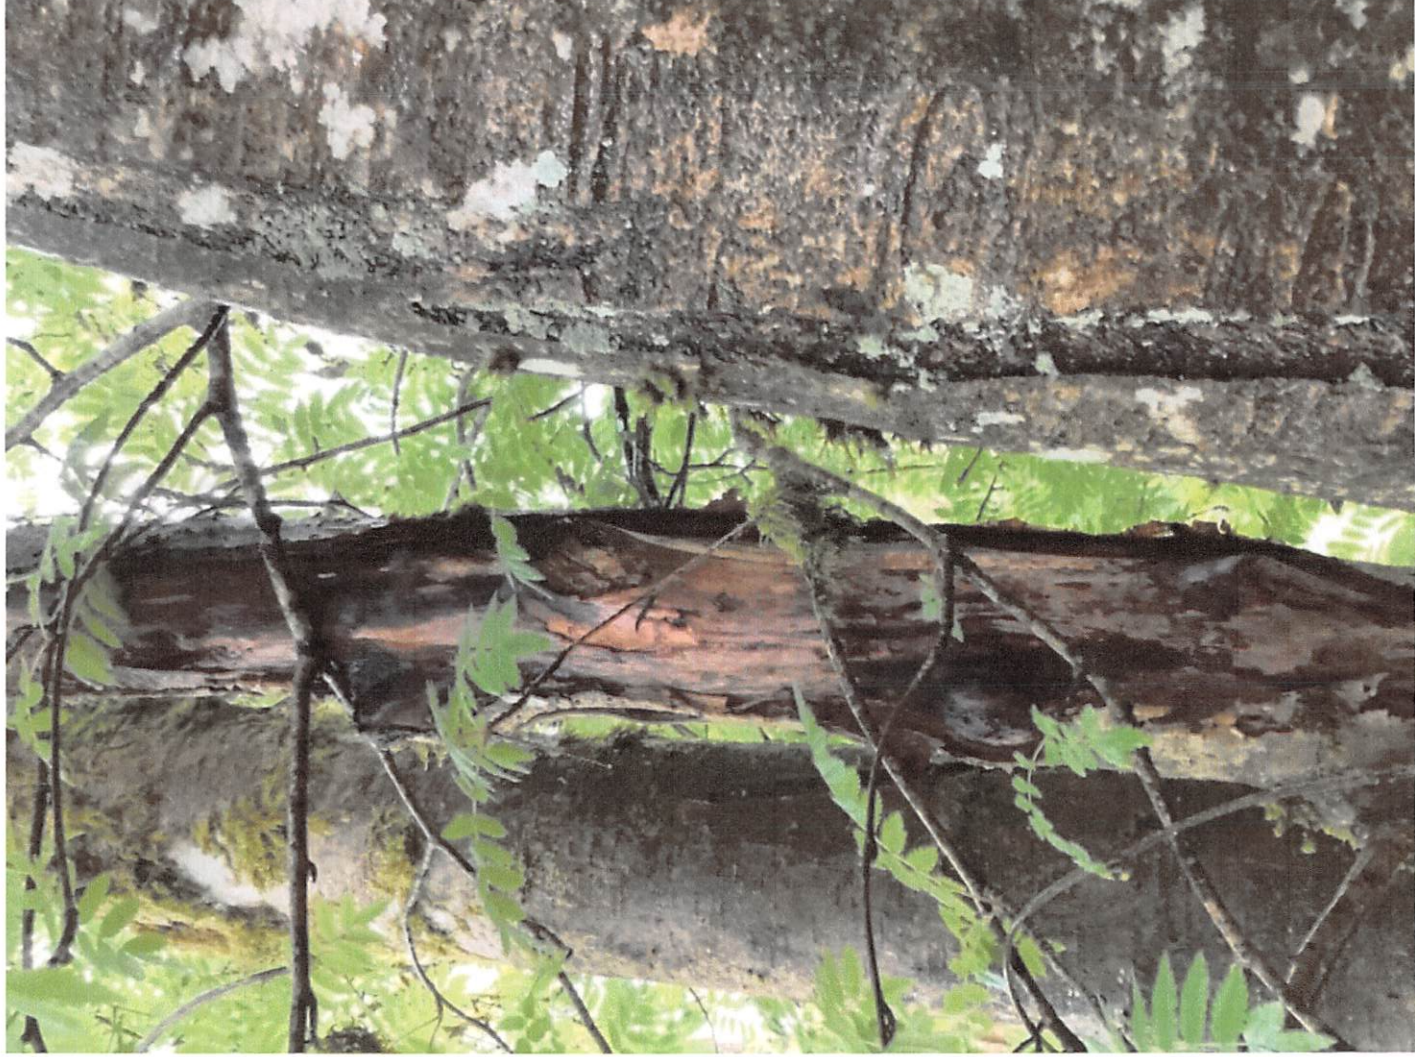
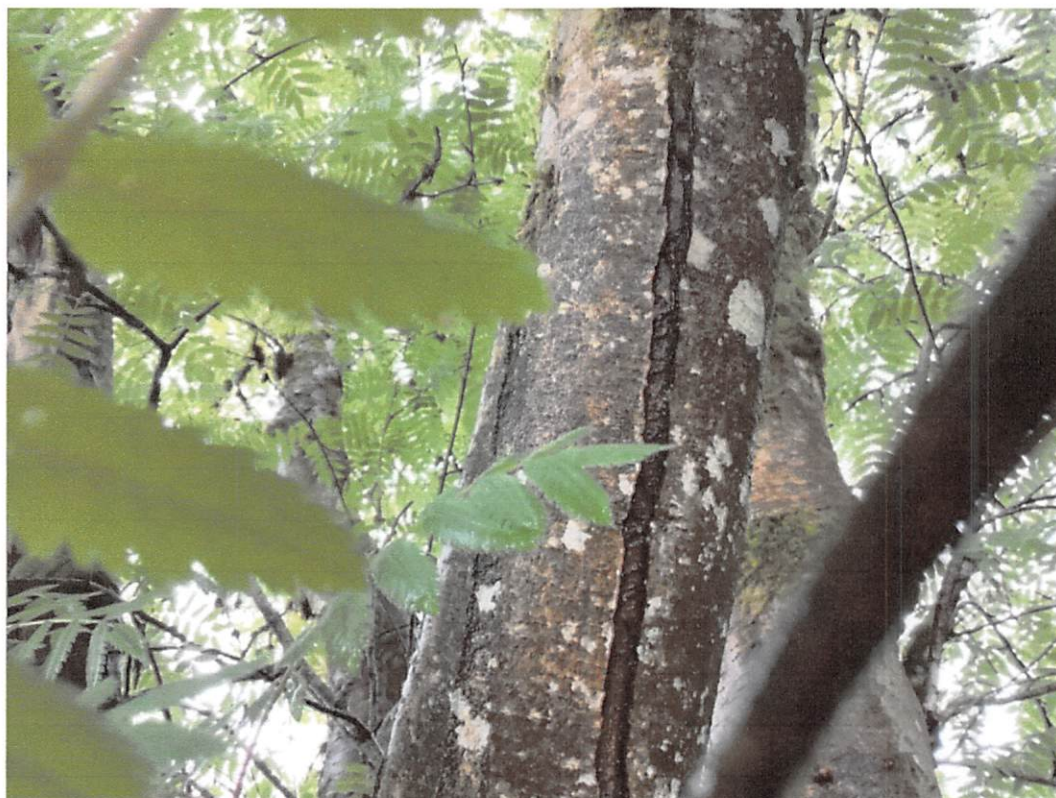
928 Mountain Ash is along the West property line in the rear yard.

- Fair condition.
- Main scaffold branches arise codominantly low on the trunk. Reference Figure 11. The resulting 'V' shaped unions have weak attachments and included bark, putting them at high risk of failure.
- One dead stem is in advanced decay. Reference Figure 12. This is a vector for vertical decay potentially affecting the lower trunk and roots.
- Vertical cracks in the stems. Reference Figure 13. Long term they can cause structural problems or provide an opportunity for decay.
- Critical root zone will be impacted by driveway. Reference Figure 2.

Figure 10: Tree 928

Figure 12: Tree 928 dead stem

Figure 13: Tree 928 vertical crack

Due to structural defects and decay, removal of this Mountain Ash for the proposed construction is appropriate.

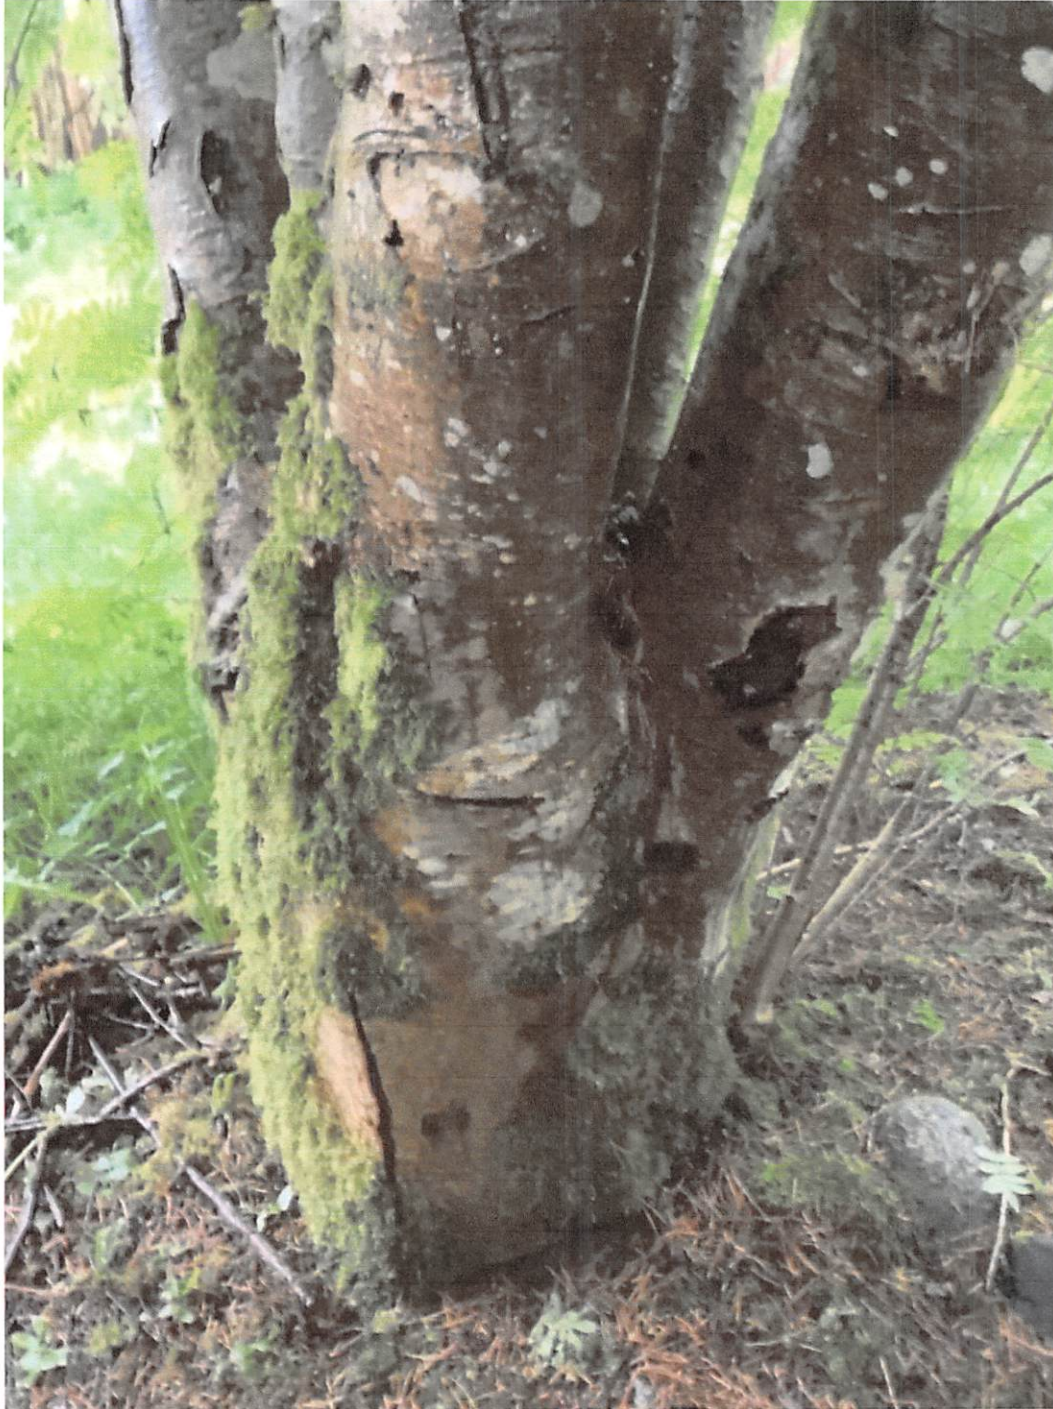
Figure 11: Tree 928 multi-stem trunk

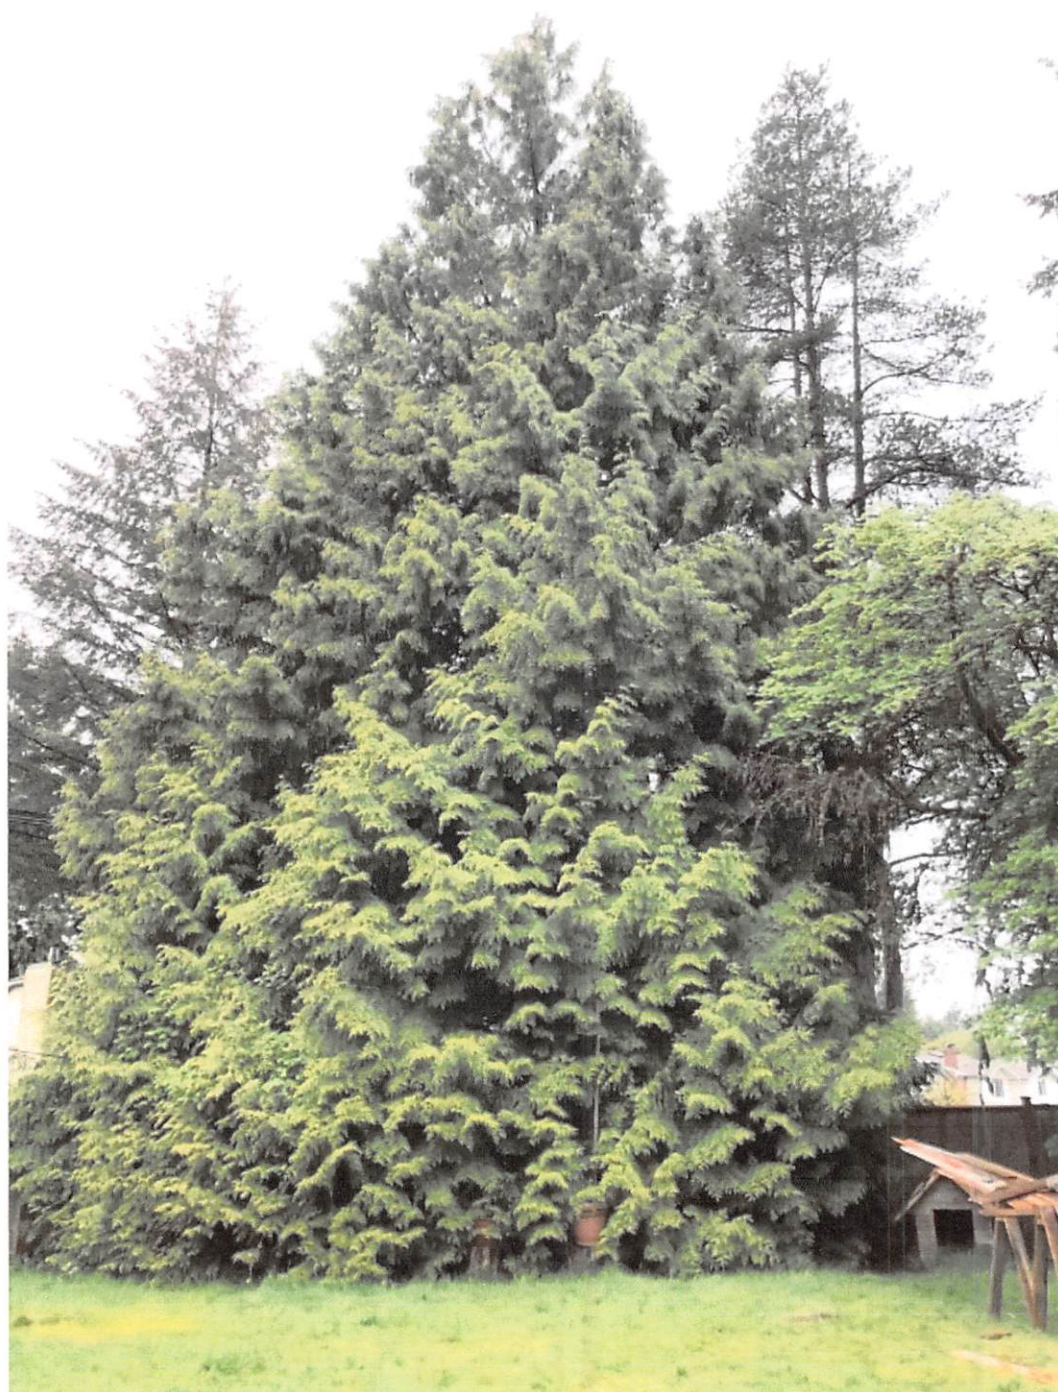
929 Western Red Cedar is on the Southwest corner of the property.

Figure 14: Tree 929

Tree removal may be necessitated due City requirements for setbacks. Tree retention is only possible if the City of Port Coquitlam development requirements, and approved building envelope will accommodate a critical zone of 5.04 metres from the trunk. If tree is to be retained, I recommend pruning, including the removal of the lower buried limbs, and crown raising. Recommended tree protection details are included in the Tree Management and Replacement section.

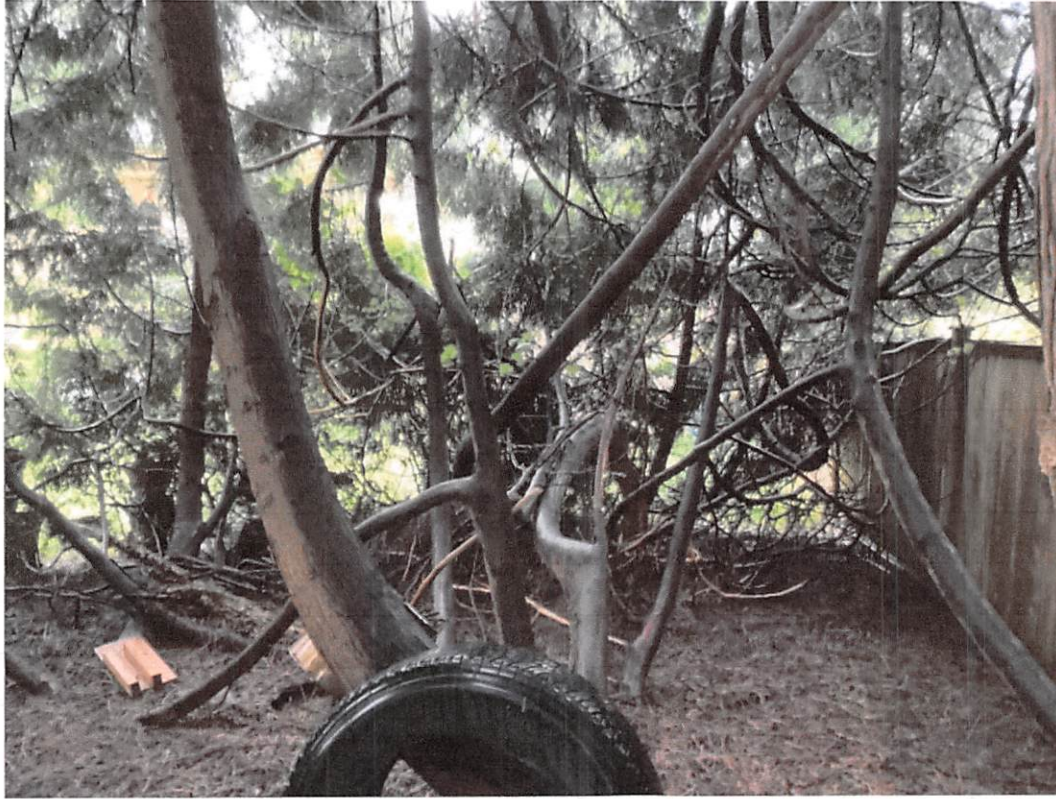
- Fair condition.
- Low lying branches are bowed and contacting the ground. Resulting in multiple off-shoots expanding the dripline. Reference Figure 15.
- Codominant stems arise at the base of the tree. One 'V' shaped union has included bark. One union with stem extending laterally East of the main stem. Reference Figure 16.
- Tree may be impacted by construction, and Southwest corner setback.

Figure 15: Tree 929 noting lower branches in contact with ground.

If the City of Port Coquitlam determines tree 929 Western Red Cedar is to be retained, it shall be pruned according to sound Arboriculture standards. Removal of buried limbs and off-shoots. Crown raised, and limb length reduction to limit interference with roofline of new construction. Upon completion of pruning, Tree protection fencing shall be erected 5.04 metres from the trunk. Reference illustration Figure 18.

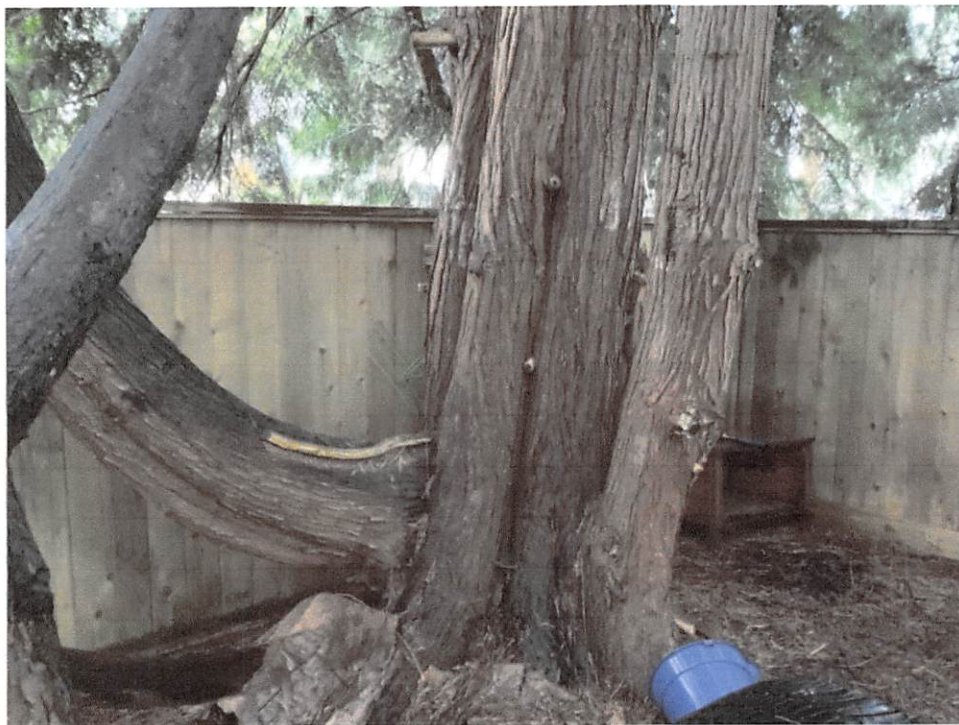
Figure 16: Tree 929 multi-stem trunk

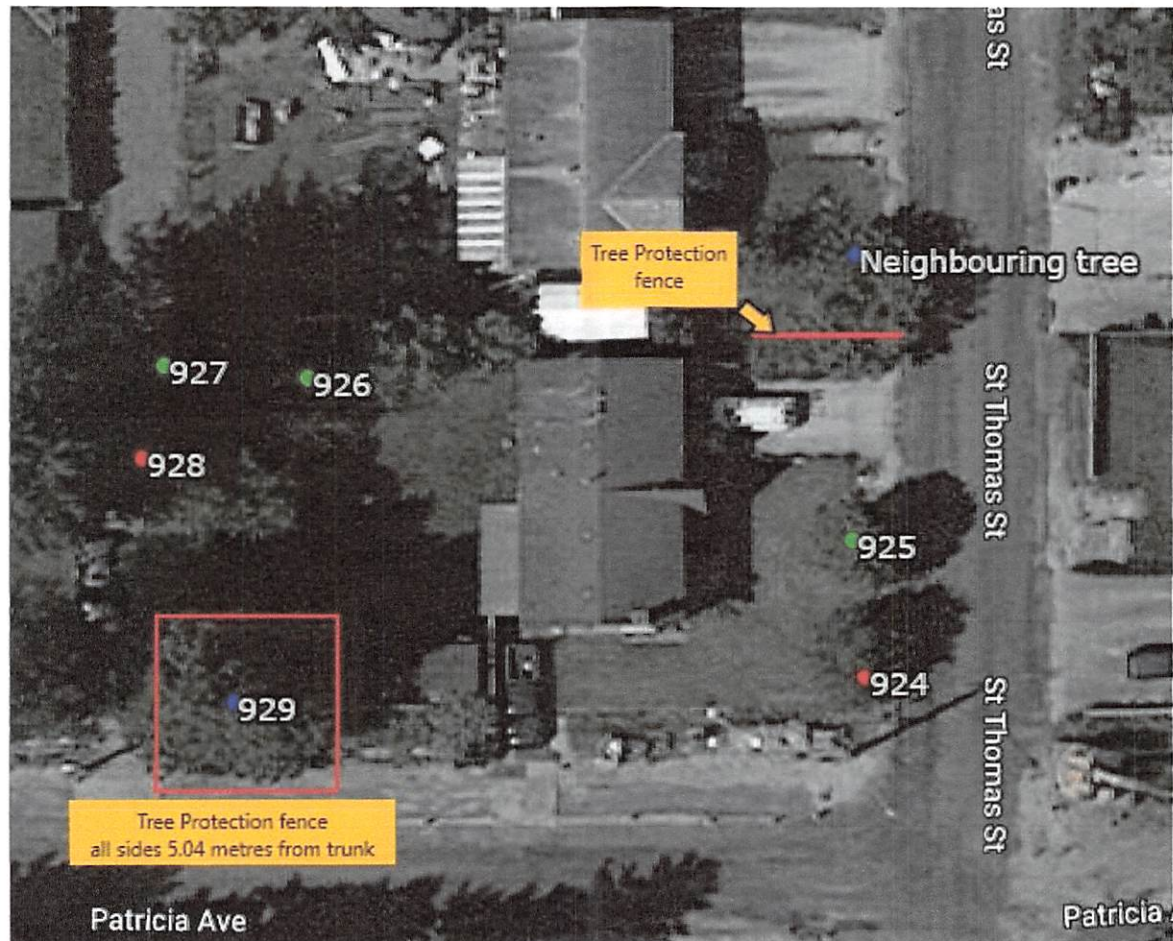
Figure 18: Tree protection zone illustration

For the neighbouring tree to the North, erect Tree Protection fencing along the North property line. Reference illustration Figure 18.
