PHOENIX

Re: Environmental Impact Assessment – 1160 Victoria Drive, Port Coquitlam, B.C.

Phoenix Environmental Services Ltd. (Phoenix) is pleased to present this Environmental Impact Assessment report for the property located at 1160 Victoria Drive in Port Coquitlam (the Site). This report has been updated from an earlier draft report dated March 2019 in order to address the latest plans for the proposed residential subdivision at the Site. The latest plans reflect comments from the City of Port Coquitlam regarding preliminary development concepts as well as through stakeholder consultation (the Hyde Creek Watershed Society). This Environmental Impact Assessment has been carried out to address the City of Port Coquitlam's requirements for a Watercourse Development Permit (Watercourse DP) as specified under Division 10 – Watercourse Protection DPs under the City of Port Coquitlam Development Procedures Bylaw 2001, No. 3296.

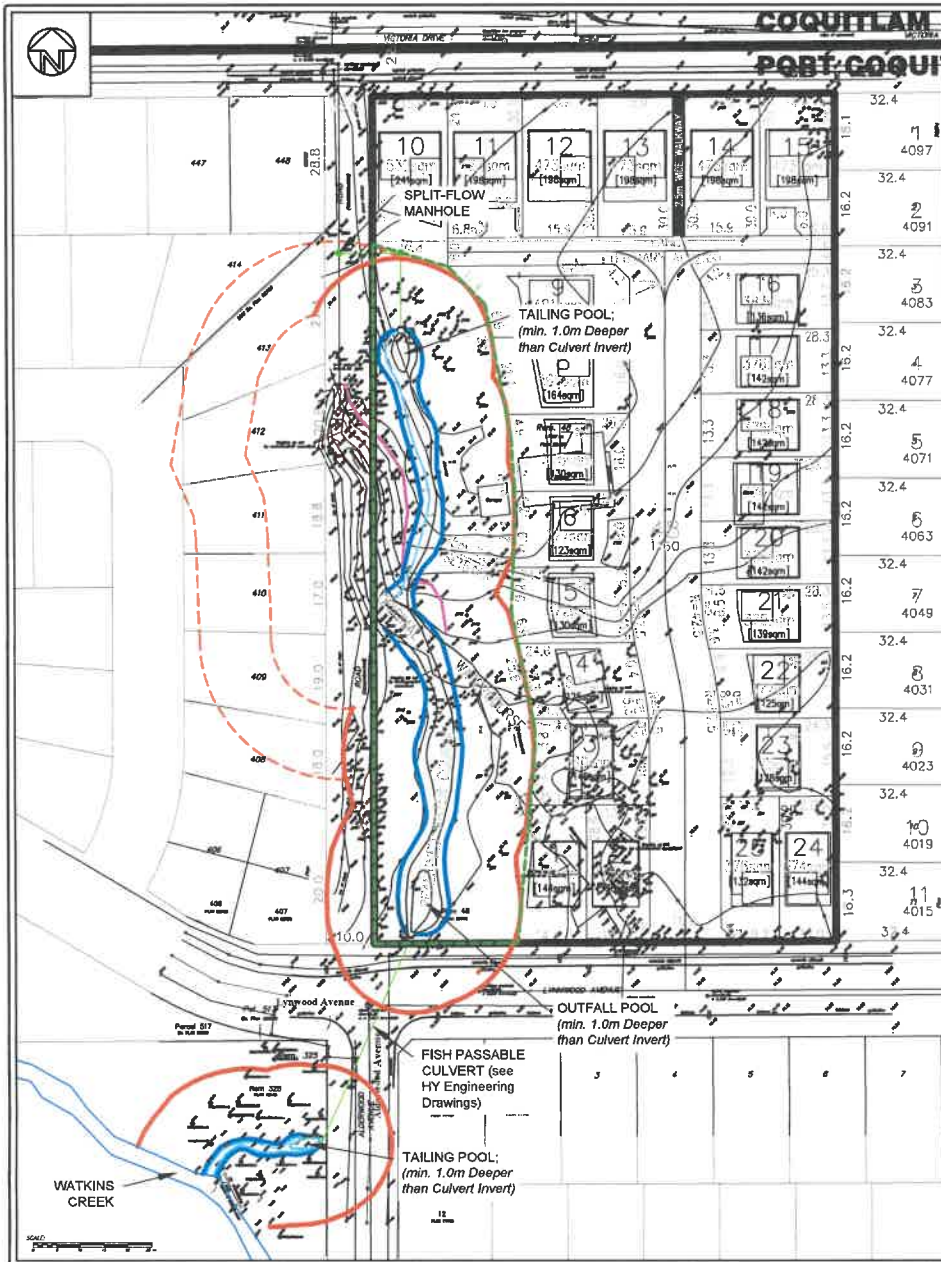
CHANNEL REALIGNMENT & SETBACK MAP

INSET OF TIE-IN TO WATKINS CREEK:

Also presented in Appendix A is the Habitat Balance Map prepared by Phoenix. The Habitat Balance Map has used the existing topographic survey as a base and includes the proposed new roads for the residential development at the Site as part of the map base. As with the Channel Realignment and Setback Map, the Habitat Balance Map shows the proposed new streams at the Site and in the Park outlined in blue. The existing unnamed stream within the ravine and the lower reach that will be eliminated and replaced by the new realigned stream and new stream to the north are outlined in blue and the portions to be lost for the proposed residential lots is shaded in orange hatching. A 15-m streamside setback boundary along the existing stream is shown on the Habitat Balance Map by a bold red line. As it is proposed for the existing and realigned stream to be made fish accessible by extending a new channel west along the south Site boundary to the proposed fish-passable culvert inlet, a 15-m streamside setback has been applied to the existing and realigned stream for the purposes of the Habitat Balance comparison of existing fish habitat losses to proposed fish habitat gains on a quantitative basis (e.g. square metre loss to square metre gain).

On the basis that the City may accept the streamside setback for the southern realigned stream channel extending into the unopened (Newberry St.) road allowance, and relative to the 15-m setback that applies to the new stream to the north of the existing stream, the area outside of the existing stream setback is shown with green hatching on the Habitat Balance Map as added streamside setback area within the proposed park dedication. As noted on the Habitat Balance Map, with the proposed stream realignment and new stream at the Site and proposed residential lot development, the loss of existing riparian fish habitat (1,602 m²) is offset by gains in additional riparian fish habitat (1,891 m²), with a net gain (289 m²) of riparian habitat. The loss of existing wetted stream habitat would be 581 m², is offset by 741 m² of new wetted stream habitat; resulting is net gain of 160 m² of wetted fish habitat under the proposed development plan for the Site. While there will be quantitative net gains in fish habitat, there will also be qualitative gains in fish habitat associated with improved stream channel morphology (e.g. pools and riffles, increased stream depth at low flows) and enhanced streamside vegetation by planting overhanging new shrubs and trees for greater insect drop, leaf litter and shading than is currently provided by the existing stream habitat to be lost to the proposed development.

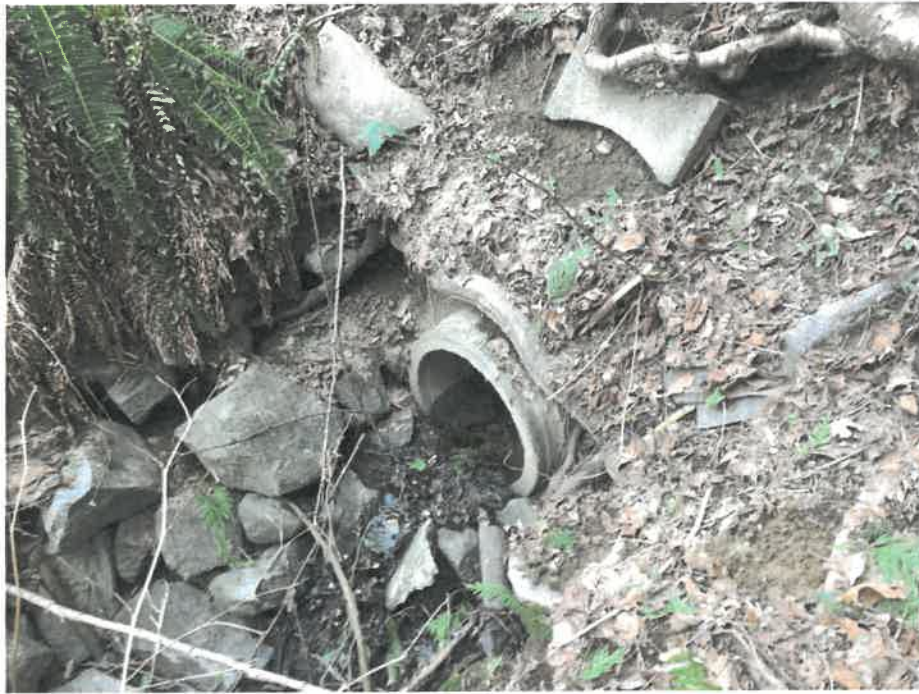
Photo 2: View of the unnamed stream within the ravine adjacent to the Site.

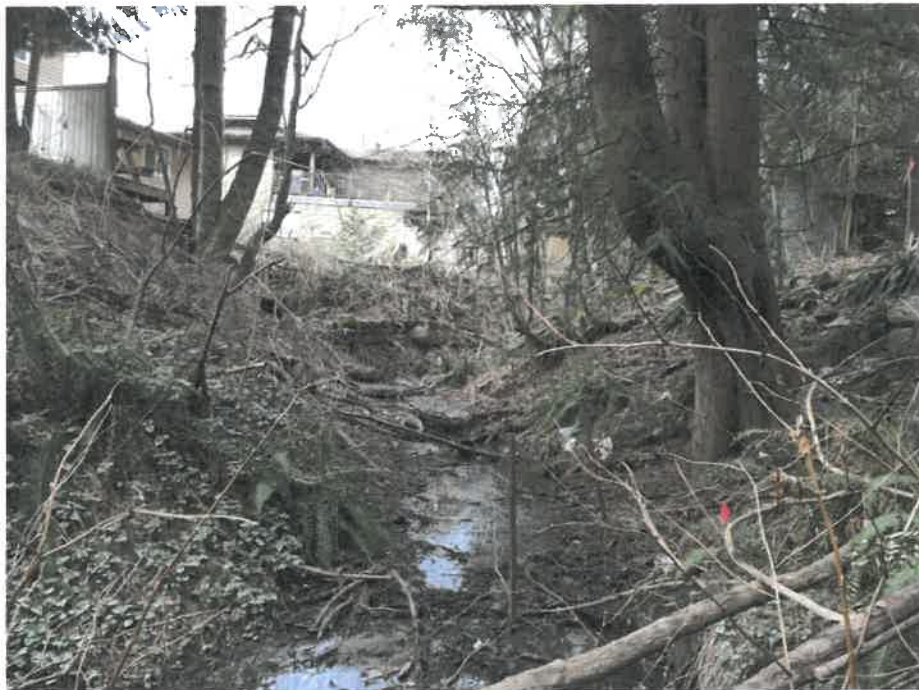
Photo 3: The unnamed stream turns and continues to flow southeast towards the center of the Site. A small gravel bar has formed in front of the boulder.

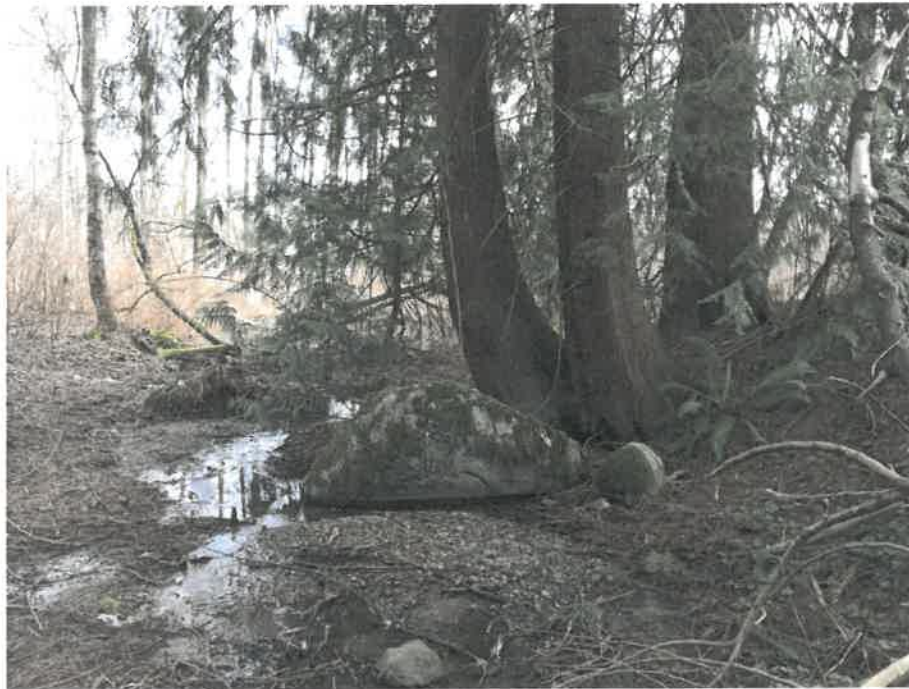
Photo 4: View of the unnamed stream as it flows across the Site. The width of the stream was between 0.5 m to 1.3 m.

The stream top of bank was observed by Phoenix to be between 0.5 m and 1.3 m wide and follows the stream channel, not the bottom of the slope along the east side as is indicated on the Land and Topographic Survey. However, there are two seepage zones adjacent to the stream and the east slope which are delineated as the top of bank on the topographic survey. These low-lying seepage areas are part of the stream and this EIA has applied the surveyed top of banks shown on the topographic survey (Appendix D).

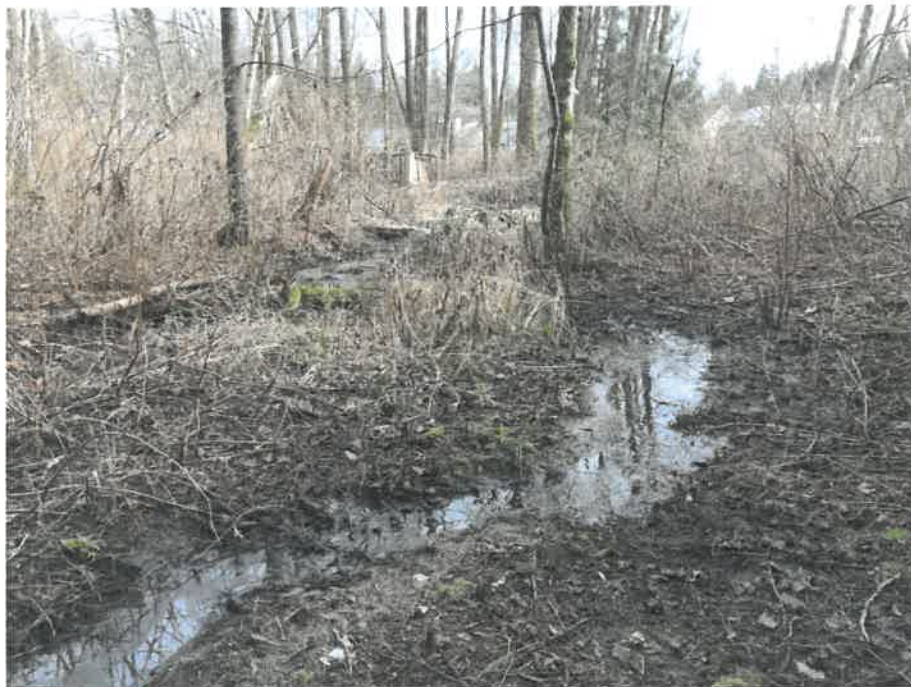
Photo 5: View of the unnamed stream where braiding of the stream was occurring. A tree had fallen into the stream channel which may have changed the flow of the stream. There were groundwater seepages along the toe of the slope in this area contributing to stream flows.

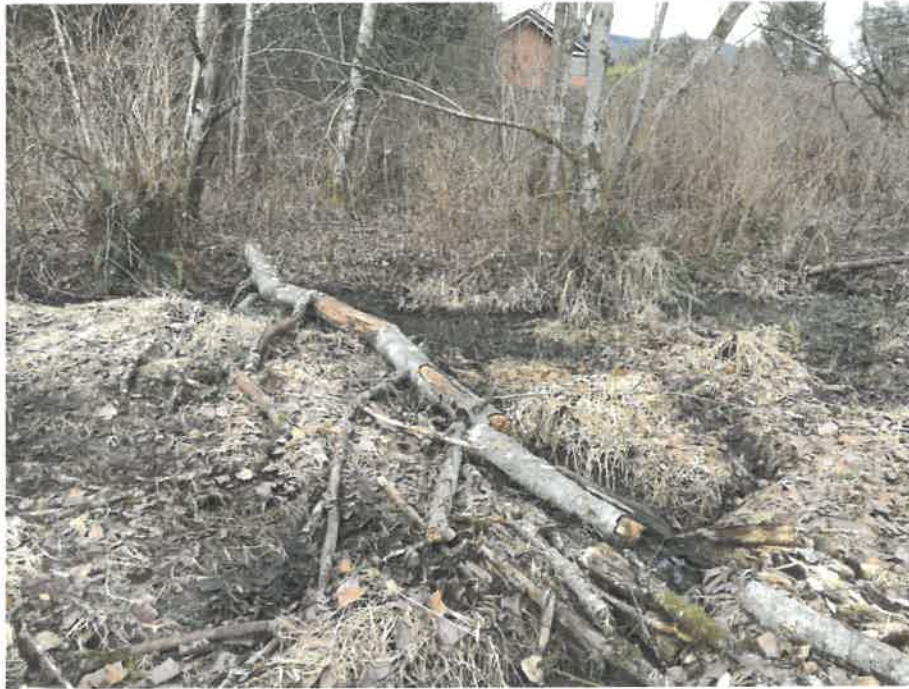
Photo 6: A man-made rock berm was located within the stream channel in between two areas where the stream was braided.

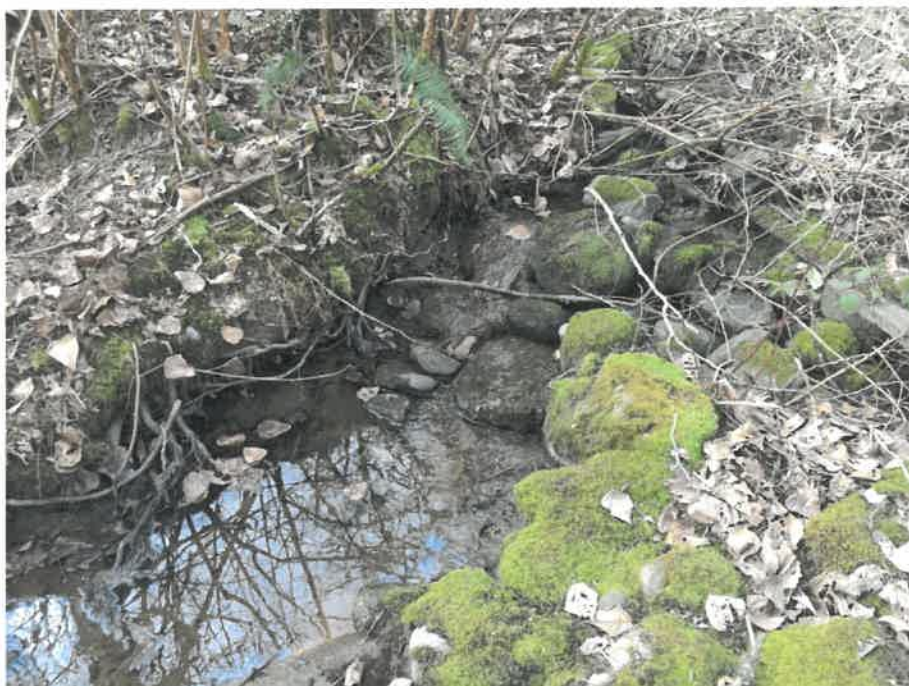
Photo 7: View of the unnamed stream where it becomes braided near the center of the Site. The substrate in this area was siltier with high organic matter.

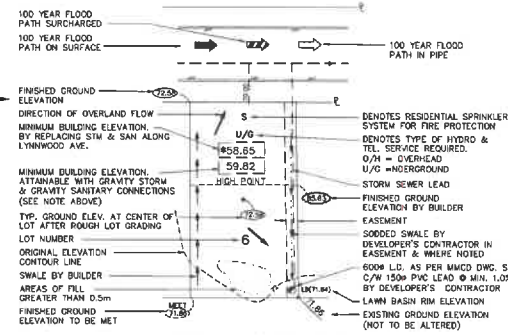
TYPICAL LOT GRADING DETAIL

- CRAWL SPACE DEFINES SPACE BETWEEN FLOOR AND UNDERLYING GROUND. (MAX. HEIGHT 1.50m TO UNDERSIDE JOIST) NOT TO BE USED FOR STORAGE OF GOODS OR EQUIPMENT DAMAGEABLE BY FLOOD WATERS.

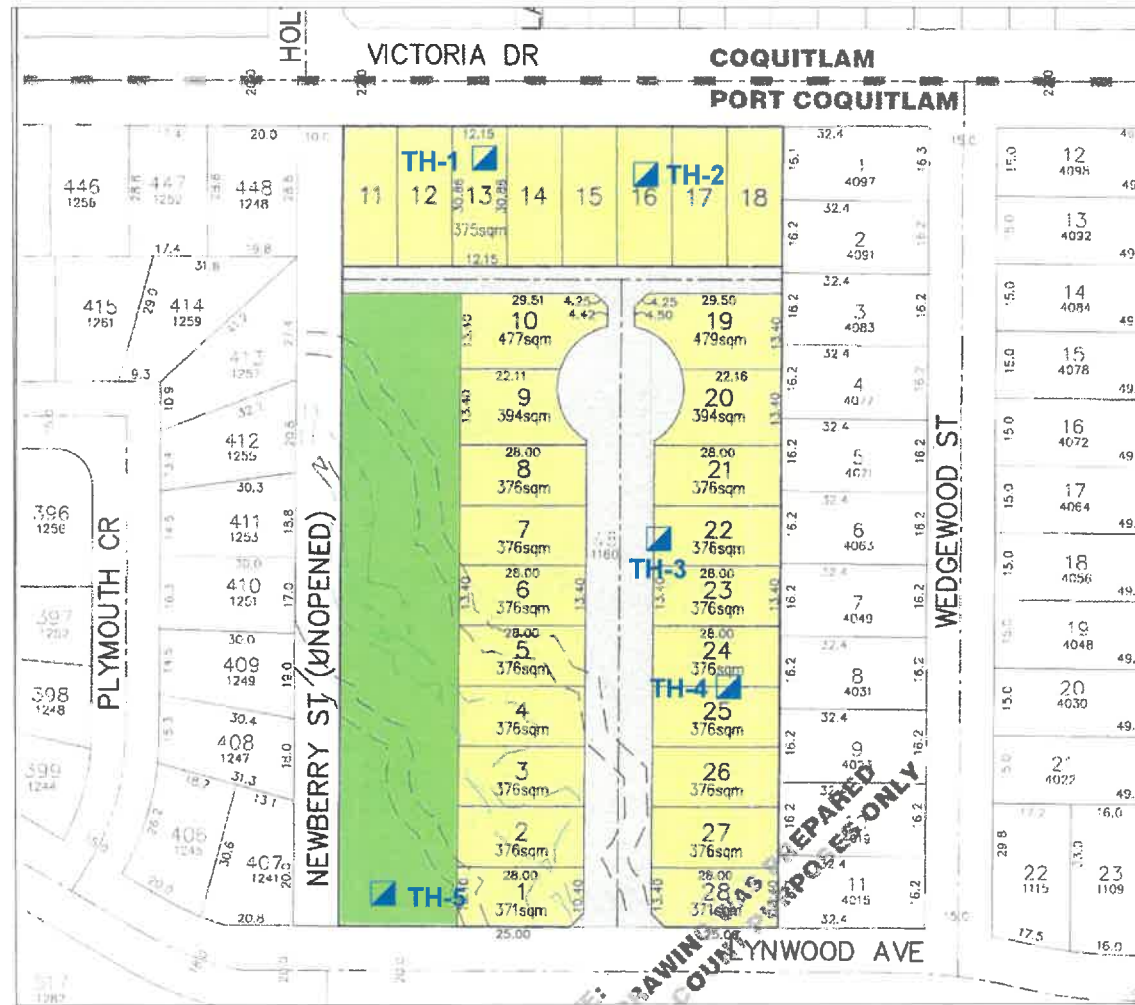
The subsoil investigation was carried out on January 9, 2018. A Cornerstone's geotechnical engineer conducted a geotechnical site assessment and visual inspection on January 12, 2018. Five test holes (TH-1 through TH-5) were excavated using a track-mounted hoe excavator supplied by the client, to a maximum depth of 1.8 m. A Cornerstone's representative laid out the test holes, logged the soil conditions and collected soil samples for laboratory identification. The approximate location of the test holes was recorded using a handheld GPS. The location of the Test Holes (TH) is shown in Figures 2 and 3, attached.
