## **PORT COQUITLAM COMMUNITY CENTRE**

### **Owner's Representative Progress Report #27**

**June 2019**

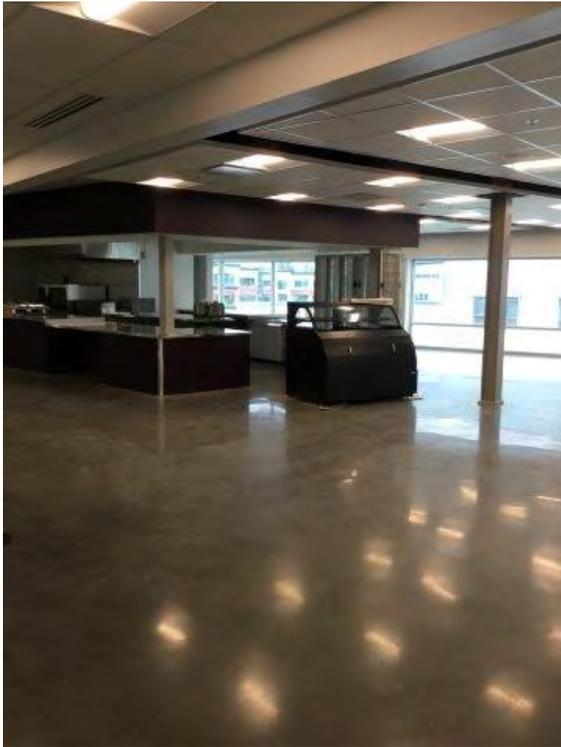
Phase 1A – Concessions

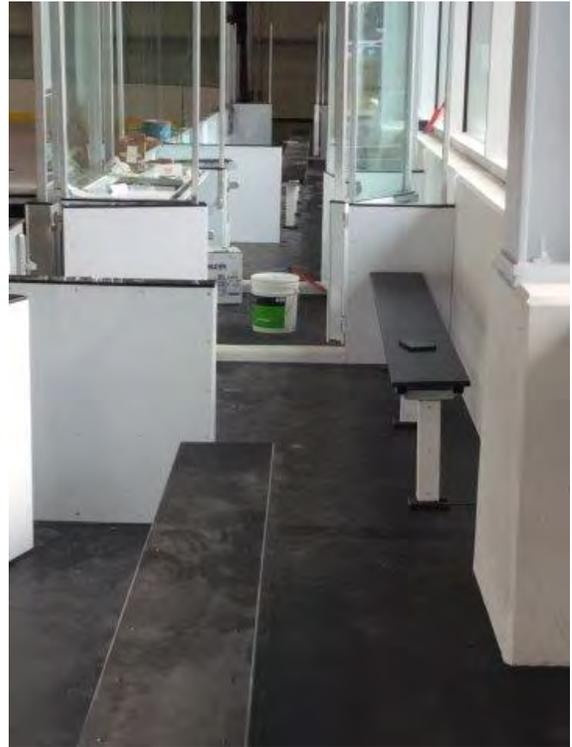
Phase 1A – Rink 2 Players and penalty box

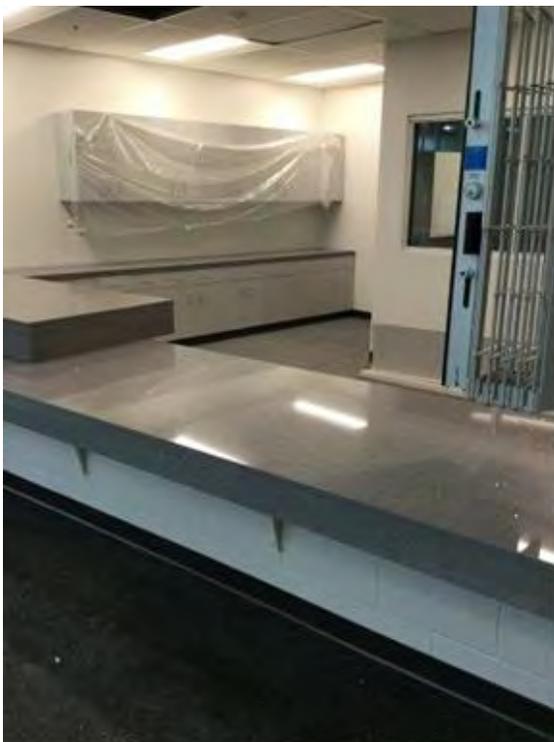
Phase 1A – Stake Lobby service point

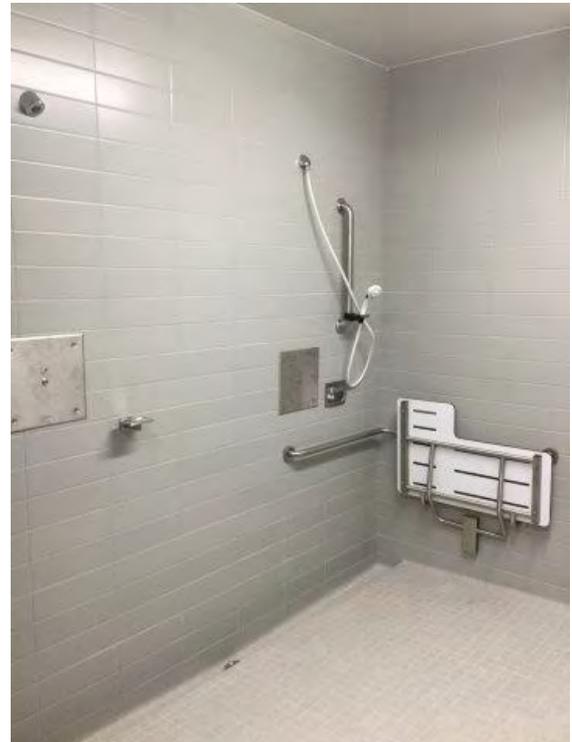
Phase 1A - Changeroom showers & accessibility seating

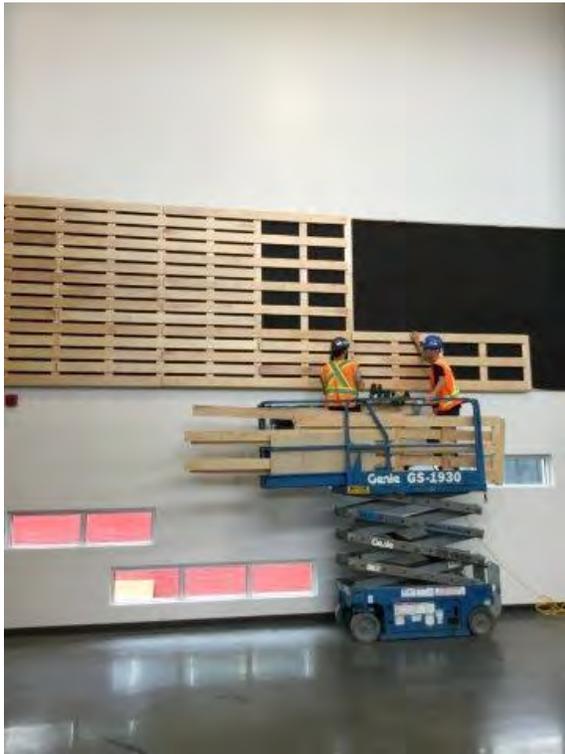
Phase 1B – Wood wall to public corridor

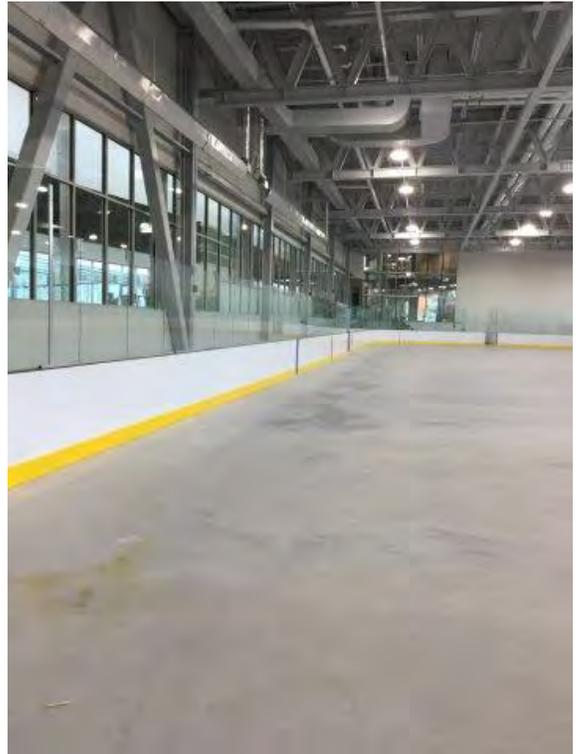
Phase 1B – dasher boards and plexi-glass

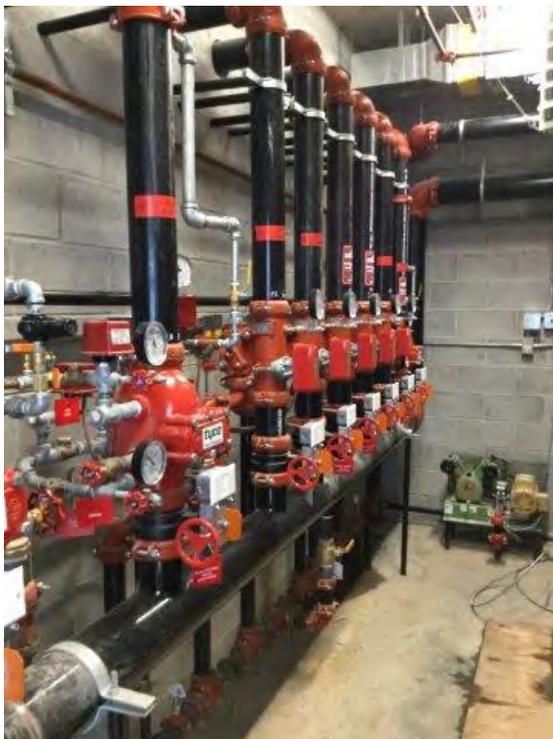
Phase 1B – Sprinkler tree ready for labelling

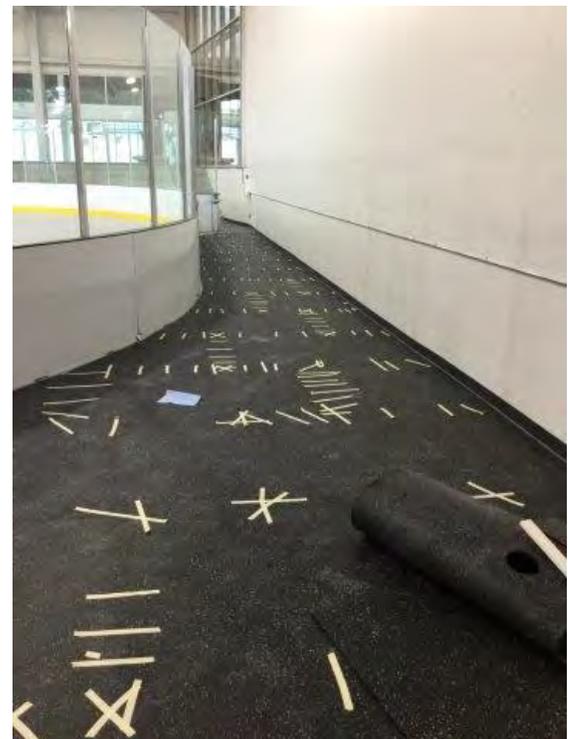
Phase 1B – Rubber skate flooring install

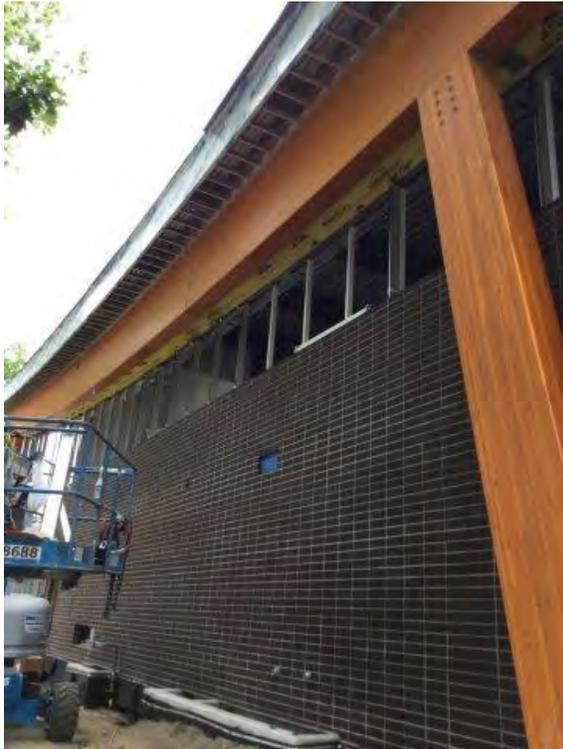
Phase 1C – West elevation glazing

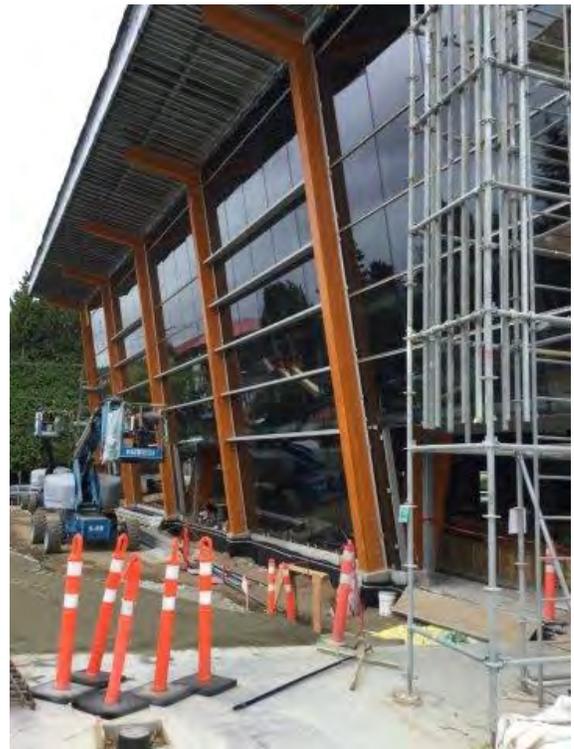
Phase 1C – South elevation glazing

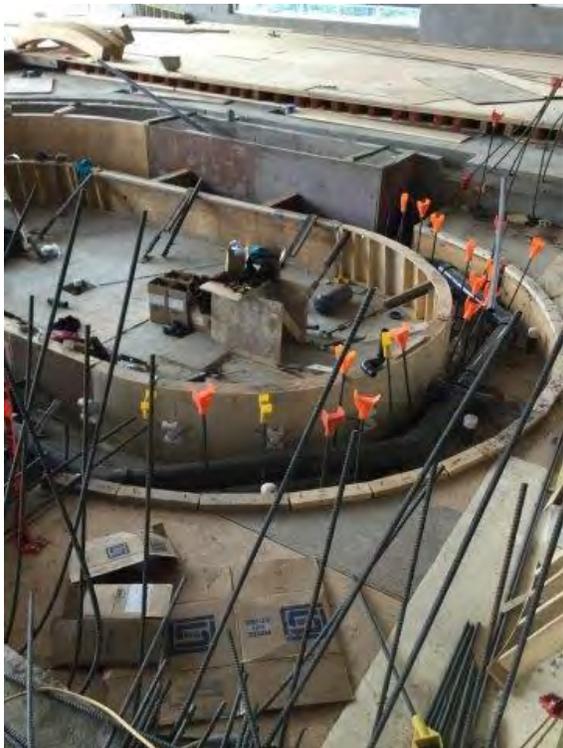
Phase 1C – Hot tub progress

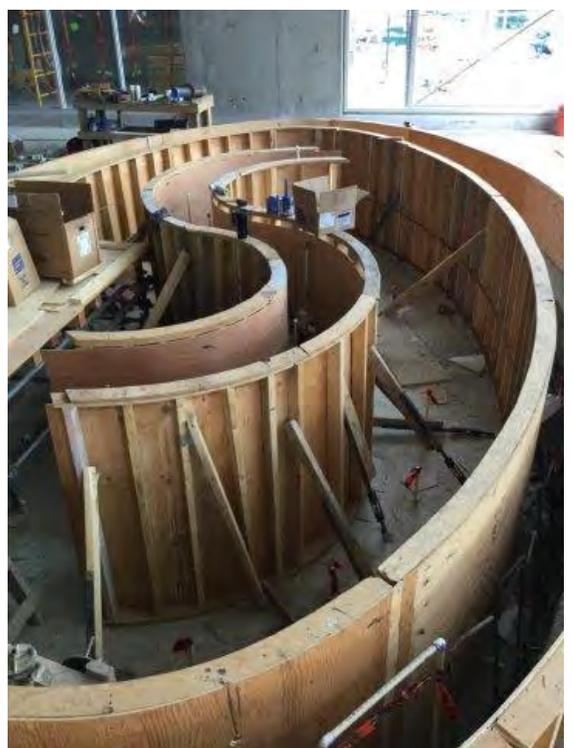
Phase 1C – Lazy river progress

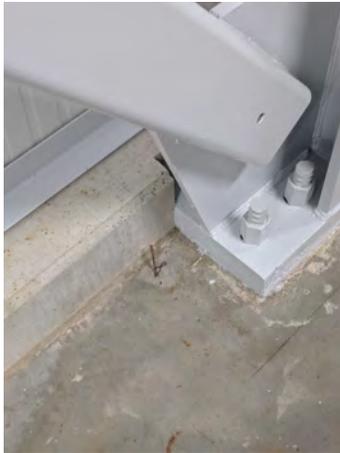
IMG\_20190619\_153521.jpg - Jun 21, 2019 - Adam Chambers

<p><i>Type / Subtype</i> Action Required / Action Required</p> <p><i>Location</i> P1B &gt; Level 1 &gt; 1B110 - STORAGE</p> <p><i>Root Cause</i></p> <p><i>Checklist Source</i></p> <p><i>Reference Drawing</i></p> <p><i>Creator</i> <b>Adam Chambers</b> Architecture49</p> <p><i>Issue Owner</i> <b>Adam Chambers</b> Architecture49</p> <p><i>Assignee</i></p> <p><i>Description</i> Review of room before handover to City. Electrical to be completed and reviewed. Wire and nail to be removed and cleaned up.</p>
---

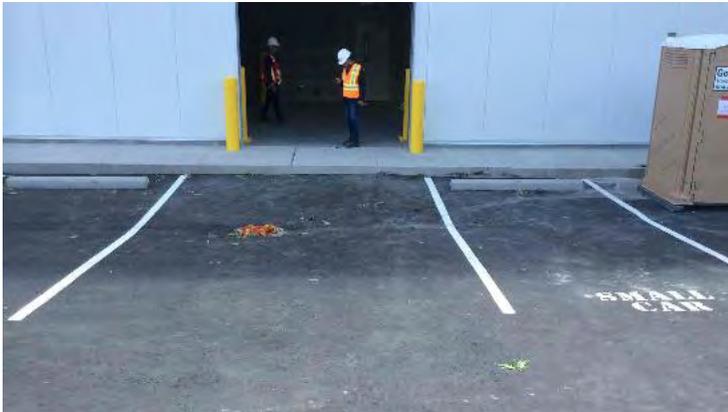
IMG\_156097892875995.jpeg - Jun 19, 2019 - Adam Chambers

<i>Type / Subtype</i> Action Required / Action Required
<i>Location</i> P1B > Exterior > Wall > Rink 3 (Outside 1B106 overhead door.)
<i>Root Cause</i>
<i>Checklist Source</i>
<i>Reference Drawing</i>
<i>Creator</i> <b>Adam Chambers</b> Architecture49
<i>Issue Owner</i> <b>Adam Chambers</b> Architecture49
<i>Assignee</i>
<i>Description</i> Ramp to be provided from sidewalk to parking surface as per A-P1AB-101.

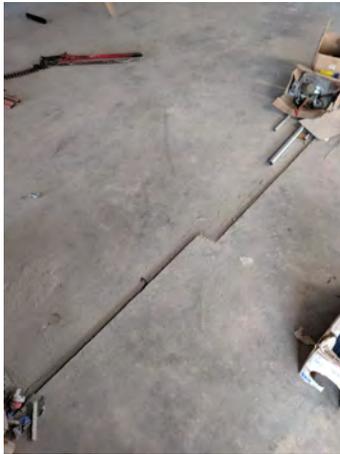
IMG\_20190619\_144634.jpg - Jun 24, 2019 - Adam Chambers

### #52 Small Multipurpose Floor Step

<i>Type / Subtype</i> Action Required / Action Required
<i>Location</i> P1C > Level 2 > 1C220 - SMALL MULTIPURPOSE (Floor)
<i>Root Cause</i>
<i>Checklist Source</i>
<i>Reference Drawing</i>
<i>Creator</i> <b>Adam Chambers</b> Architecture49
<i>Issue Owner</i> <b>Adam Chambers</b> Architecture49
<i>Assignee</i>
<i>Description</i> Step in concrete floor in the small multipurpose room to be corrected.

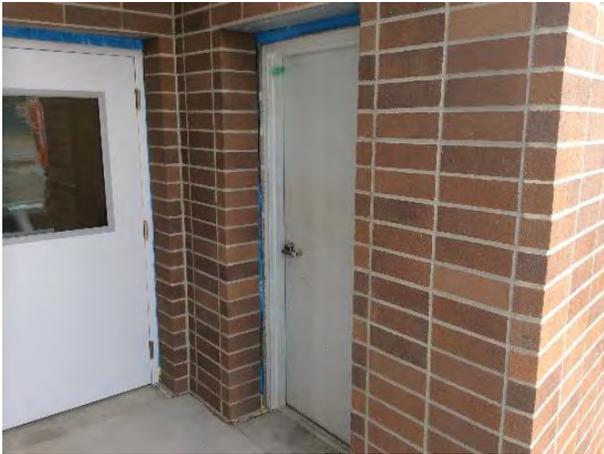
IMG\_0403.JPG - Jun 24, 2019 - Adam Chambers

### #55 Water Entry Room Door

<i>Type / Subtype</i> Action Required / Action Required
<i>Location</i> P1B > Level 1 > 1B113 - WATER ENTRY (Exterior door to room.)
<i>Root Cause</i>
<i>Checklist Source</i>
<i>Reference Drawing</i>
<i>Creator</i> <b>Adam Chambers</b> Architecture49
<i>Issue Owner</i> <b>Adam Chambers</b> Architecture49
<i>Assignee</i>
<i>Description</i> Flashing to be installed to cover AVB and masonry cavity.

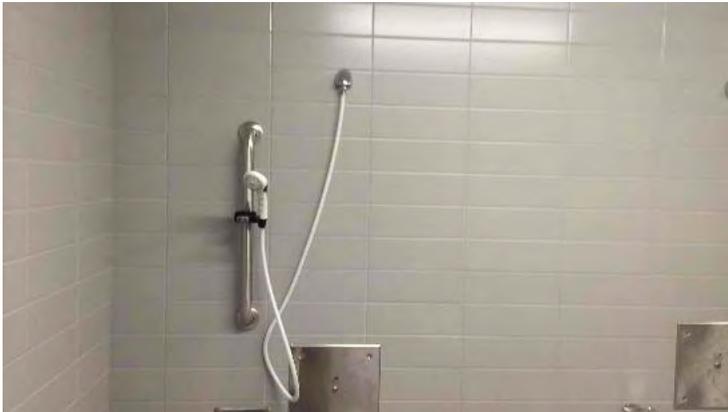
IMG\_156097840958815.jpeg - Jun 19, 2019 - Adam Chambers

#30 Standard showerhead missing.

<i>Type / Subtype</i> Action Required / Action Required
<i>Location</i> P1AB Hockey Changerooms
<i>Root Cause</i>
<i>Checklist Source</i>
<i>Reference Drawing</i>
<i>Creator</i> <b>Adam Chambers</b> Architecture49
<i>Issue Owner</i> <b>Adam Chambers</b> Architecture49
<i>Assignee</i>
<i>Description</i>

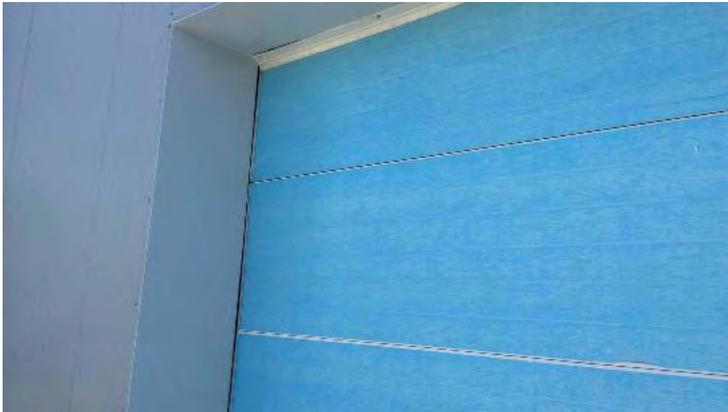
IMG\_156097825326610.jpeg - Jun 19, 2019 - Adam Chambers

<i>Type / Subtype</i>	Action Required / Action Required
<i>Location</i>	P1A > Exterior > Wall > Rink 2 (East Side)
<i>Root Cause</i>	
<i>Checklist Source</i>	
<i>Reference Drawing</i>	
<i>Creator</i>	<b>Adam Chambers</b> Architecture49
<i>Issue Owner</i>	<b>Adam Chambers</b> Architecture49
<i>Assignee</i>	
<i>Description</i>

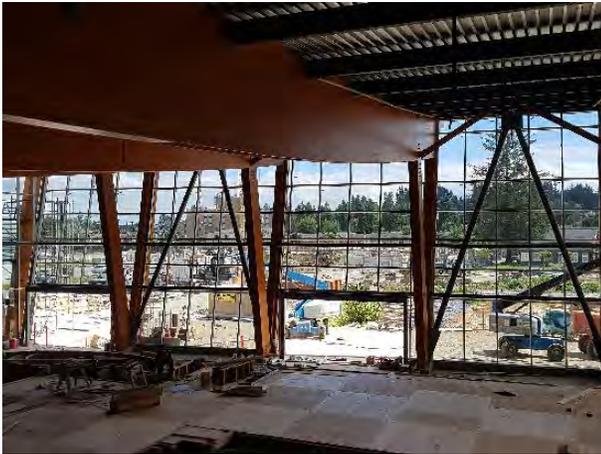
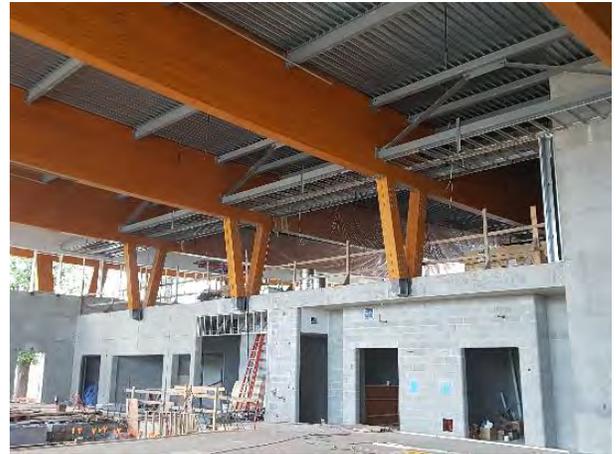
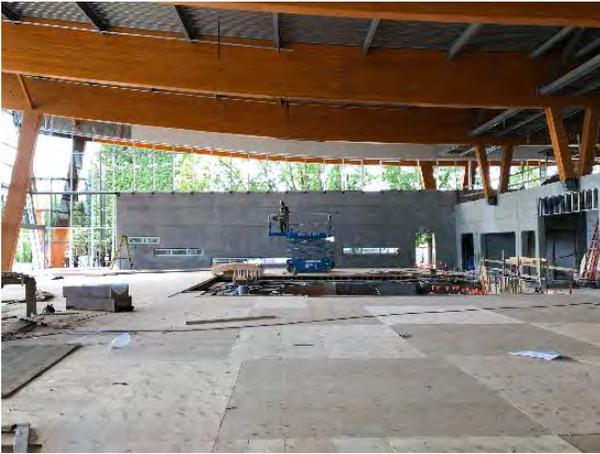
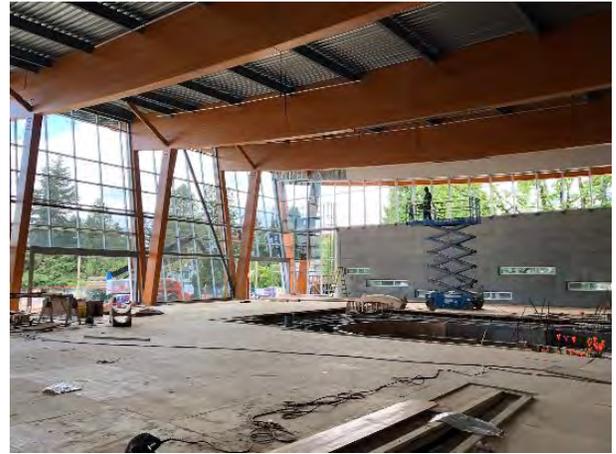
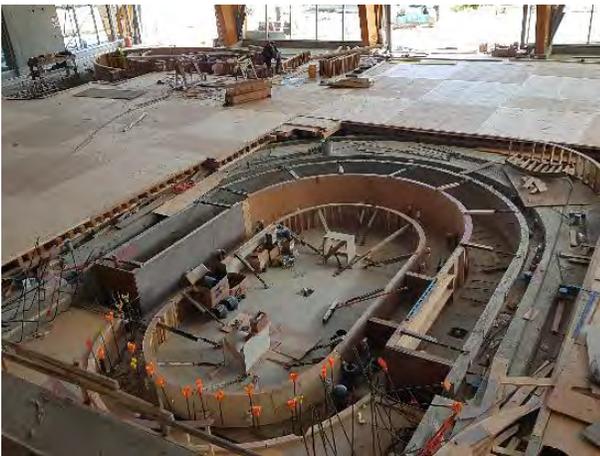
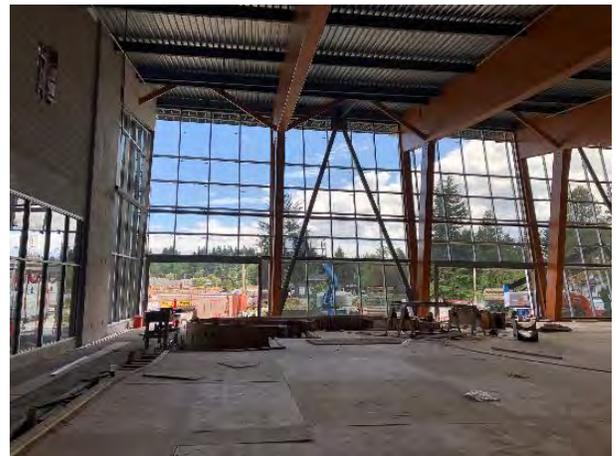
### #48 Pool Progress

<i>Type / Subtype</i> Observation / Observation
<i>Location</i> P1C > Level 1 > 1C139 - POOL
<i>Root Cause</i>
<i>Checklist Source</i>
<i>Reference Drawing</i>
<i>Creator</i> <b>Adam Chambers</b> Architecture49
<i>Issue Owner</i> <b>Adam Chambers</b> Architecture49
<i>Assignee</i>
<i>Description</i> Progress of the pool and natatorium construction.

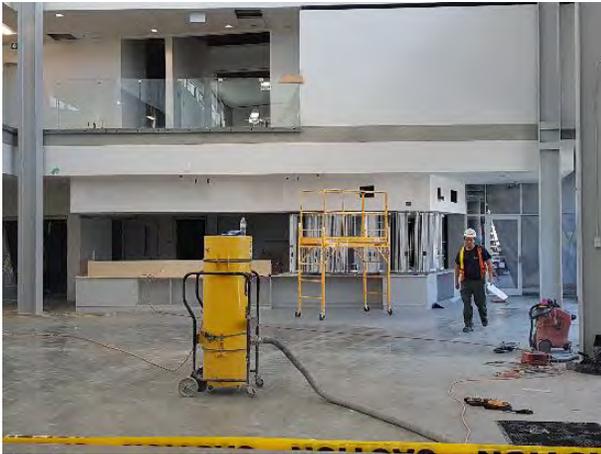
20190619\_123658.jpg - Jun 24, 2019 - Adam Chambers

### #47 Main Entry / Reception Progress

<i>Type / Subtype</i> Observation / Observation
<i>Location</i> P1C > Level 1 > 1C117 - RECEPTION
<i>Root Cause</i>
<i>Checklist Source</i>
<i>Reference Drawing</i>
<i>Creator</i> <b>Adam Chambers</b> Architecture49
<i>Issue Owner</i> <b>Adam Chambers</b> Architecture49
<i>Assignee</i>
<i>Description</i> Progress of of the main entry and reception area.

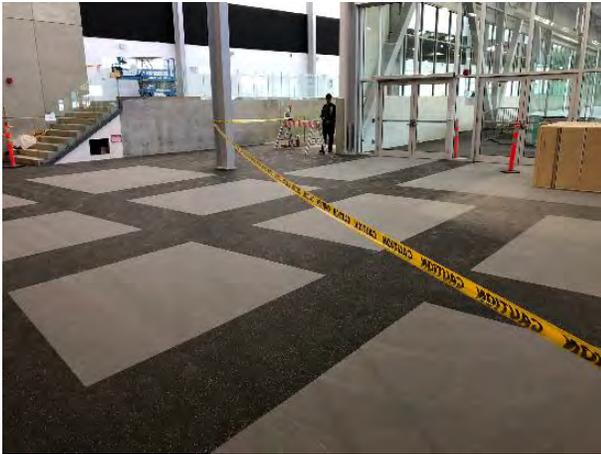
IMG\_1673.JPEG - Jun 24, 2019 - Adam Chambers

<i>Type / Subtype</i> Observation / Observation
<i>Location</i> P1B > Level 1 > 1B121 - SKATE LOBBY
<i>Root Cause</i>
<i>Checklist Source</i>
<i>Reference Drawing</i>
<i>Creator</i> <b>Adam Chambers</b> Architecture49
<i>Issue Owner</i> <b>Adam Chambers</b> Architecture49
<i>Assignee</i>
<i>Description</i> Progress of the Skate lobby flooring.

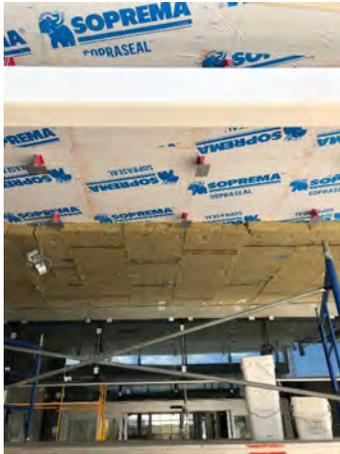
IMG\_1685.JPEG - Jun 24, 2019 - Adam Chambers

### #49 AVB and Insulation Progress outside South Entry

<i>Type / Subtype</i> Observation / Observation
<i>Location</i> P1C > Exterior > Wall > Party Room/Entry (Soffit outside 1C144)
<i>Root Cause</i>
<i>Checklist Source</i>
<i>Reference Drawing</i>
<i>Creator</i> <b>Adam Chambers</b> Architecture49
<i>Issue Owner</i> <b>Adam Chambers</b> Architecture49
<i>Assignee</i>
<i>Description</i> Progress of the AVB and Insulation.

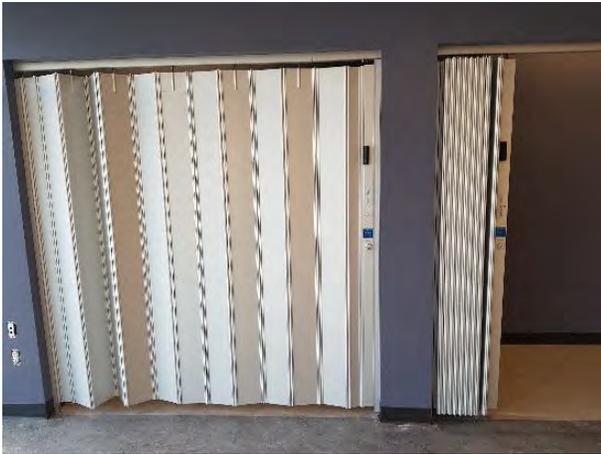
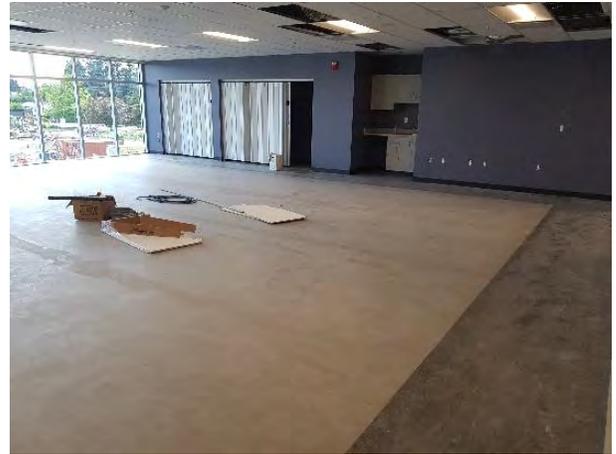
### #53 Multipurpose Room Progress

<i>Type / Subtype</i> Observation / Observation
<i>Location</i> P1C > Level 2 > 1C217 - MEDIUM MULTIPURPOSE 2
<i>Root Cause</i>
<i>Checklist Source</i>
<i>Reference Drawing</i>
<i>Creator</i> <b>Adam Chambers</b> Architecture49
<i>Issue Owner</i> <b>Adam Chambers</b> Architecture49
<i>Assignee</i>
<i>Description</i> Progress of the Multipurpose rooms.

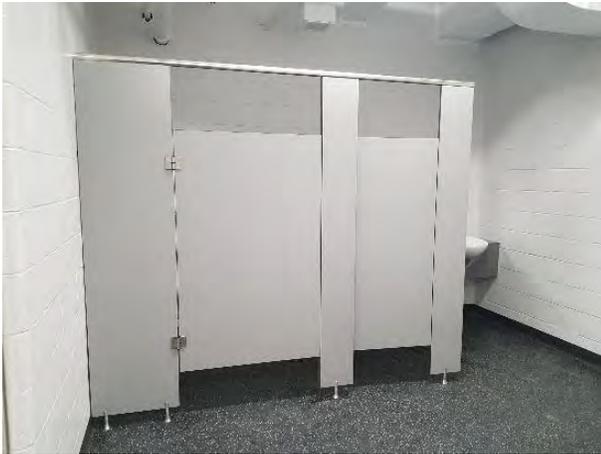
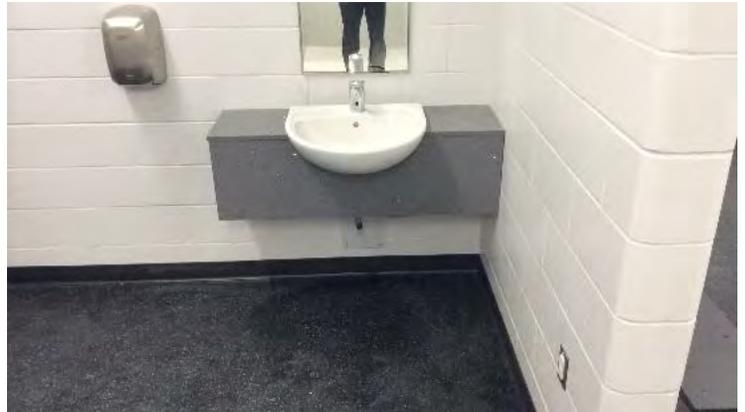
### #54 Hockey Changeroom Progress

<p><i>Type / Subtype</i> Observation / Observation</p> <p><i>Location</i></p> <p><i>Root Cause</i></p> <p><i>Checklist Source</i></p> <p><i>Reference Drawing</i></p> <p><i>Creator</i> <b>Adam Chambers</b> Architecture49</p> <p><i>Issue Owner</i> <b>Adam Chambers</b> Architecture49</p> <p><i>Assignee</i></p> <p><i>Description</i> Progress of the hockey changeroom fixture installation.</p>
--

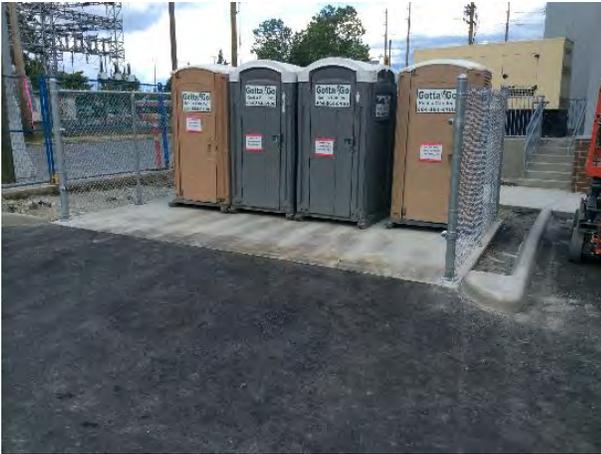
IMG\_0401.JPG - Jun 24, 2019 - Adam Chambers

### #56 Temporary Garbage Enclosure Progress

<p><i>Type / Subtype</i> Observation / Observation</p> <p><i>Location</i></p> <p><i>Root Cause</i></p> <p><i>Checklist Source</i></p> <p><i>Reference Drawing</i></p> <p><i>Creator</i> <b>Adam Chambers</b> Architecture49</p> <p><i>Issue Owner</i> <b>Adam Chambers</b> Architecture49</p> <p><i>Assignee</i></p> <p><i>Description</i> Garbage enclosure slab and fence progress.</p>
---

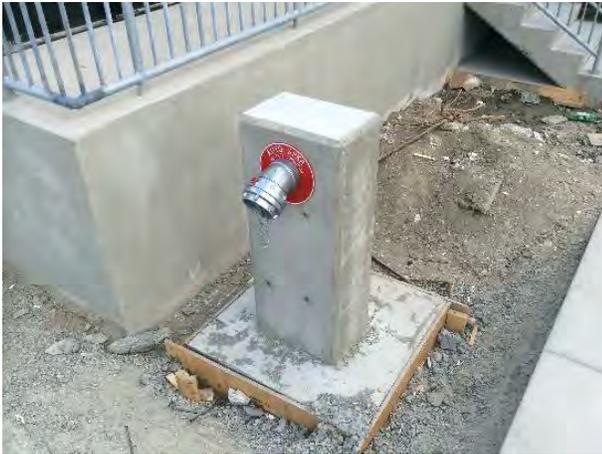
IMG\_0402.JPG - Jun 24, 2019 - Adam Chambers

### #57 P1AB Fire Department Connection

<p><i>Type / Subtype</i> Observation / Observation</p> <p><i>Location</i></p> <p><i>Root Cause</i></p> <p><i>Checklist Source</i></p> <p><i>Reference Drawing</i></p> <p><i>Creator</i> <b>Adam Chambers</b> Architecture49</p> <p><i>Issue Owner</i> <b>Adam Chambers</b> Architecture49</p> <p><i>Assignee</i></p> <p><i>Description</i> Progress of the P1AB fire department connection.</p>
---

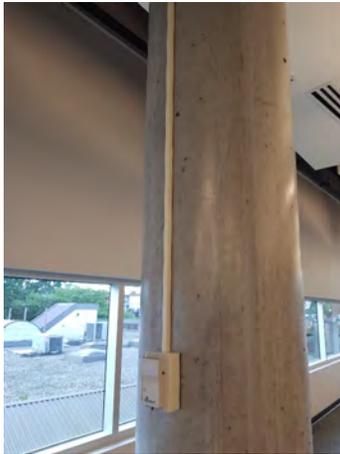
20190619\_141958.jpg - Jun 24, 2019 - Adam Chambers

<p><i>Type / Subtype</i> Observation / Observation</p> <p><i>Location</i> P1B &gt; Level 2 &gt; 1B273 - PUBLIC INTERNET AREA</p> <p><i>Root Cause</i></p> <p><i>Checklist Source</i></p> <p><i>Reference Drawing</i></p> <p><i>Creator</i> <b>Adam Chambers</b> Architecture49</p> <p><i>Issue Owner</i> <b>Adam Chambers</b> Architecture49</p> <p><i>Assignee</i></p> <p><i>Description</i> Paint exposed wiremold in library colour, Rand Moon.</p>
--

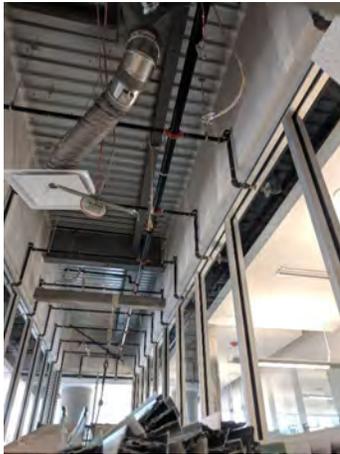
IMG\_20190619\_141817.jpg - Jun 21, 2019 - Adam Chambers

### #37 Stair 4 Fire Rated Bulkhead

<p><i>Type / Subtype</i> Observation / Observation</p> <p><i>Location</i> P1B &gt; Level 2 &gt; ST04 - STAIR 4 (Bulkhead above Glazing)</p> <p><i>Root Cause</i></p> <p><i>Checklist Source</i></p> <p><i>Reference Drawing</i></p> <p><i>Creator</i> <b>Adam Chambers</b> Architecture49</p> <p><i>Issue Owner</i> <b>Adam Chambers</b> Architecture49</p> <p><i>Assignee</i></p> <p><i>Description</i> Fire Rated bulkhead assembly appears complete around staircase.</p>
--

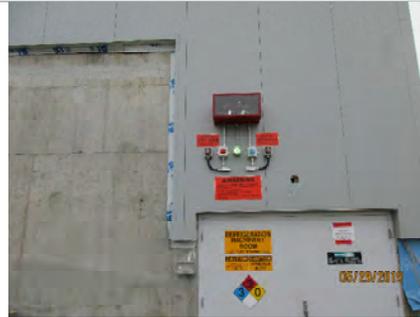
Photo #2: Ammonia Detector Lights

3. Mechanical and plumbing components to-date installed as per contract documents.
4. Ammonia detector lights and switches are installed on building exterior [photo #2]

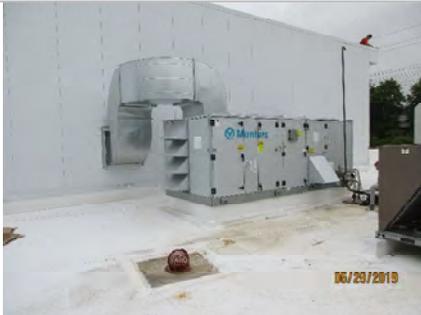
18. ~~Phase 1C – No HVAC is installed in Level 2 west of grid line IC-7 (photo #14)~~
19. Dehumidifier DH-1, Condenser CON-1, and HRV-2 are installed (photo #3, 4, 5)

Photo #3: Dehumidifier DH-1

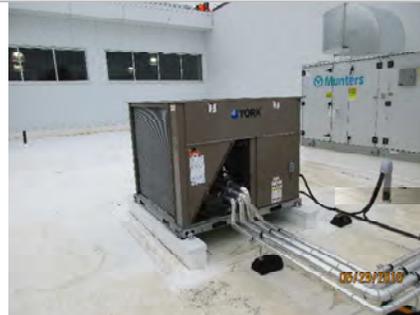
Photo #4: Condenser CON-1

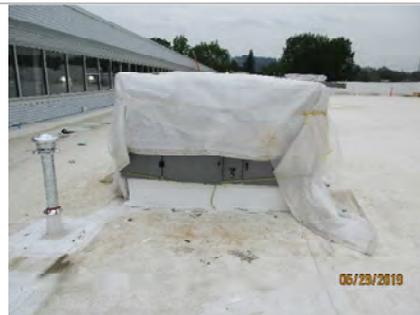
Photo #6: Rooftop RTU-1

20. Rooftop unit RTU-1 is in place. However, damages during delivery have occurred (photo #6)
21. Fireplace exhaust and EF-43 are installed (photo #7)
22. Supply fan SF-5 is installed (photo #8)

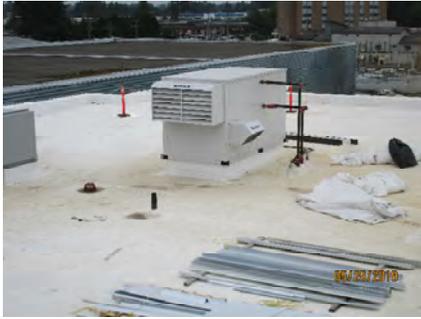
Photo #9: HRV-6

23. HRV-4, HRV-6, RTU-2, EF-28 are installed (photo #9, 10, 11)
24. Pool dehumidification DH-4 is installed with no ductwork (photo #12)
25. Main ducts and heat pumps are installed in Level 1C (photo #14)

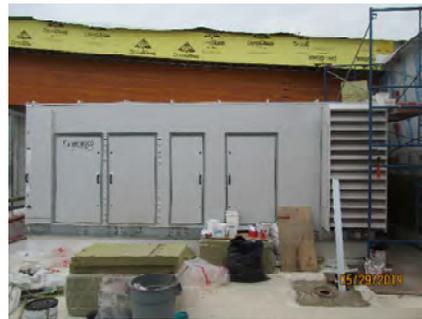
Photo #11: RTU-2, EF-28

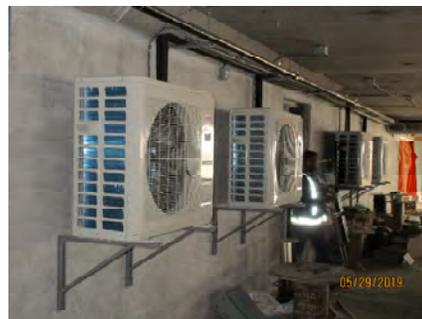
Photo #15 - HRV-2A

26. Heat Recovery Unit HRV-2A is installed (photo #15)
27. Condensing Units SCU-1, 2, 3, 4 & FC-1, 2, 3, 4 are installed (photo #16)
28. Boilers B-3 & B-4 and vents are installed (photo #18)

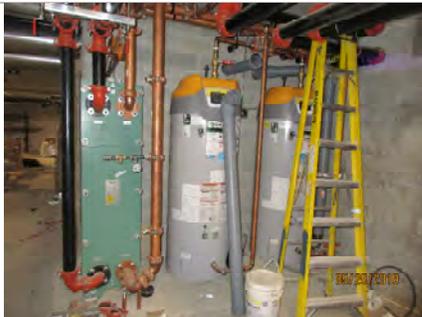
Photo #19 - HX-3, DWH heater WH-7, 8

29. Water heaters WH-7, 8 and HX-3 are installed (photo #19)

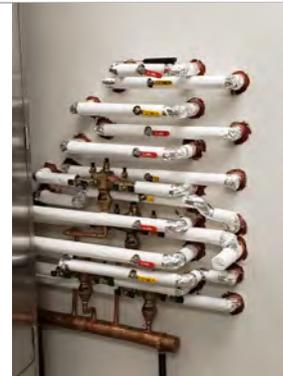
Photo #20 - Level 2: Concession Storage

- Rough-in of Phase 1C plumbing piping (Water, Sanitary and Venting)
- ~~Phase 1ABC Storm piping from roof drains down to tie-in points above grade.~~
- ~~Phase 1ABC Gas piping mains inside building.~~
- ~~Phase 1AB hydronic piping.~~
- Phase 1C Sheet metal ductwork inside building
- Commissioning
- ~~Phase 1ABC sprinkler piping inside building.~~
- Phase 1A Concession fixtures installation in progress (photo #20)

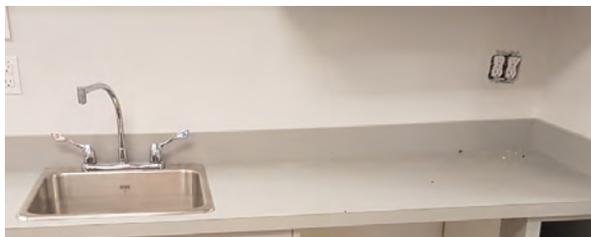
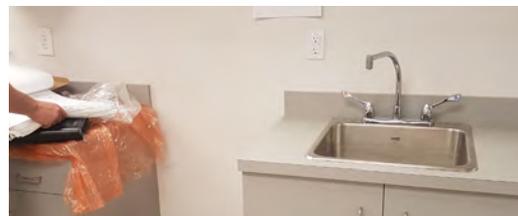
Item 1.2.7

- 1.2.7 Receptacles in Library Kitchen area are not GFI but are within required clearance from a sink. These must be replaced.
  - 1.2.8 BX cable at corridor exit from Electrical Room #5 requires fastening to wall.

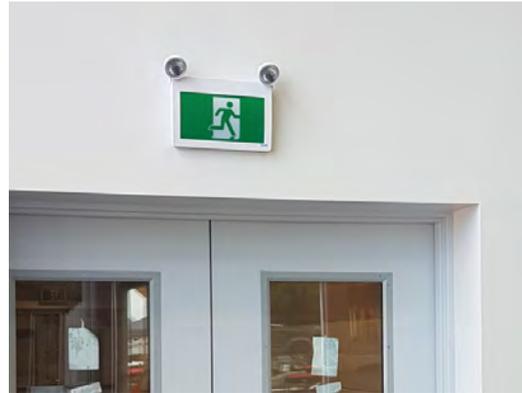
Item 1.2.9

- 1.2.9 Combination Emergency light/Exit lights installed with Rink Areas. These were not called for in the design but are acceptable and an improvement to emergency lighting levels. These lights require testing to ensure 30 minute operation upon power failure.
