PORT COQUITLAM COMMUNITY CENTRE

Owner's Representative Progress Report #29

August 2019

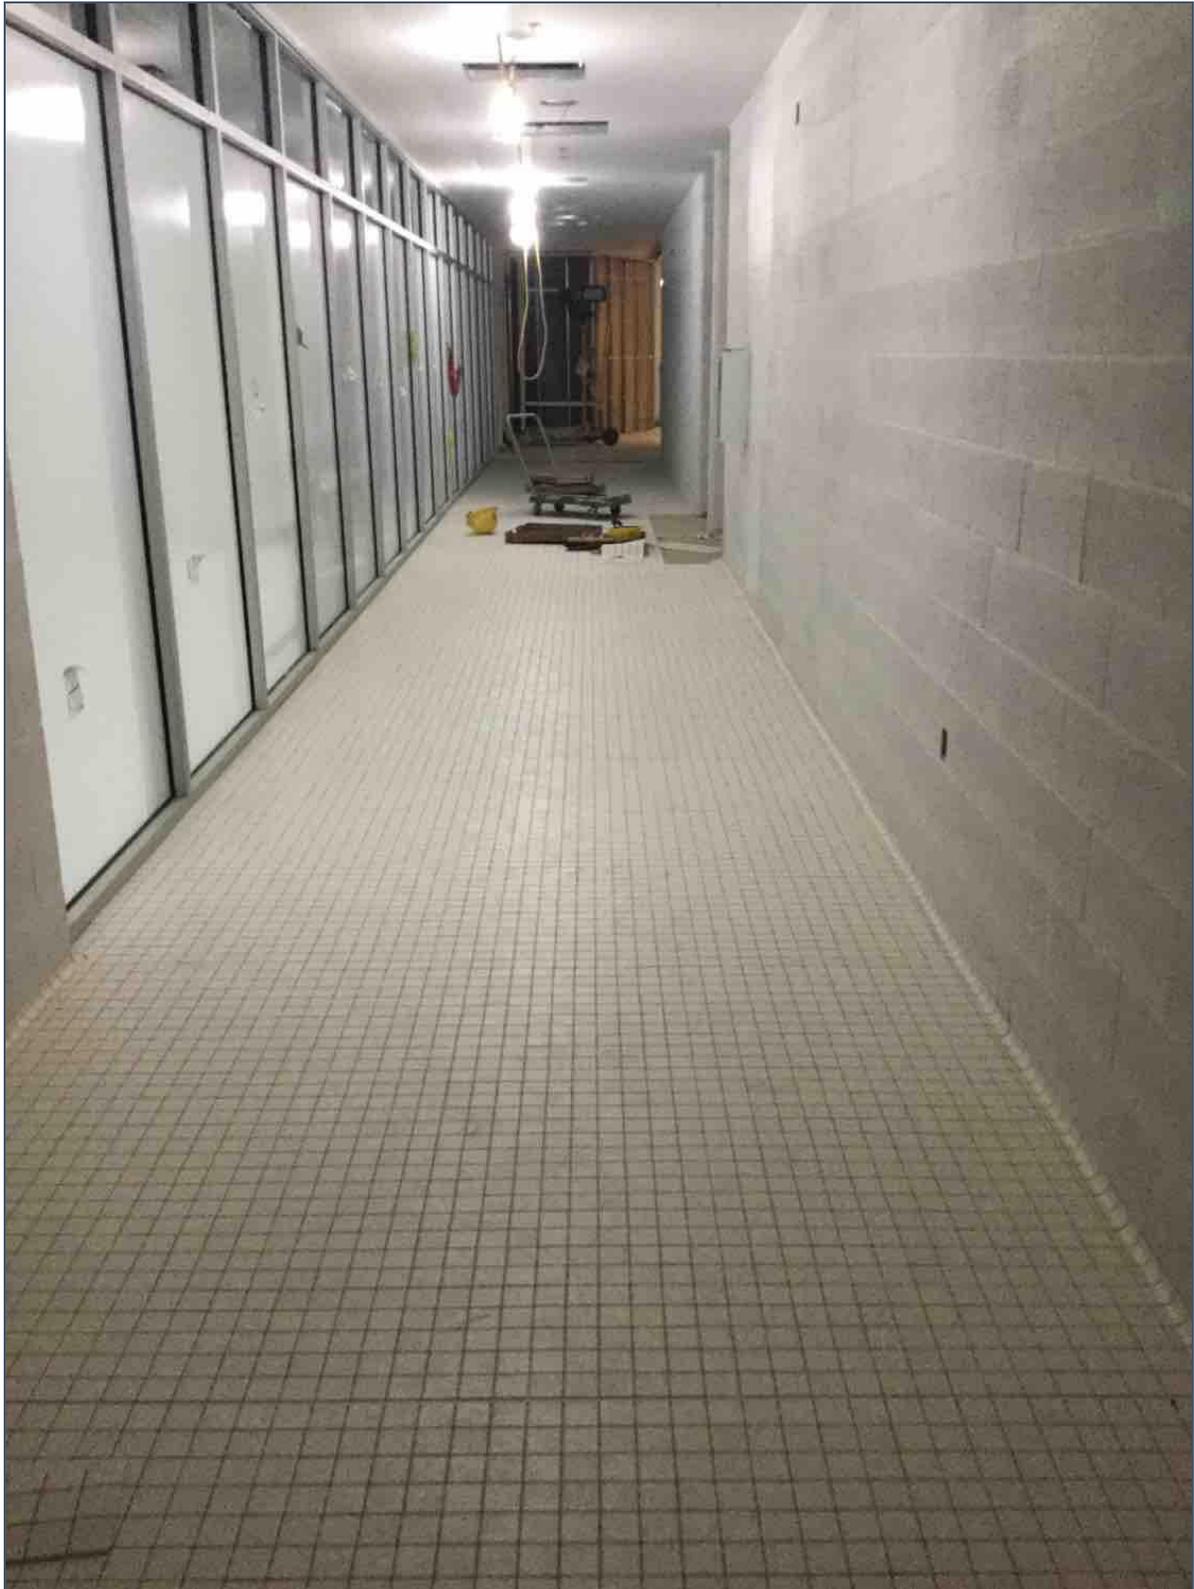
Phase 1C – Tiling complete to changeroom corridor

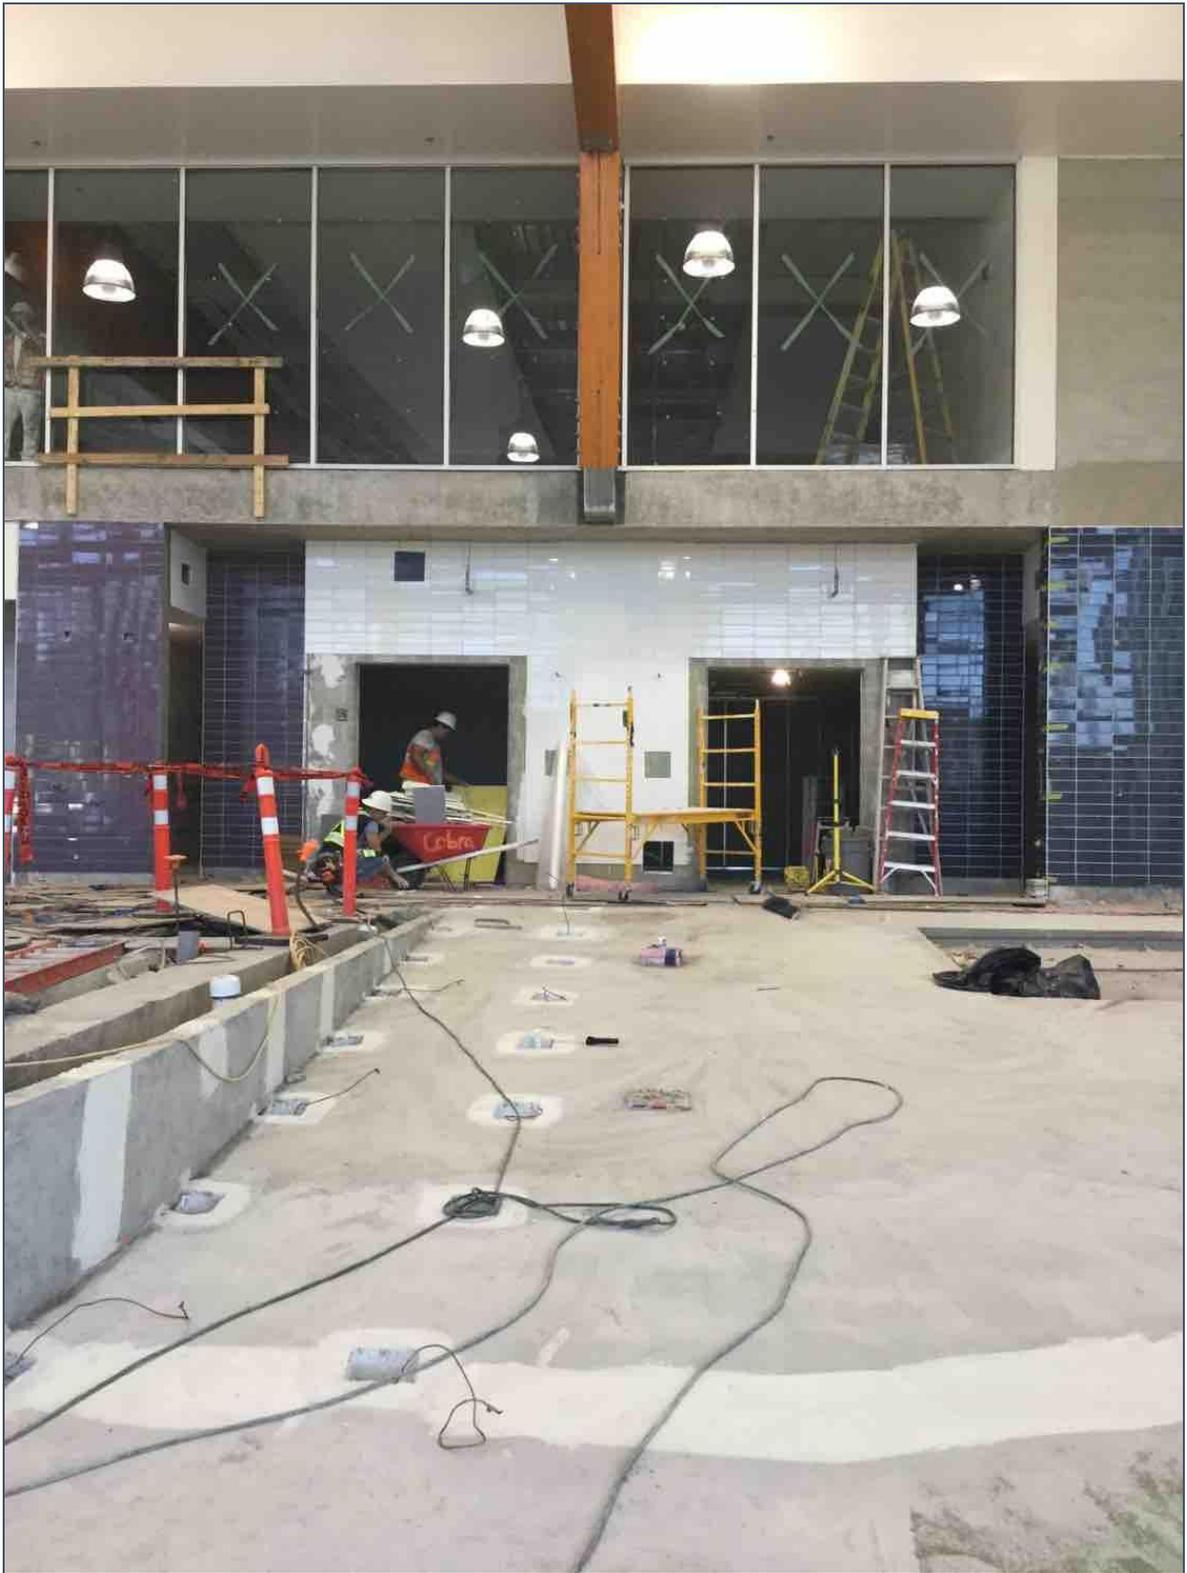
Phase 1C – Tiling to change room, steam room and sauna entrances

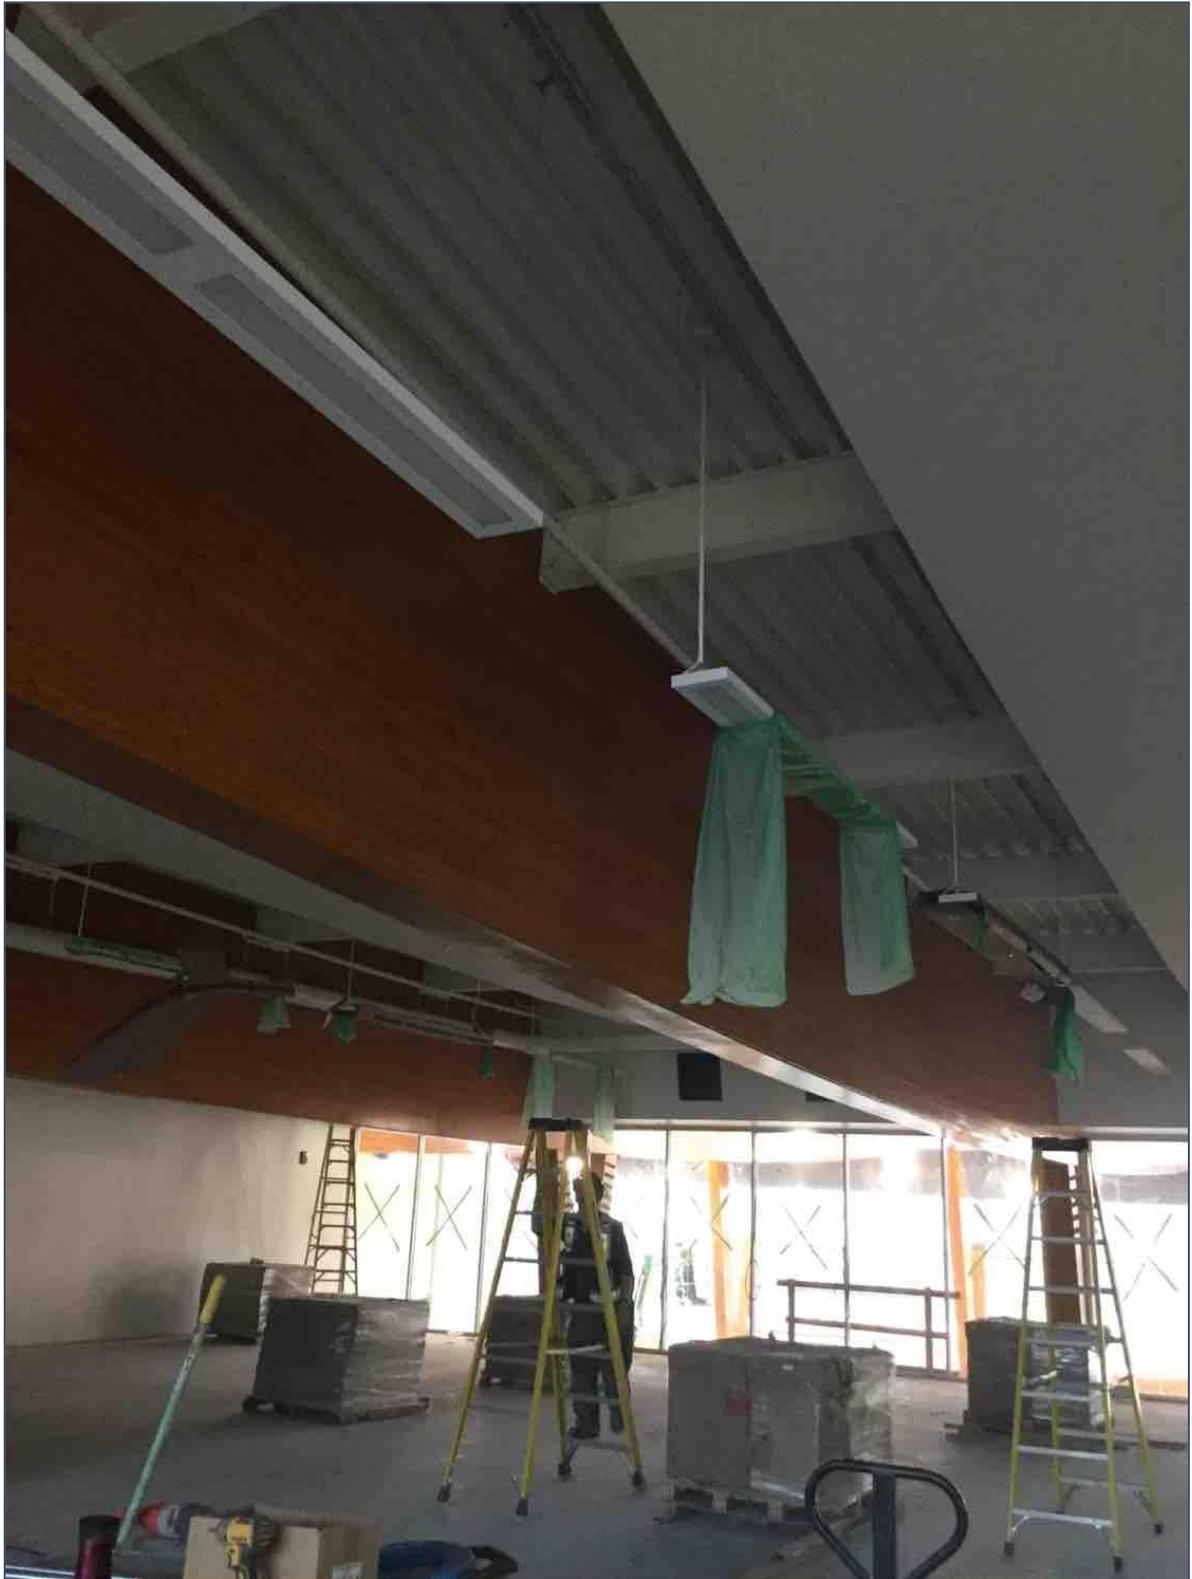
Phase 1C – Weights Area: Lighting install

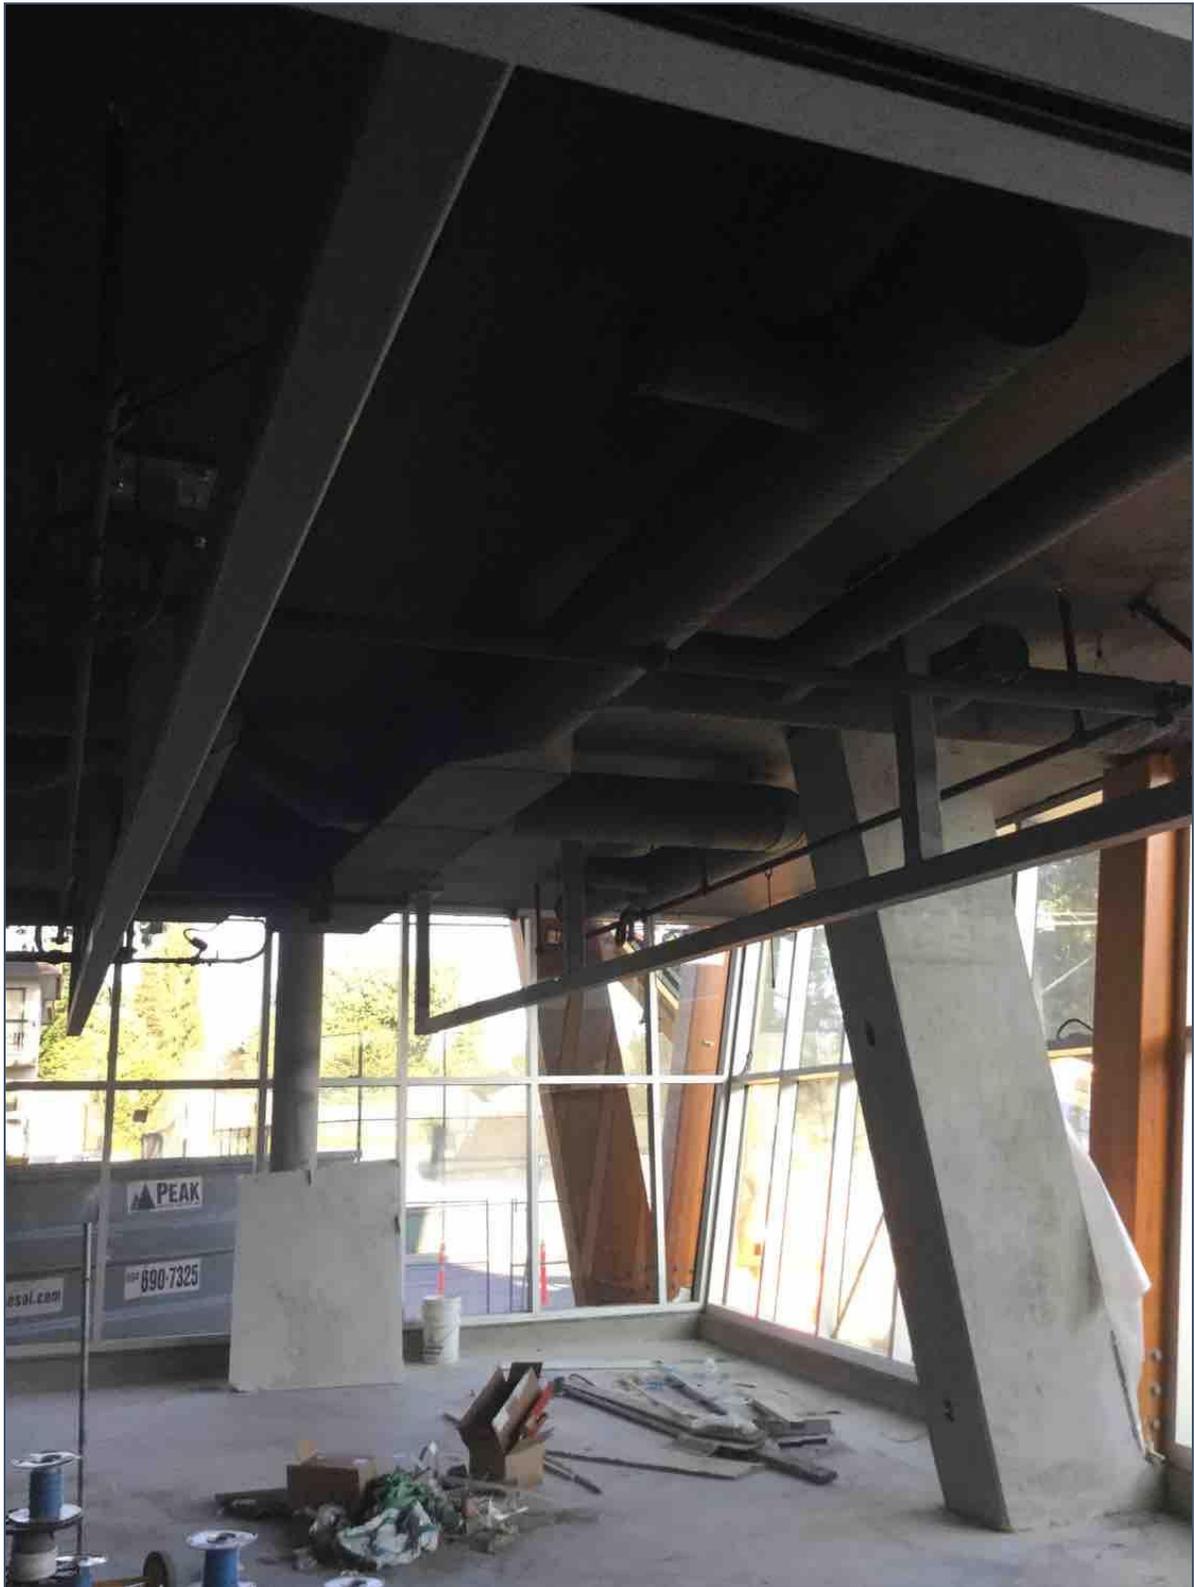
Phase 1C – TRX steelwork installation

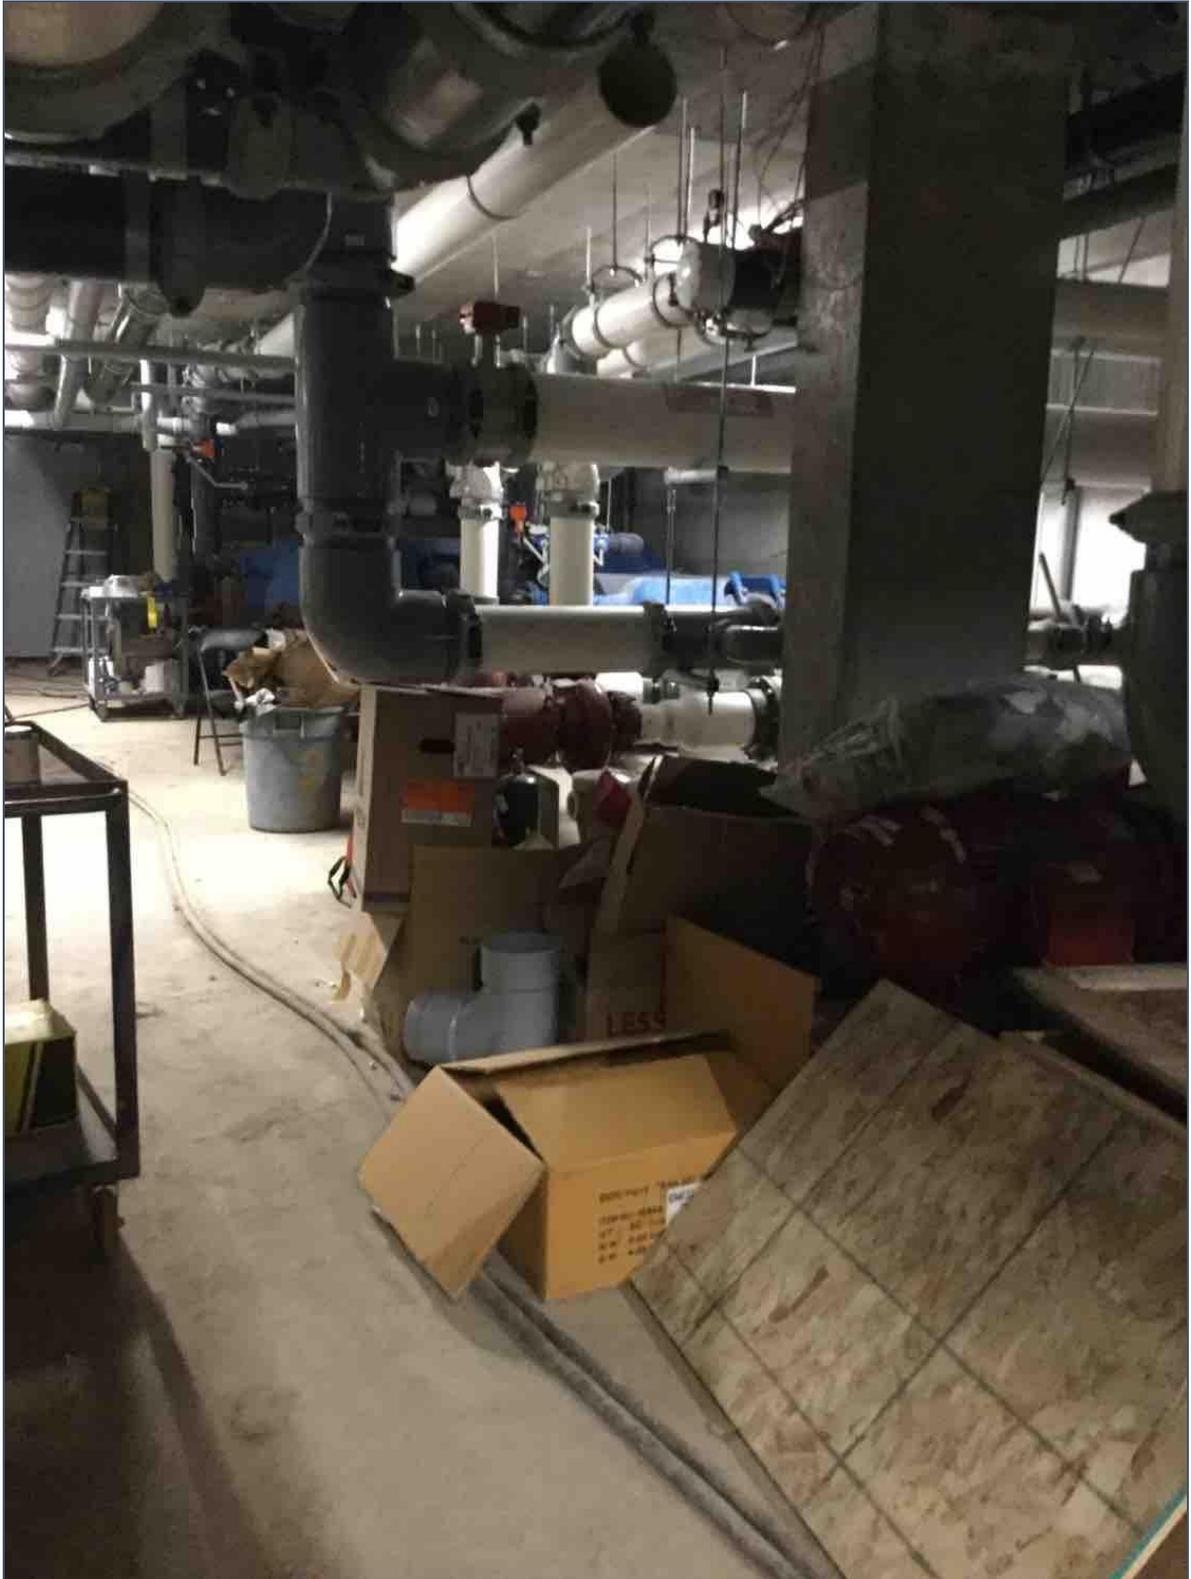
Phase 1C – Pool equipment room

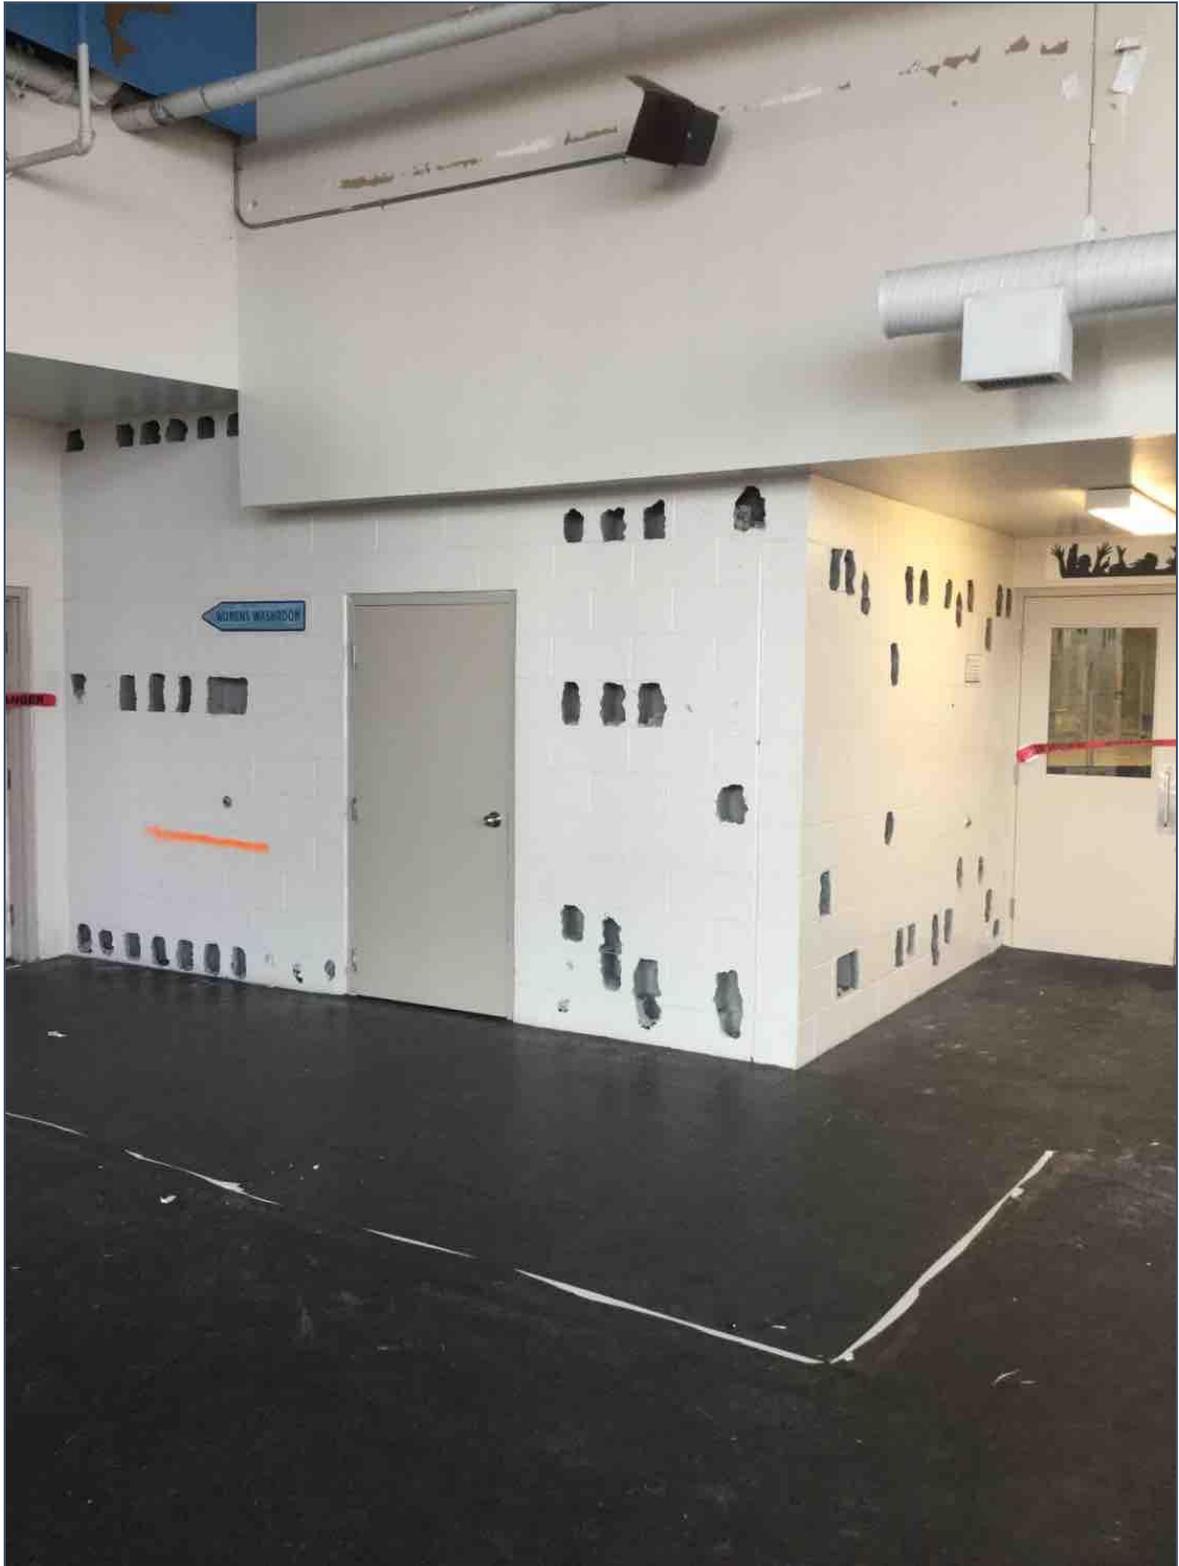
Phase 2 – Asbestos abatement in old facility

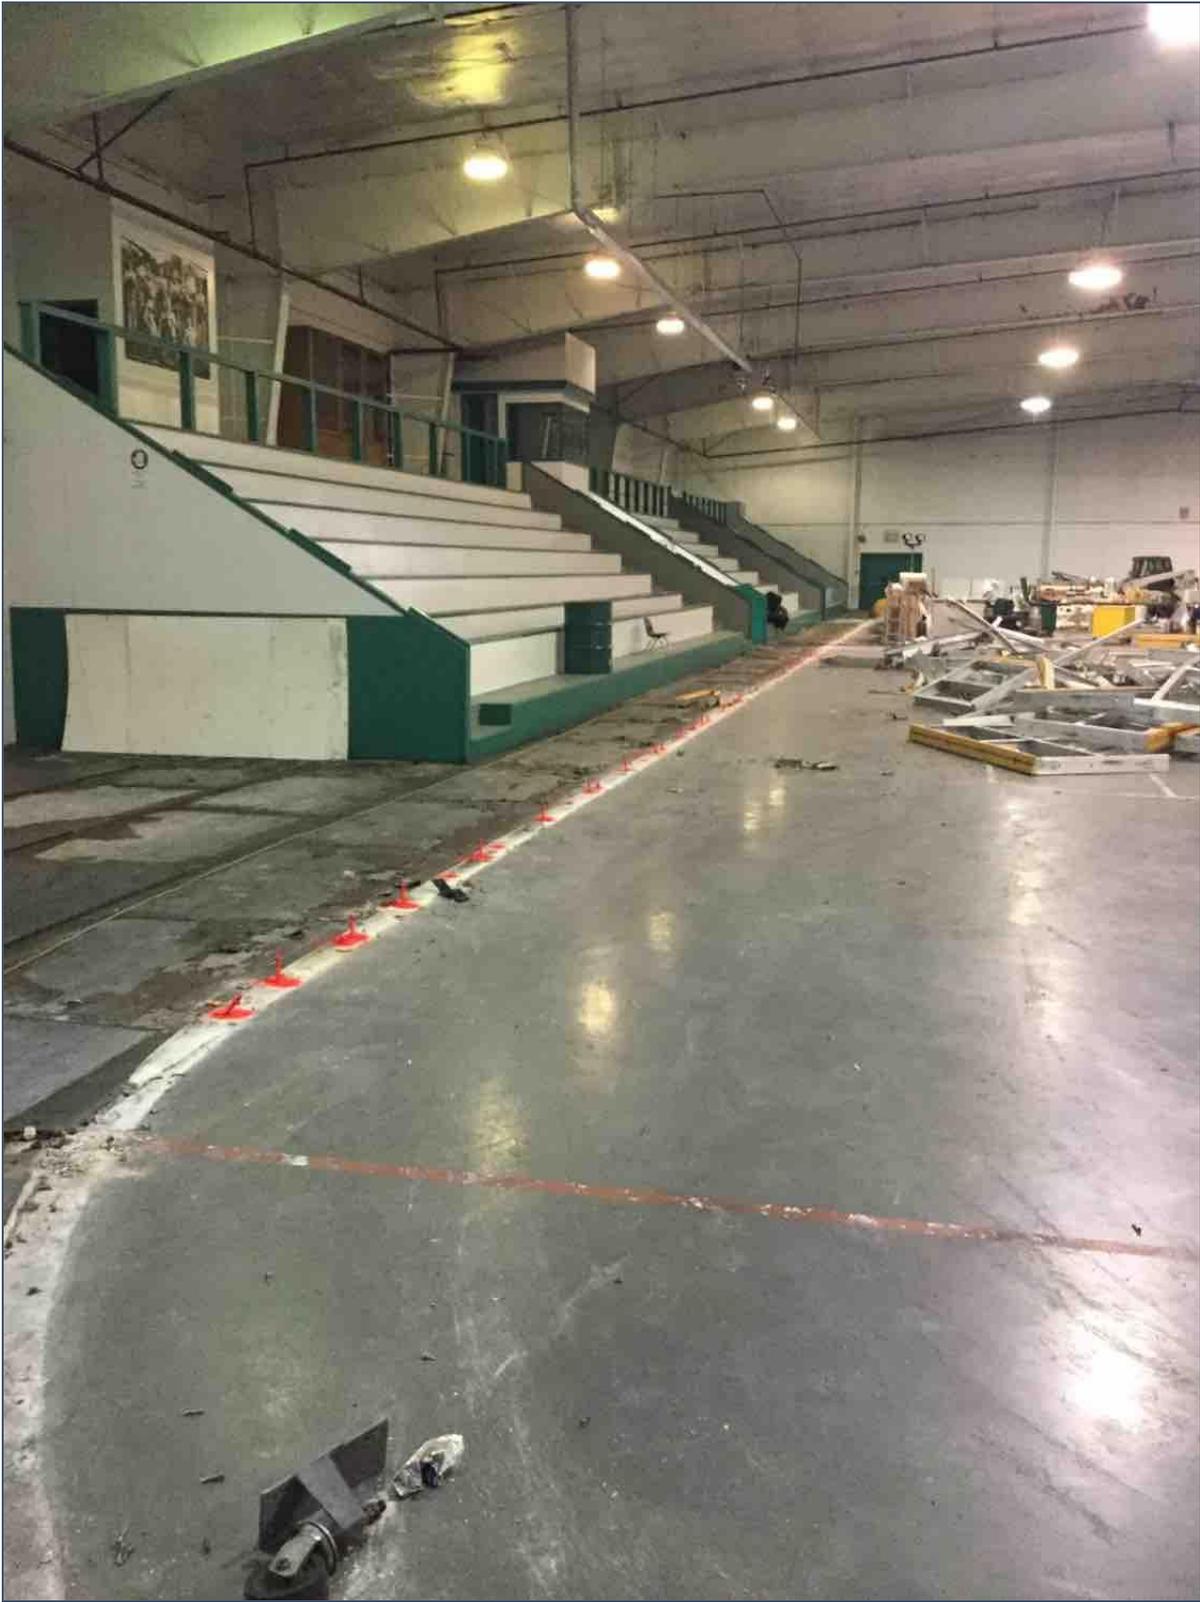
Phase 2 – Green Arena Demolition

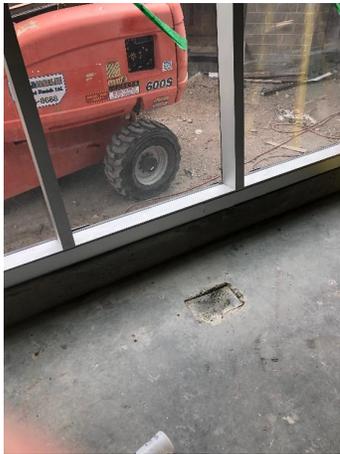
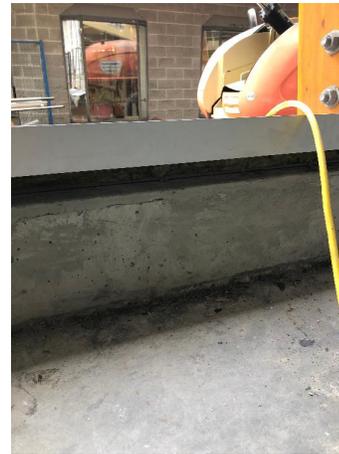
Type / Subtype Observation / Observation
Location P1C > Exterior > Wall > Fitness North
Root Cause
Checklist Source
Reference Drawing
Creator **Adam Chambers** Architecture49
Issue Owner **Adam Chambers** Architecture49
Assignee
Description

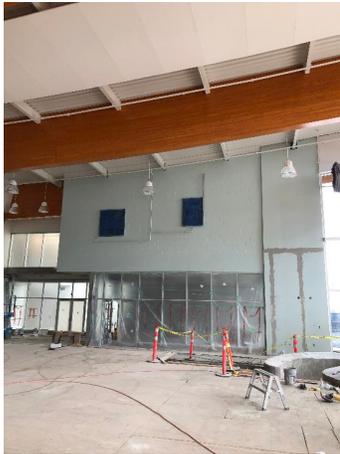
IMG_0090.JPG - Aug 21, 2019 - Adam Chambers

#302 54.2.01 - Int - Pool Interior Painting

<i>Type / Subtype</i> Observation / Observation
<i>Location</i> P1C > Level 1 > 1C139 - POOL
<i>Root Cause</i>
<i>Checklist Source</i>
<i>Reference Drawing</i>
<i>Creator</i> Adam Chambers Architecture49
<i>Issue Owner</i> Adam Chambers Architecture49
<i>Assignee</i>
<i>Description</i>

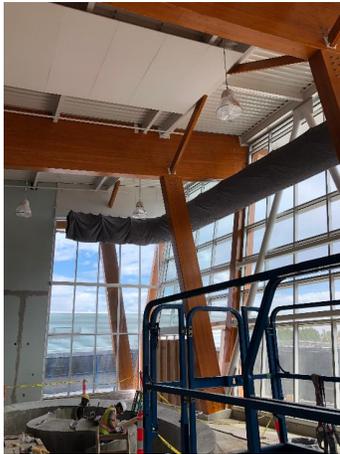
IMG_0091.JPG - Aug 21, 2019 - Adam Chambers

#303 54.2.02 - Int - Pool Fabric Duct Installation

<i>Type / Subtype</i> Observation / Observation
<i>Location</i> P1C > Level 1 > 1C139 - POOL
<i>Root Cause</i>
<i>Checklist Source</i>
<i>Reference Drawing</i>
<i>Creator</i> Adam Chambers Architecture49
<i>Issue Owner</i> Adam Chambers Architecture49
<i>Assignee</i>
<i>Description</i>

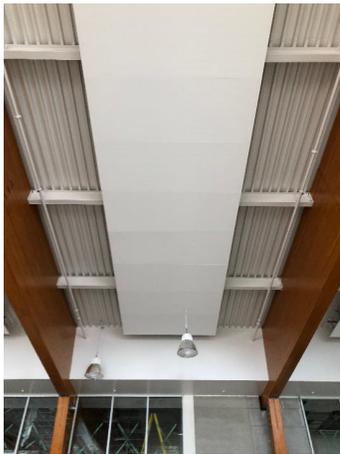
IMG_0092.JPG - Aug 21, 2019 - Adam Chambers

#304 54.2.03 - Int - Pool Ceiling Installation

<i>Type / Subtype</i>	Action Required / Action Required
<i>Location</i>	P1C > Level 1 > 1C139 - POOL
<i>Root Cause</i>	
<i>Checklist Source</i>	
<i>Reference Drawing</i>	
<i>Creator</i>	Adam Chambers Architecture49
<i>Issue Owner</i>	Adam Chambers Architecture49
<i>Assignee</i>	
<i>Description</i>	As discussed with Matt while on site, adjust ceiling panels to minimize gaps and height changes between panels. Supporting structure for ceiling to be painted.

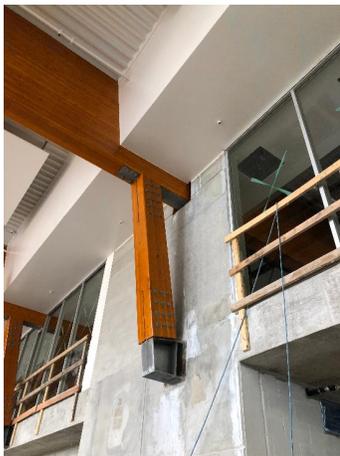
IMG_0093.JPG - Aug 21, 2019 - Adam Chambers

#305 54.2.04 - Int - Detail Required at Glulam Penetration of Shear Wall

<i>Type / Subtype</i>	Action Required / Action Required
<i>Location</i>	P1C > Level 1 > 1C139 - POOL
<i>Root Cause</i>	
<i>Checklist Source</i>	
<i>Reference Drawing</i>	
<i>Creator</i>	Adam Chambers Architecture49
<i>Issue Owner</i>	Adam Chambers Architecture49
<i>Assignee</i>	
<i>Description</i>	A49 to provide detail of penetration closure.
Post Review Note: Detail was issued as part of RFI-537 response.

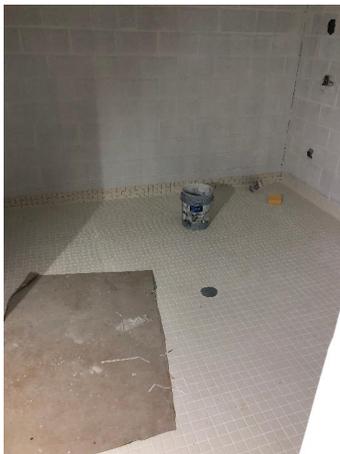
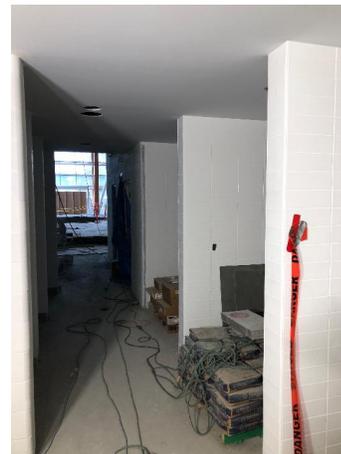
#306 54.2.05 - Int - Pool Change Room Tile Installation Progress

<p><i>Type / Subtype</i> Observation / Observation</p> <p><i>Location</i> P1C > Level 1 > 1C139 - POOL</p> <p><i>Root Cause</i></p> <p><i>Checklist Source</i></p> <p><i>Reference Drawing</i></p> <p><i>Creator</i> Adam Chambers Architecture49</p> <p><i>Issue Owner</i> Adam Chambers Architecture49</p> <p><i>Assignee</i></p> <p><i>Description</i> Pool change room tile installation is progressing through-out most change rooms. VCC advised that universal change room floor tile installation will happen with pool deck tile so grout lines will match.</p>
--

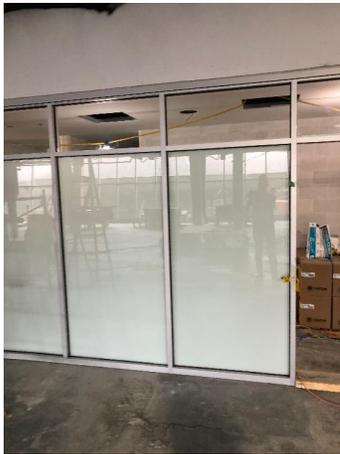
IMG_0098.JPG - Aug 21, 2019 - Adam Chambers

#307 54.2.06 - Int - Fitness Centre/Pool Corridor Glazing Progress

<p><i>Type / Subtype</i> Observation / Observation</p> <p><i>Location</i> P1C > Level 1 > 1C125 - CORRIDOR</p> <p><i>Root Cause</i></p> <p><i>Checklist Source</i></p> <p><i>Reference Drawing</i></p> <p><i>Creator</i> Adam Chambers Architecture49</p> <p><i>Issue Owner</i> Adam Chambers Architecture49</p> <p><i>Assignee</i></p> <p><i>Description</i> The glazing between the Level 1 Fitness Centre and the Pool Corridor is progressing with the frames nearing completion, and the majority of the clear and fritted glass installed.</p>
--

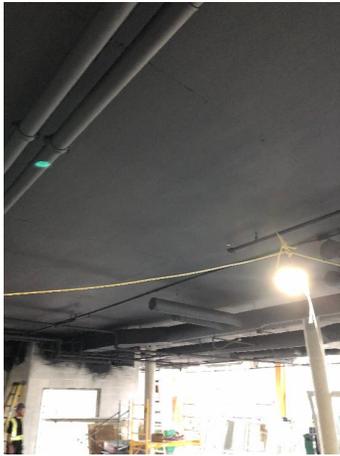
IMG_0099.JPG - Aug 21, 2019 - Adam Chambers

#308 54.2.07 - Int - Fitness Centre Ceiling Painting Progress

<i>Type / Subtype</i> Observation / Observation
<i>Location</i> P1C > Level 1 > 1C121 - WEIGHT ROOM LEVEL 1
<i>Root Cause</i>
<i>Checklist Source</i>
<i>Reference Drawing</i>
<i>Creator</i> Adam Chambers Architecture49
<i>Issue Owner</i> Adam Chambers Architecture49
<i>Assignee</i>
<i>Description</i> Exposed ceiling painting is progressing.

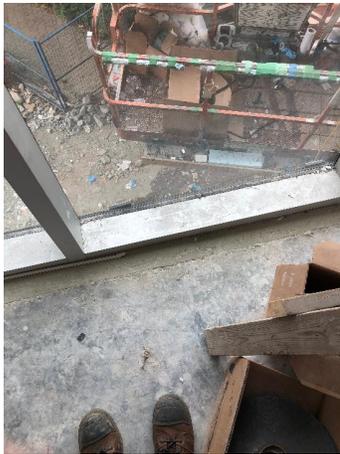
IMG_0105.JPG - Aug 21, 2019 - Adam Chambers

#310 54.2.08 - Int - Curtain Wall Fire Stopping Detail

<p><i>Type / Subtype</i> Action Required / Action Required</p> <p><i>Location</i> P1C > Level 2 > 1C230 - FITNESS STUDIO</p> <p><i>Root Cause</i></p> <p><i>Checklist Source</i></p> <p><i>Reference Drawing</i></p> <p><i>Creator</i> Adam Chambers Architecture49</p> <p><i>Issue Owner</i> Adam Chambers Architecture49</p> <p><i>Assignee</i></p> <p><i>Description</i> Please provide ULC tested detail for installed assembly. Please provide documentation that installed products conform to ULC tested detail provided.</p>
--

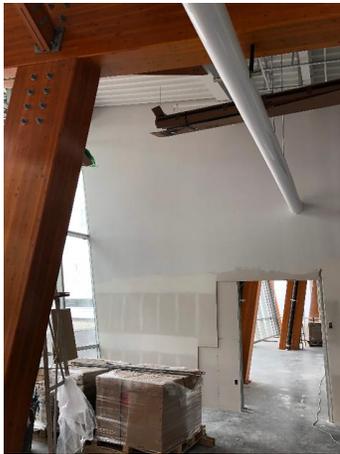
IMG_0107.JPG - Aug 21, 2019 - Adam Chambers

#311 54.2.09 - Int - Fire Rated Wall between Fitness Studio and Medical Office

<p><i>Type / Subtype</i> Observation / Observation</p> <p><i>Location</i> P1C > Level 2 > 1C230 - FITNESS STUDIO</p> <p><i>Root Cause</i></p> <p><i>Checklist Source</i></p> <p><i>Reference Drawing</i></p> <p><i>Creator</i> Adam Chambers Architecture49</p> <p><i>Issue Owner</i> Adam Chambers Architecture49</p> <p><i>Assignee</i></p> <p><i>Description</i> Progress of the fire rated wall between the second floor fitness studio and the future sports medicine office.</p>
--

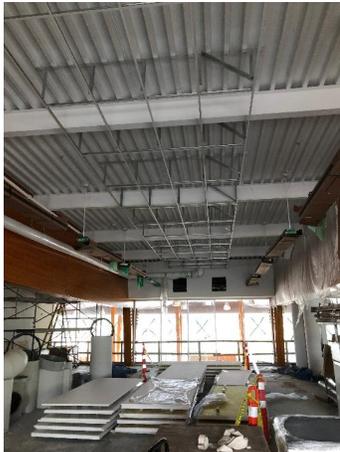
IMG_0109.JPG - Aug 21, 2019 - Adam Chambers

#312 54.2.10 - Int - Second Floor Fitness Centre Ceiling Progress

<i>Type / Subtype</i> Observation / Observation
<i>Location</i> P1C > Level 2 > 1C231 - WEIGHT ROOM LEVEL 2
<i>Root Cause</i>
<i>Checklist Source</i>
<i>Reference Drawing</i>
<i>Creator</i> Adam Chambers Architecture49
<i>Issue Owner</i> Adam Chambers Architecture49
<i>Assignee</i>
<i>Description</i> The ceiling on the second level fitness is beginning to be installed.

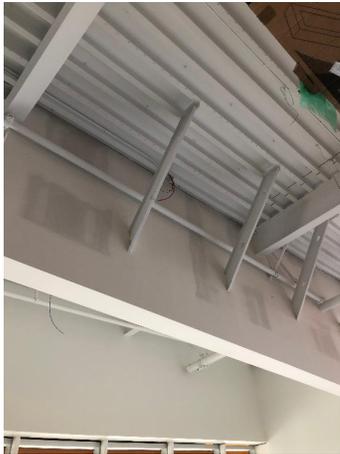
IMG_0111.JPG - Aug 21, 2019 - Adam Chambers

#313 54.2.11 - Int - Fire Stopping at Stair 3 Bulkhead

<i>Type / Subtype</i> Action Required / Action Required
<i>Location</i> P1C > Level 2 > S1C3 - STAIR 1C3
<i>Root Cause</i>
<i>Checklist Source</i>
<i>Reference Drawing</i>
<i>Creator</i> Adam Chambers Architecture49
<i>Issue Owner</i> Adam Chambers Architecture49
<i>Assignee</i>
<i>Description</i> Fire stopping at bulkhead and roof deck to be installed as per ULC tested detail.

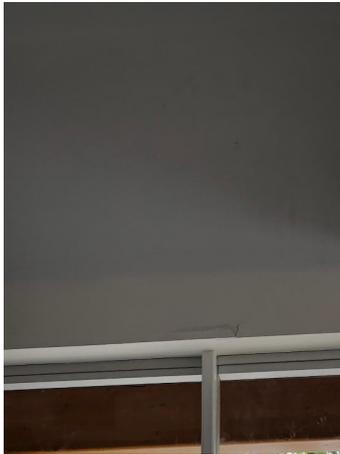
IMG_0112.JPG - Aug 21, 2019 - Adam Chambers

#314 54.2.12 - Int - Cracked Gypsum Wall Board

<i>Type / Subtype</i> Action Required / Action Required
<i>Location</i> P1C > Level 2 > 1C231 - WEIGHT ROOM LEVEL 2 (West side above glazing near Stair 3.)
<i>Root Cause</i>
<i>Checklist Source</i>
<i>Reference Drawing</i>
<i>Creator</i> Adam Chambers Architecture49
<i>Issue Owner</i> Adam Chambers Architecture49
<i>Assignee</i>
<i>Description</i> Repair and make good cracked gypsum wall finish.

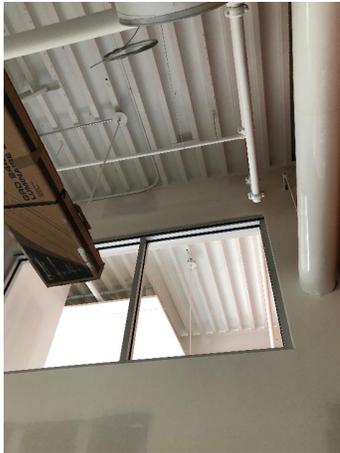
IMG_0113.JPG - Aug 21, 2019 - Adam Chambers

#315 54.2.13 - Int - Gypsum Bulkhead between Fitness Studio and Weight Room on Level 2

<i>Type / Subtype</i> Observation / Observation
<i>Location</i> P1C > Level 2 > 1C231 - WEIGHT ROOM LEVEL 2
<i>Root Cause</i>
<i>Checklist Source</i>
<i>Reference Drawing</i>
<i>Creator</i> Adam Chambers Architecture49
<i>Issue Owner</i> Adam Chambers Architecture49
<i>Assignee</i>
<i>Description</i> Progress of the gypsum board bulkhead between the Level 2 weight room and fitness studio.

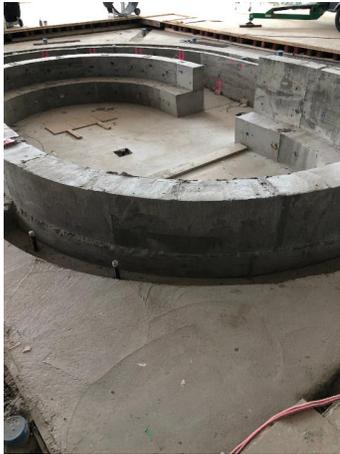
IMG_0115.JPG - Aug 21, 2019 - Adam Chambers

#316 54.2.14 - Int - Hot Tub Drainage Openings Required

<i>Type / Subtype</i> Action Required / Action Required
<i>Location</i> P1C > Level 1 > 1C139 - POOL (North Hot Tub Wall)
<i>Root Cause</i>
<i>Checklist Source</i>
<i>Reference Drawing</i>
<i>Creator</i> Adam Chambers Architecture49
<i>Issue Owner</i> Adam Chambers Architecture49
<i>Assignee</i>
<i>Description</i> Provide openings through concrete wall as noted on Drawing A-P1C-1101.

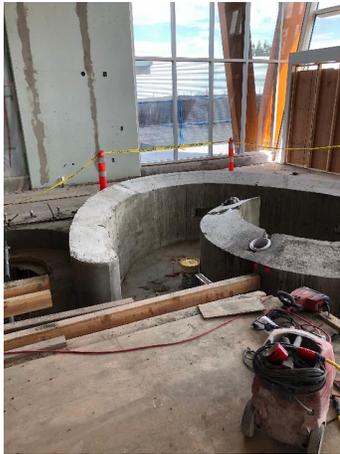
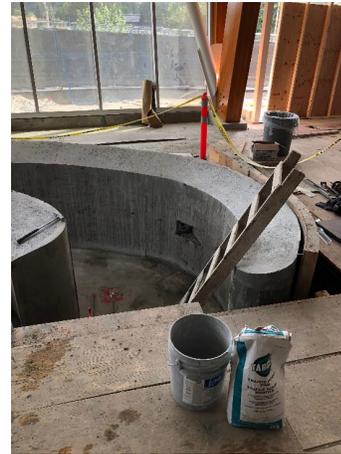
#317 54.2.15 - Int - Lazy River Progress

<i>Type / Subtype</i> Observation / Observation
<i>Location</i> P1C > Level 1 > 1C139 - POOL
<i>Root Cause</i>
<i>Checklist Source</i>
<i>Reference Drawing</i>
<i>Creator</i> Adam Chambers Architecture49
<i>Issue Owner</i> Adam Chambers Architecture49
<i>Assignee</i>
<i>Description</i> Progress of the Lazy River construction.

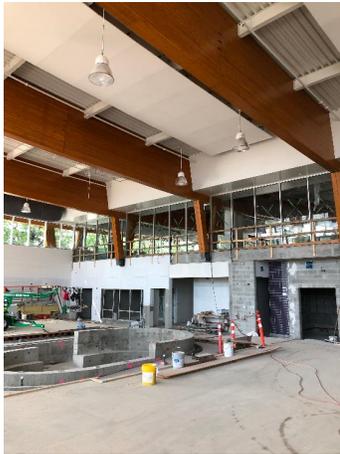
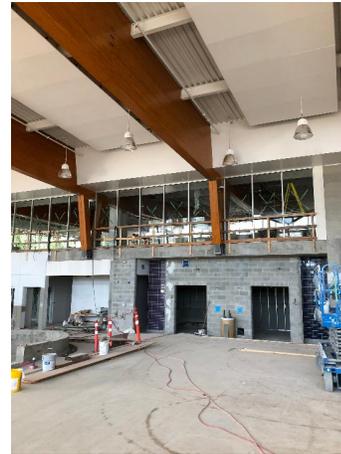
#318 54.2.16 - Int - Glazing Between Pool and Level 2 Fitness Centre Progress

<p><i>Type / Subtype</i> Observation / Observation</p> <p><i>Location</i> P1C > Level 1 > 1C139 - POOL</p> <p><i>Root Cause</i></p> <p><i>Checklist Source</i></p> <p><i>Reference Drawing</i></p> <p><i>Creator</i> Adam Chambers Architecture49</p> <p><i>Issue Owner</i> Adam Chambers Architecture49</p> <p><i>Assignee</i></p> <p><i>Description</i> Glazing between the Level 2 Fitness Centre and Pool is progressing.</p>
