PORT COQUITLAM COMMUNITY CENTRE

Owner's Representative Progress Report #32

November 2019

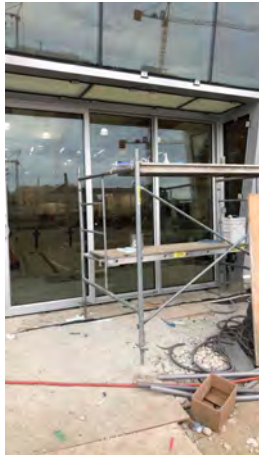
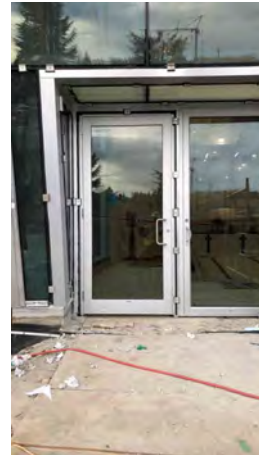
<i>Type / Subtype</i>	Observation / Observation
<i>Location</i>	P1C > Exterior > Wall > Pool South
<i>Root Cause</i>	
<i>Checklist Source</i>	
<i>Reference Drawing</i>	
<i>Creator</i>	Adam Chambers Architecture49
<i>Issue Owner</i>	Adam Chambers Architecture49
<i>Assignee</i>	
<i>Description</i>

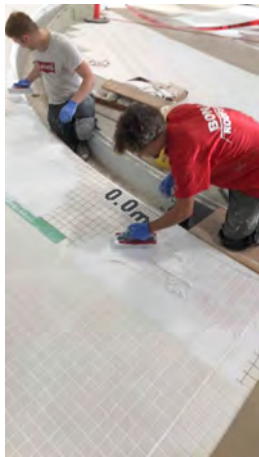
#433 59.2.01 - Pool Depth Marker - Deck Level

<i>Type / Subtype</i>	Observation / Observation
<i>Location</i>	P1C > Level 1 > 1C139 - POOL
<i>Root Cause</i>	
<i>Checklist Source</i>	
<i>Reference Drawing</i>	
<i>Creator</i>	Adam Chambers Architecture49
<i>Issue Owner</i>	Adam Chambers Architecture49
<i>Assignee</i>	
<i>Description</i>

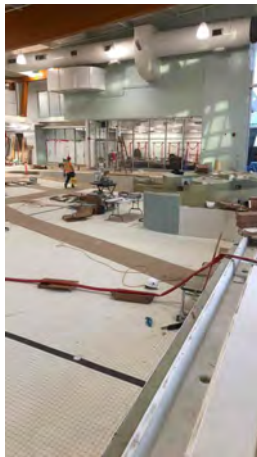
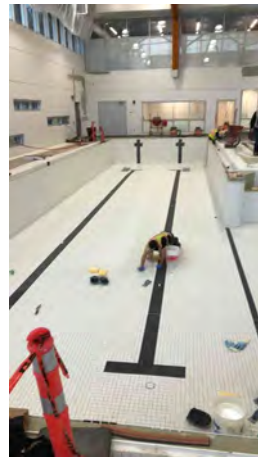
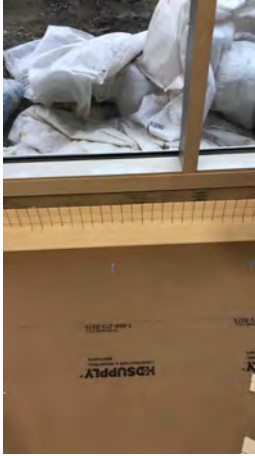
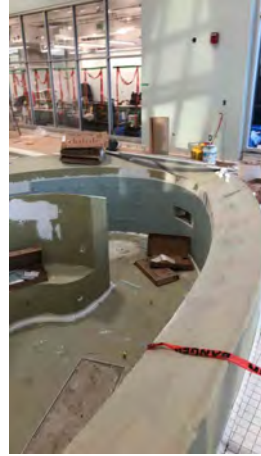
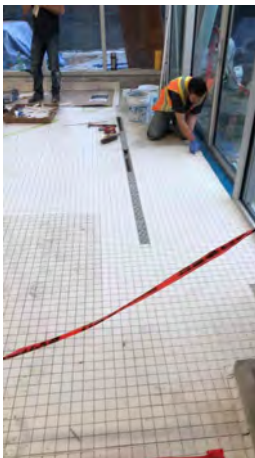
#436 59.2.03 - Pool Tiling Progress

Type / Subtype	Observation / Observation
Location	P1C > Level 1 > 1C139 - POOL
Root Cause	
Checklist Source	
Reference Drawing	
Creator	Adam Chambers Architecture49
Issue Owner	Adam Chambers Architecture49
Assignee	
Description

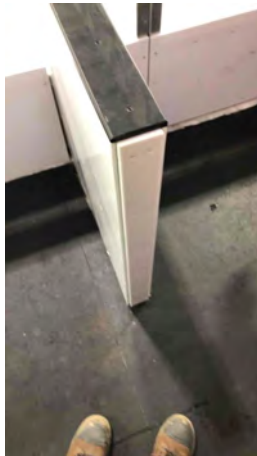
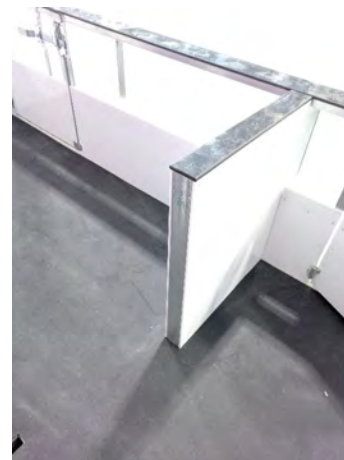
Type / Subtype	Action Required / Deficiency
Location	Rink 2 & 3
Root Cause	
Checklist Source	
Reference Drawing	
Creator	Adam Chambers Architecture49
Issue Owner	Adam Chambers Architecture49
Assignee	
Description	Provide full height backer panel on dasher board ends between player and penalty boxes, typical.

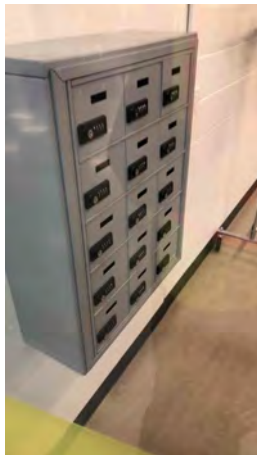
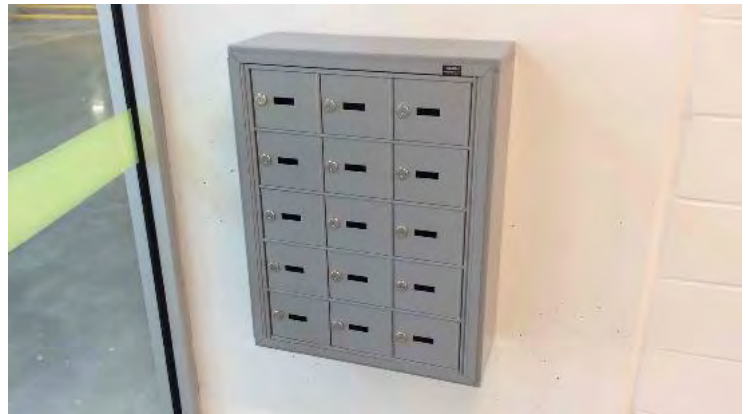
#182 Install resettable code locks.

<i>Type / Subtype</i>	Action Required / Deficiency
<i>Location</i>	P1C > Level 1 > 1C108 - GAME ROOM
<i>Root Cause</i>	
<i>Checklist Source</i>	
<i>Reference Drawing</i>	
<i>Creator</i>	Adam Chambers Architecture49
<i>Issue Owner</i>	Adam Chambers Architecture49
<i>Assignee</i>	
<i>Description</i>

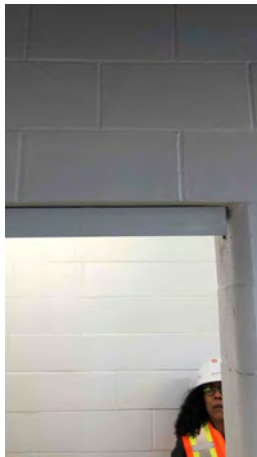
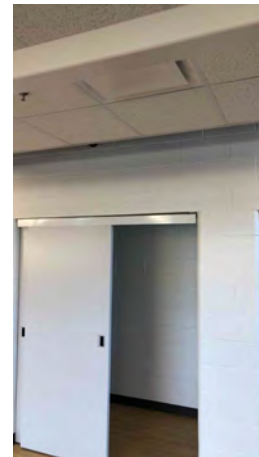
#426 58.2.04 - Door Slider Falling

<i>Type / Subtype</i>	Action Required / Action Required
<i>Location</i>	P1C > Level 1 > 1C123 - FITNESS STUDIO
<i>Root Cause</i>	
<i>Checklist Source</i>	
<i>Reference Drawing</i>	
<i>Creator</i>	Adam Chambers Architecture49
<i>Issue Owner</i>	Adam Chambers Architecture49
<i>Assignee</i>	
<i>Description</i>

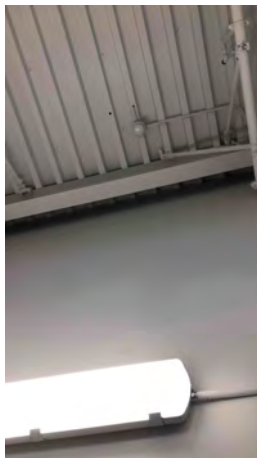
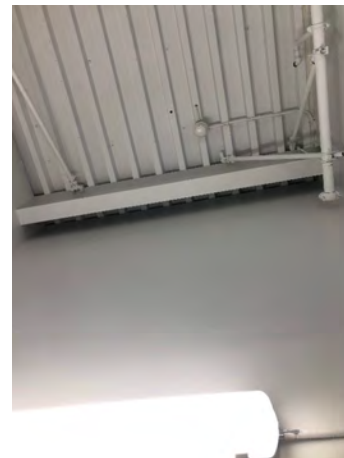
#420 57.2.38 - Fire Stopping Missing at Top of Concrete Wall in Stair 3

VCC has advised that the fire stopping was installed appropriately.
 By Adam Chambers - Nov 19, 2019 03:45 PM Architecture49

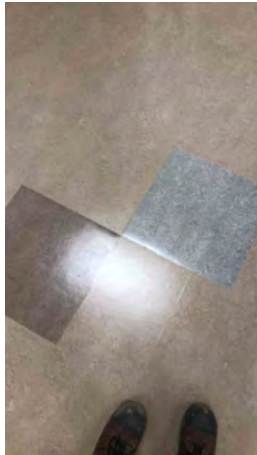
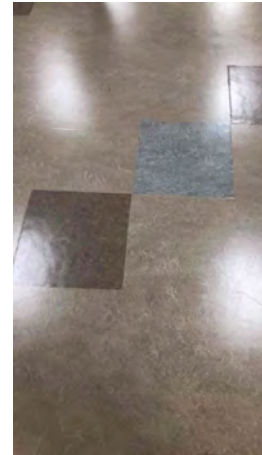
<i>Type / Subtype</i>	Action Required / Action Required
<i>Location</i>	P1C > Level 2 > 1C220 - SMALL MULTIPURPOSE
<i>Root Cause</i>	
<i>Checklist Source</i>	
<i>Reference Drawing</i>	
<i>Creator</i>	Adam Chambers Architecture49
<i>Issue Owner</i>	Adam Chambers Architecture49
<i>Assignee</i>	
<i>Description</i>	Complete the installation and seam welding of flooring.

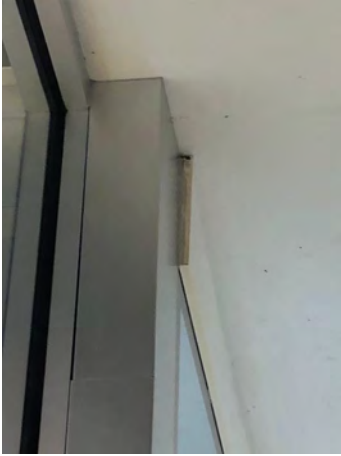
<i>Type / Subtype</i>	Action Required / Action Required
<i>Location</i>	P1C > Level 1 (Outside Entry to Fitness Centre)
<i>Root Cause</i>	
<i>Checklist Source</i>	
<i>Reference Drawing</i>	
<i>Creator</i>	Adam Chambers Architecture49
<i>Issue Owner</i>	Adam Chambers Architecture49
<i>Assignee</i>	
<i>Description</i>	Exposed gypsum board end to be finished.

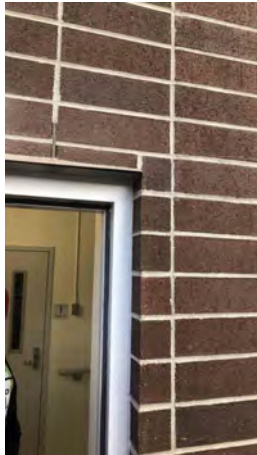
#416 57.1.04 - Seal around Door Frame

<i>Type / Subtype</i>	Action Required / Action Required
<i>Location</i>	P1C > Exterior > Wall > Pool/Fitness West (Door S1C3A)
<i>Root Cause</i>	
<i>Checklist Source</i>	
<i>Reference Drawing</i>	
<i>Creator</i>	Adam Chambers Architecture49
<i>Issue Owner</i>	Adam Chambers Architecture49
<i>Assignee</i>	
<i>Description</i>

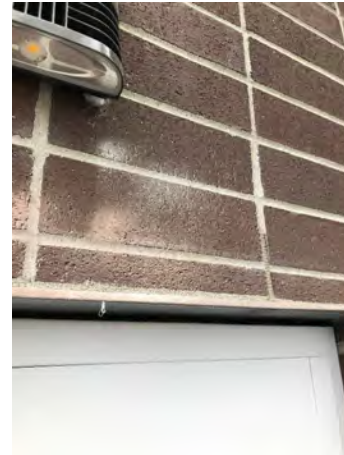
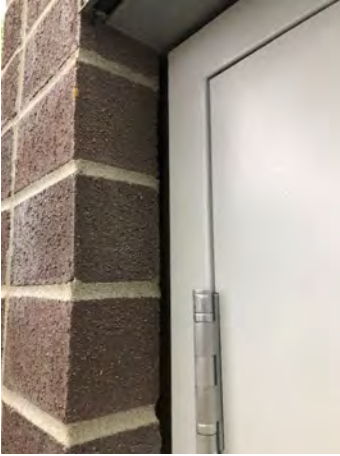
#388 57.1.03 - Cracked Masonry Mortar

<i>Type / Subtype</i>	Action Required / Action Required
<i>Location</i>	P1C > Exterior > Wall > Pool/Fitness West (Behind the Glulam Columns at GL's 1C-1 & 1C-J)
<i>Root Cause</i>	
<i>Checklist Source</i>	
<i>Reference Drawing</i>	
<i>Creator</i>	Adam Chambers Architecture49
<i>Issue Owner</i>	Adam Chambers Architecture49
<i>Assignee</i>	
<i>Description</i>	Repair and make good cracked masonry mortar.

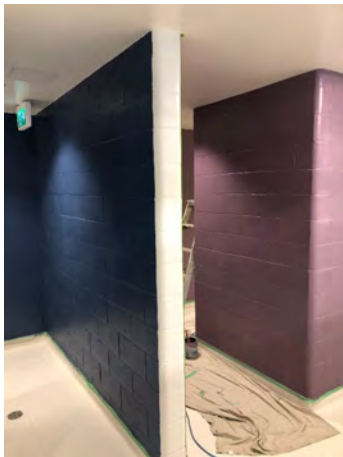
#359 56.2.13 - Int - Column Finish to be Repaired

<i>Type / Subtype</i>	Action Required / Action Required
<i>Location</i>	P1C > Level 1 > 1C123 - FITNESS STUDIO (West side of room)
<i>Root Cause</i>	
<i>Checklist Source</i>	
<i>Reference Drawing</i>	
<i>Creator</i>	Adam Chambers Architecture49
<i>Issue Owner</i>	Adam Chambers Architecture49
<i>Assignee</i>	
<i>Description</i>	Concrete repair to column is cracking. Repair and make good.

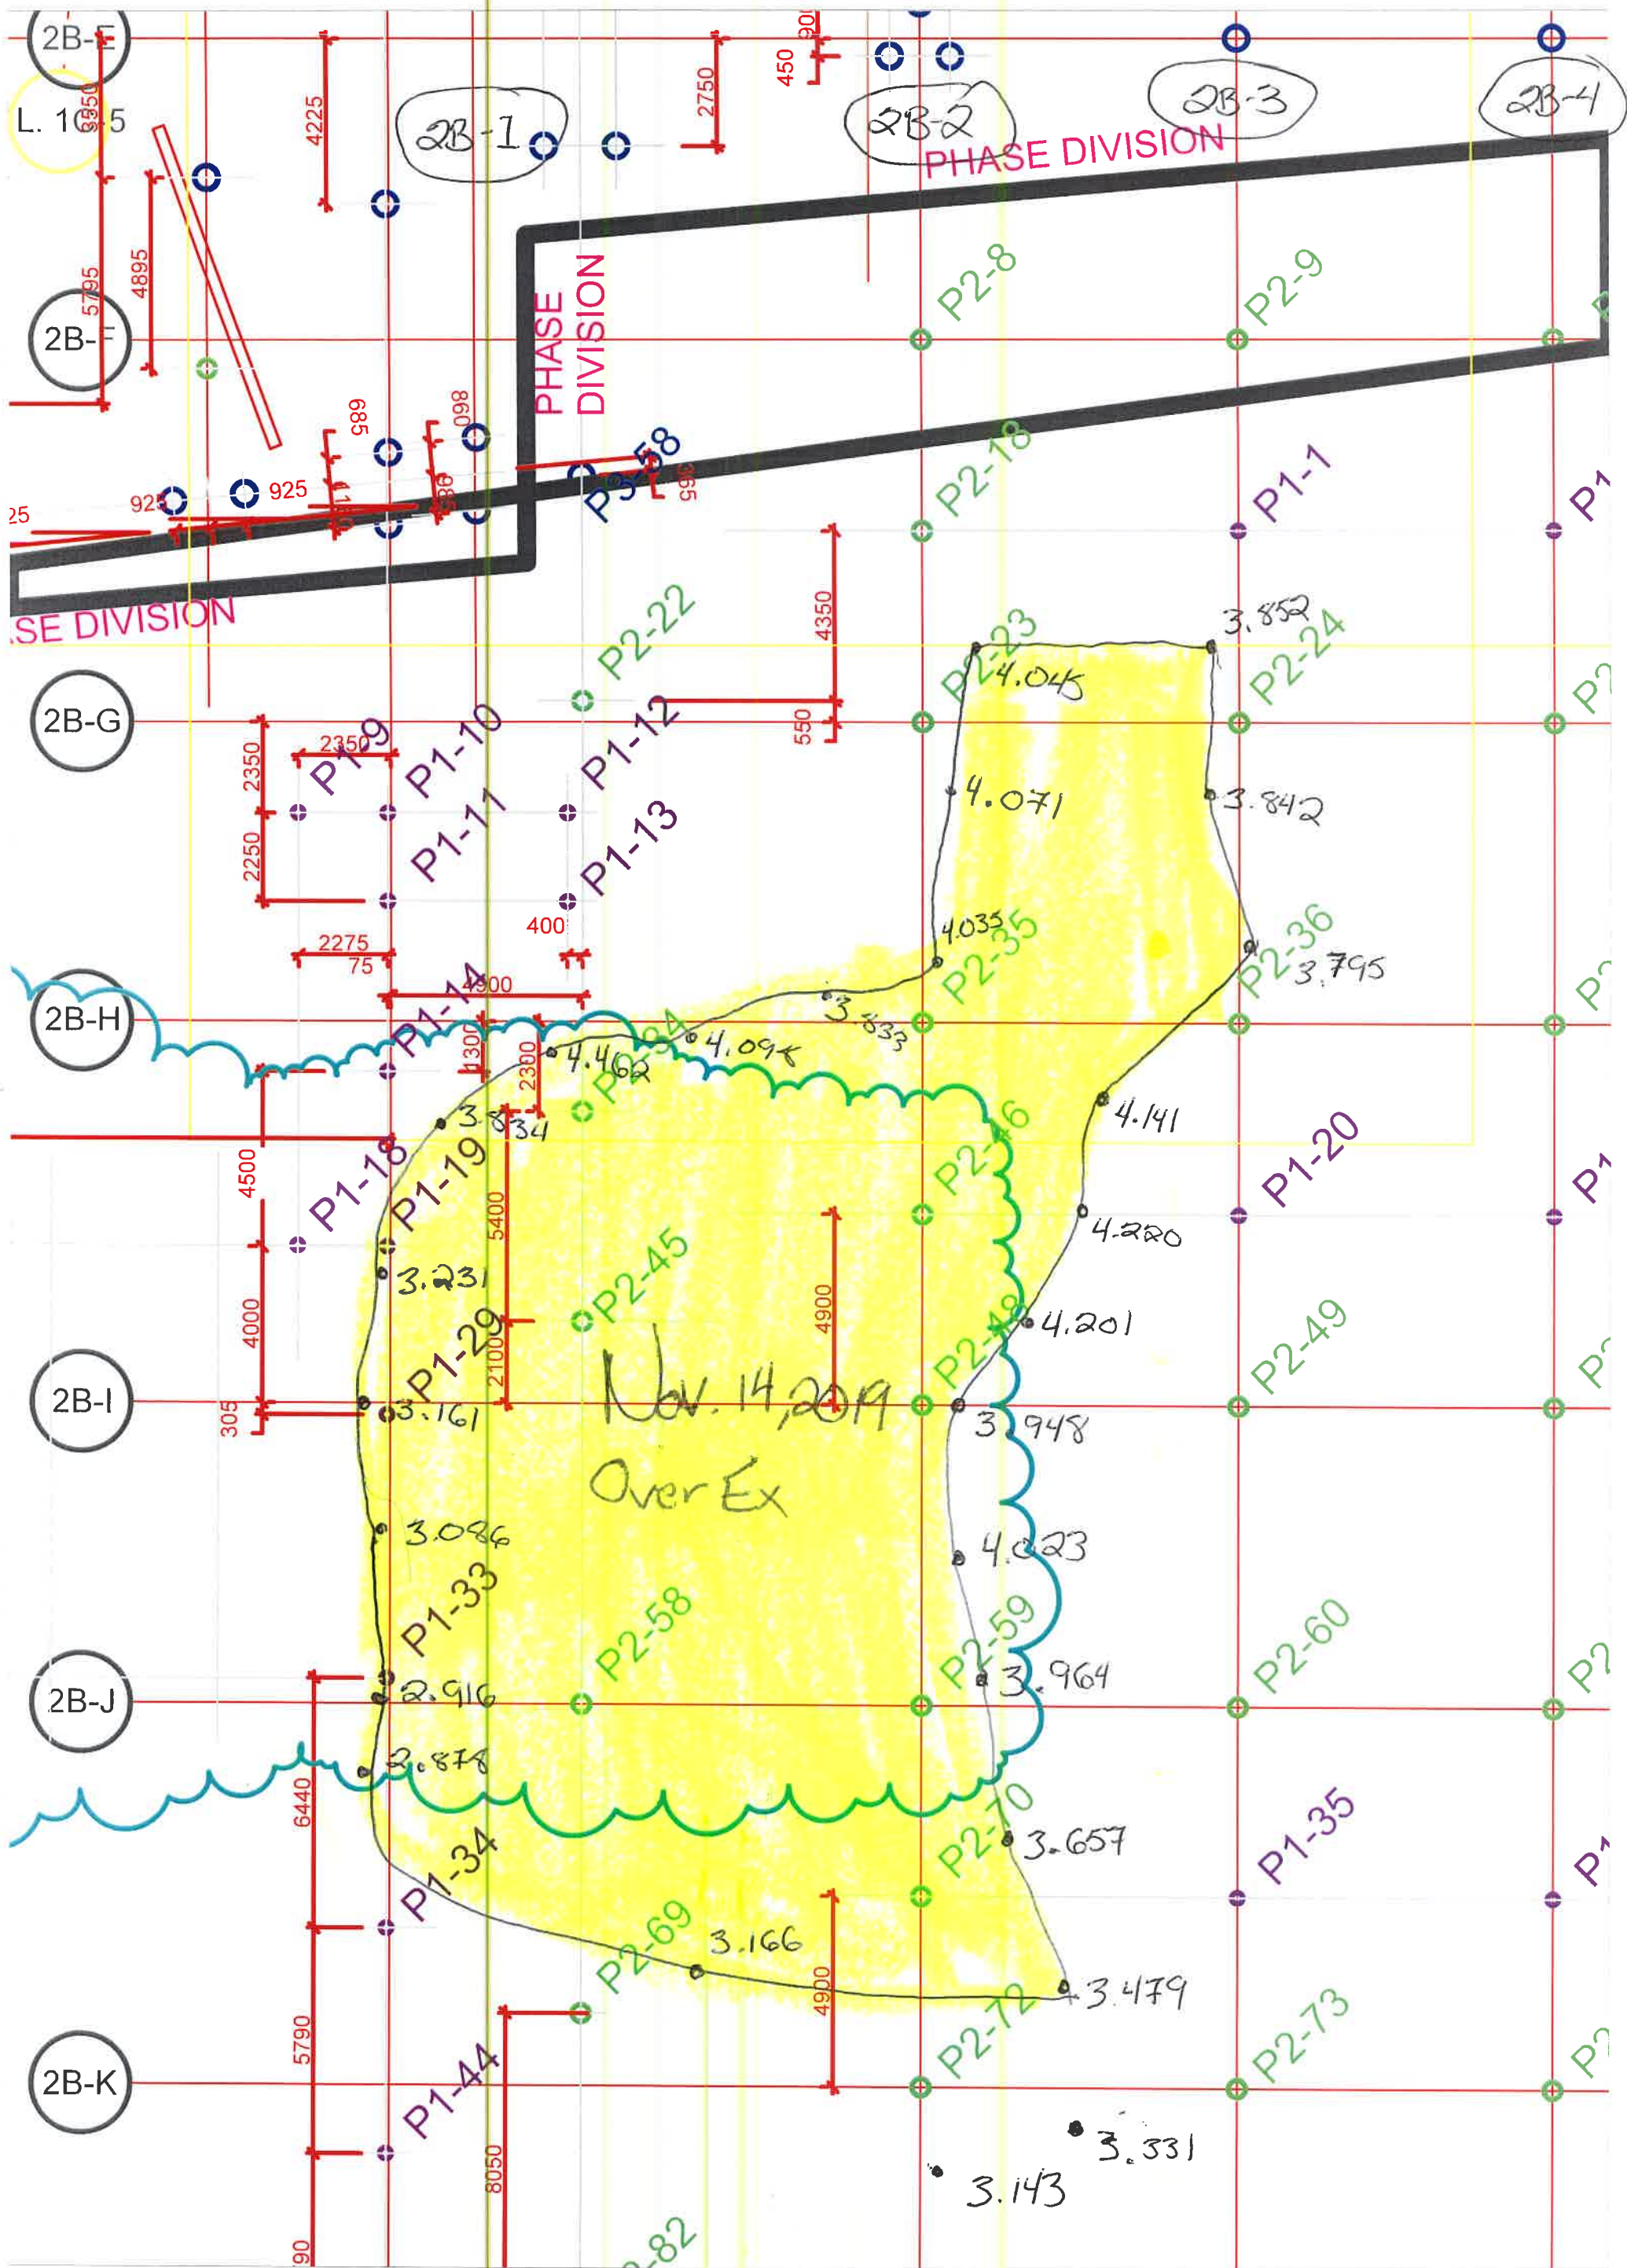
FIELD DENSITY REPORT

ATTENTION: Tallon O'Neill FILE NO.: 24160 CONTRACTOR: Hall Construction
 PROJECT: Port Coquitlam Recreation Centre REPORT DATE: November 20, 2019 AREA: Excavation – South End (Refer to Item 5 in FRR 006)
REPORT NO.: FDR 006-1 SOIL TYPE: SAND, trace gravel to gravelly, trace silt (River Sand Fill)
 CLIENT: Ventana Construction Corporation DATE TESTED: November 14, 2019 SPECIFICATION: 95% Modified Proctor Maximum Dry Density
 CC: TESTED BY: JAL
