## **PORT COQUITLAM COMMUNITY CENTRE**

### **Owner's Representative Progress Report #33**

**December 2019**

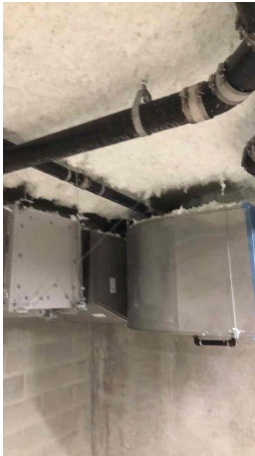
IMG\_157618378338702.jpeg - Dec 12, 2019 12:49 PM - Adam Chambers

| Description | Apply Spray Insulation to underside of slab above duct work, for a continuous, even application. |

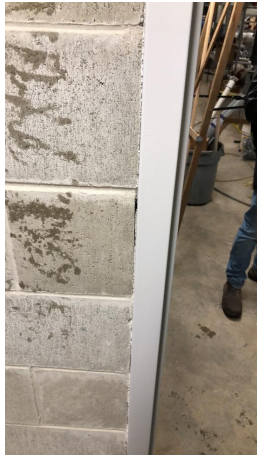
IMG\_0708.JPG - Dec 13, 2019 09:44 AM - Adam Chambers

| <i>Description</i> | Fill gaps in grouting at door frame to wall interface to seal room and fire separate. |

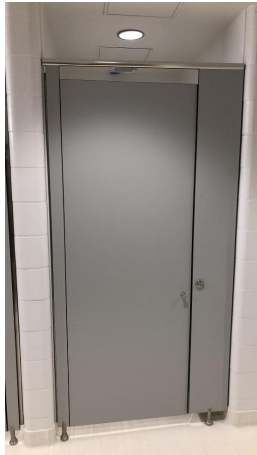
IMG\_0699.JPG - Dec 13, 2019 09:55 AM - Adam Chambers

| <i>Description</i> | Shower stall partitions have been installed within staff change room. |

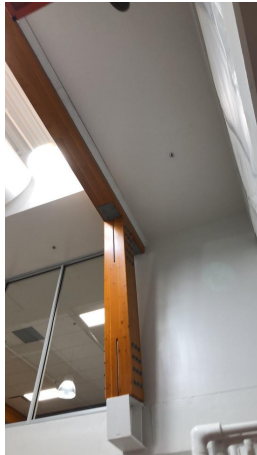
IMG\_0707.JPG - Dec 13, 2019 09:55 AM - Adam Chambers

| <i>Description</i> | Metal cover has been installed at transition between ceiling and glulam beam. |
