RE: Arborist Report for 1273508 B.C. LTD - For property located at 3390 Lancaster St., Port Coquitlam, BC

Further to the Arborist Report dated February 10, 2022, this is to serve as another revision. Due to a rezoning application and a townhouse development proposal, it was requested that a report be compiled discussing trees located at and adjacent to the address named above. This site was inspected on November 4, 2020. Thirty-one trees were assessed; they have been numbered 1 – 31 for the purpose of this report. Twelve photographs, a copy of the site survey, site plan, landscape plan, a preliminary tree replacement plan and civil drawings have been included as part of this report. The feasibility of retaining any trees will need to be reassessed once all the details of the development have been provided.

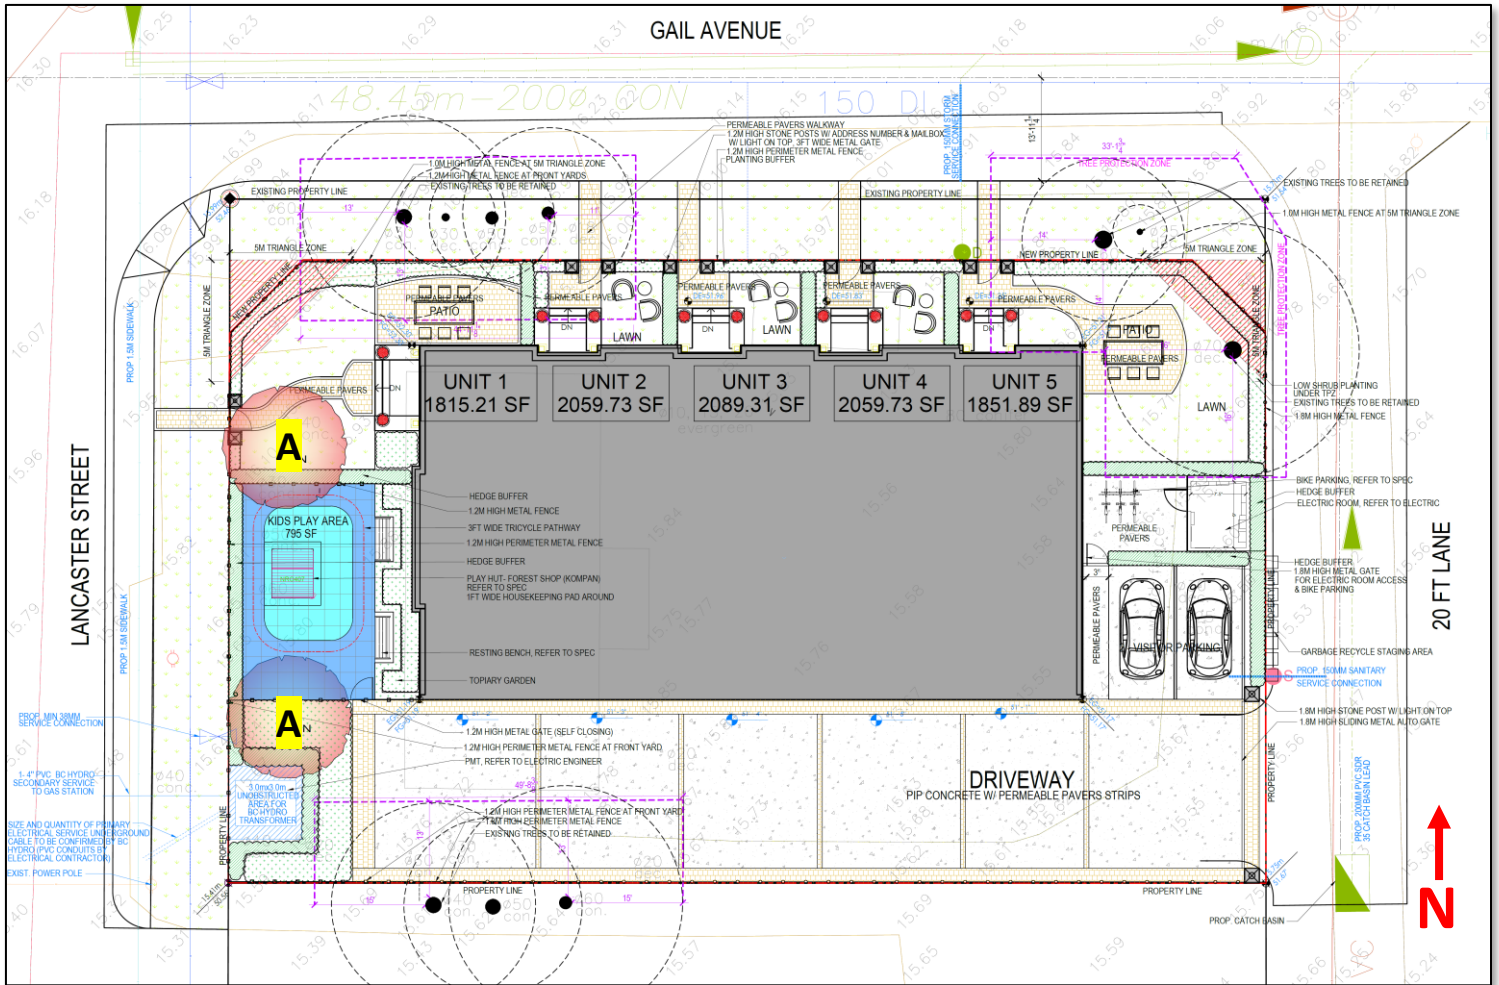
Preliminary Tree Replacement Plan – Not to Scale

TOTAL OF SIGNIFICANT TREES (60cm DBH or greater) TO BE REMOVED = 4
TOTAL OF NON-SIGNIFICANT TREES TO BE REMOVED = 17

TOTAL PROPOSED REPLACEMENTS = 2
TOTAL REPLACEMENTS REQUIRED = 25
