## CERTIFIED ARBORIST REPORT

1675 Pitt Rd, Port Coquitlam

August 29, 2022

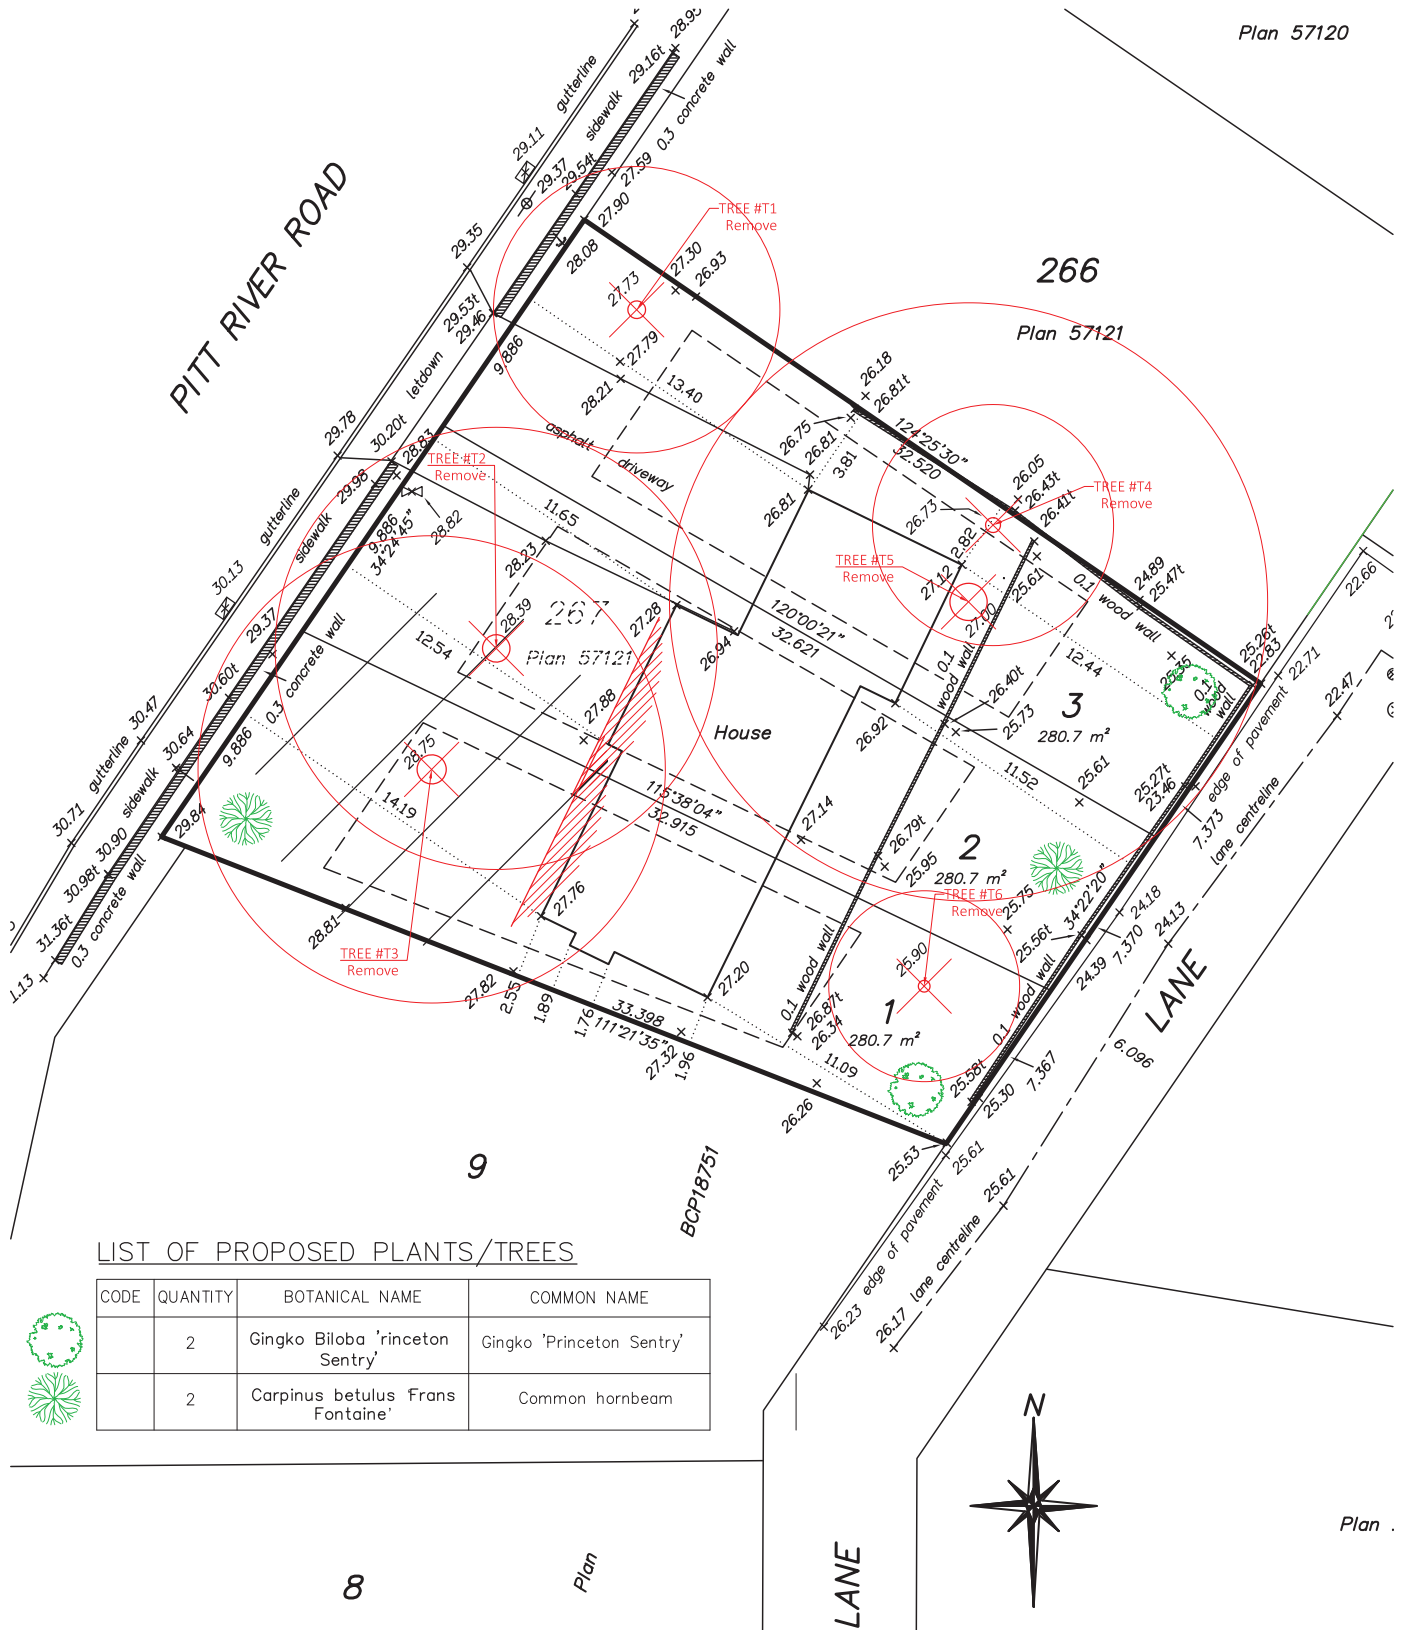
A TOTAL OF SIX (6) TREES HAVE BEEN IDENTIFIED WITHIN THE LIMITS OF THE PROPERTY. A TOTAL OF SIX (6) ON-SITE TREES HAVE BEEN RECOMMENDED FOR REMOVAL DUE TO CONFLICTS WITH THE PROPOSED DEVELOPMENT AS THEY HAD FALLEN WITHIN THE HIGH DISTURBANCE REQUIREMENT AREAS RELATING TO THE EXCAVATION, PERIMETER CONSTRUCTION WORKS, AND OTHER CONSTRUCTION RELATED ACTIVITIES OCCURRING WITHIN THE LIMITS OF THE PROPERTY.
